ROAD BARRIER CONDITION ASSESSMENT IN WIND RIVER INDIAN RESERVATION, WYOMING

Final Report For the

Department of Transportation of Wind River Indian Reservation

December, 2017

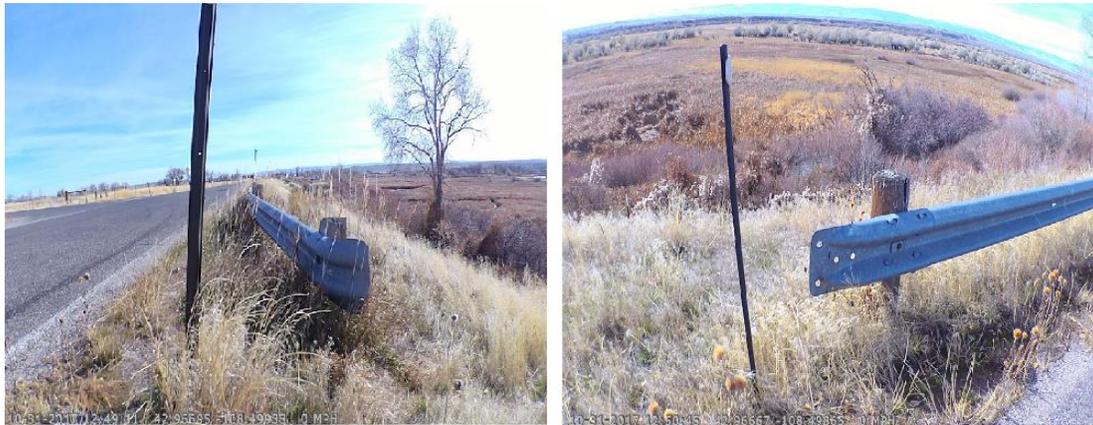
Figure 4. Condition of end-treatments in site No. 1.

Site No. 1 has a semi-rigid W-Beam guardrail with wood posts (without blockout). The poor condition of end-treatments was investigated as the main problem in this segment. As it is shown in Figure 4, one of the end-treatment seems to be a “trailing end W-Beam guardrail anchorage” type while a part of the end-post is missed. The existing end-post can apply a serious damage to

vehicles involved in a crash. In other words, it would perform the same as a sharp blade in the collisions. The first end-treatment was also missing the end terminal portion. Moreover, the offset from the edge of pavement was measured as 1 ft which is not acceptable based on the recommended offset of 4 ft in the roadside design guide (RDG) (AASHTO 2011).

a. End-treatment No. 1

b. End-treatment No. 2

Regarding the end-treatments, a tangent end-treatment would be more practical than the flared due to the limited flat area at the roadside (the flared would increase the offset from the pavement, while there is not enough width). For this reason, an “Extruder Terminal (ET-Plus),” or a “Sequential Kinking Terminal (SKT-350)” is recommended. As a cheaper alternative, the Slotted Rail Terminal (SRT-350) can be selected.

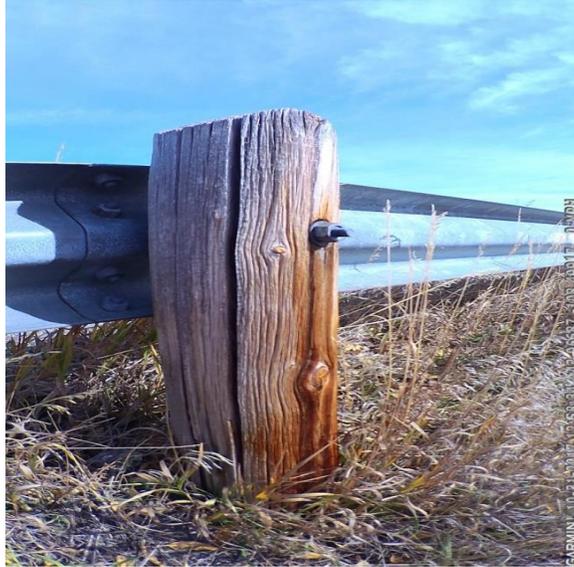
Figure 5. Condition of posts in site No. 1.

The height of barrier was the second significant problem in this segment. The low-height barriers raise the propensity of vehicle rollover and override, while very tall-barriers are also promoting the vehicle underride (Julin et al. 2017). According to Wiebelhaus et al. (2013), the low-height of 24, and 26 inches will increase the potential of vehicle override in guardrails. However, the 27, 29, and 30 inches height will lead a redirection of the vehicle. According to the RDG (AASHTO 2011), a height of 30 to 32 inches (27 inches in the old types) was suggested for semi-rigid W-Beam guardrails while the existing segment had a height equal to 21 inches. Based on FHWA’s W-Beam Guardrail repair (FHWA 2008), the guardrails with a lower height of 24 inches were categorized as “no longer reasonably functional.” One of the reasons for this difference in the height was seen due to the shoulder drop-off and the soil erosion (5 inches) in the location of posts. Almost all the posts did not have an appropriate condition because of their longtime of service. Figure 5 shows one of the posts’ condition.

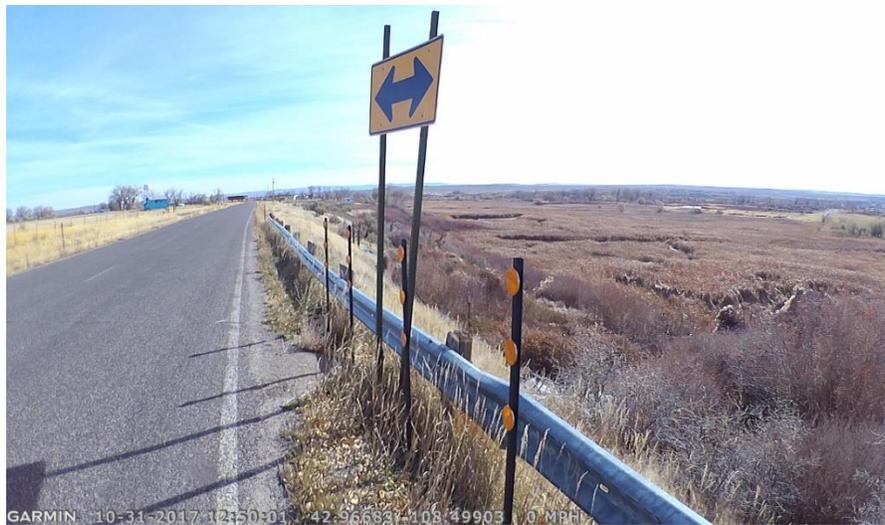
Figure 6. Wrong placement of traffic signs in site No. 1.

25 ft of the guardrail segment had severe lateral deflection, high-severity deterioration was observed on the panels, and there was a missing bolt in the connection of two panels. As shown in Figure 6, the traffic signs were not placed behind the guardrail, and this can impact the performance of the barrier in crashes. Worksheets and pictures in Appendices A and B also refer the GPS coordinates and the condition of these damages more precisely.

Since site No. 1 was ranked in a high-severity level of damages, the whole barrier should be replaced. The semi-rigid W-Beam guardrail seems to be the most appropriate type at this site. In fact, cable systems could be an expensive choice because it needs a wide width (about 10-12 ft) for the lateral deflection on crashes, and the rigid barrier is not a typical alternative for the low-volume roads like site No. 1. Therefore, three different semi-rigid guardrails are recommended at this location as shown in Table 2. The main reason for choosing these types is their low rate of the maximum deflection. So, a width as much as 4 ft (considering 1 ft offset from pavement and 3 ft behind the barrier for the deflection in crashes) would seem enough for these types of guardrails. Note that the 4-ft width is the minimum recommendation while a wider shoulder would provide a safer condition as the offset will be increased. All the traffic signs must also be shifted behind the barrier system.

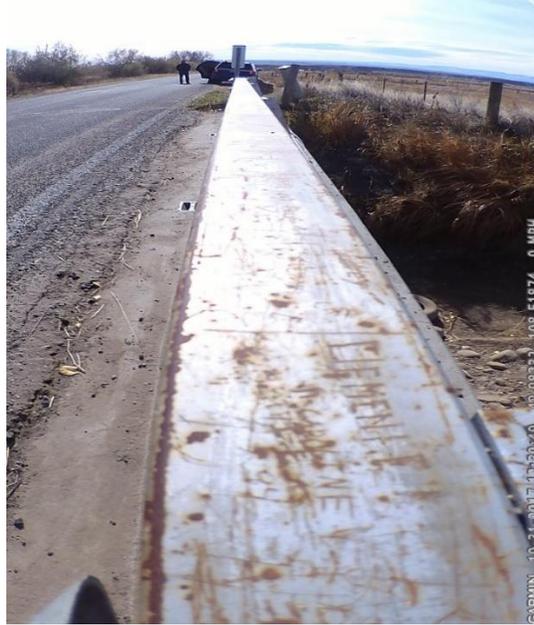
Figure 8. Low-severity deterioration observed in site No. 2.

The barrier system at site No. 2 has a Wyoming Two-Tube Bridge Railing” on the bridge and W-Beam guardrails as the end-treatments. No serious problems were observed for the barrier segment on the bridge but a low-severity deterioration due to the weather is shown in Figure 8.

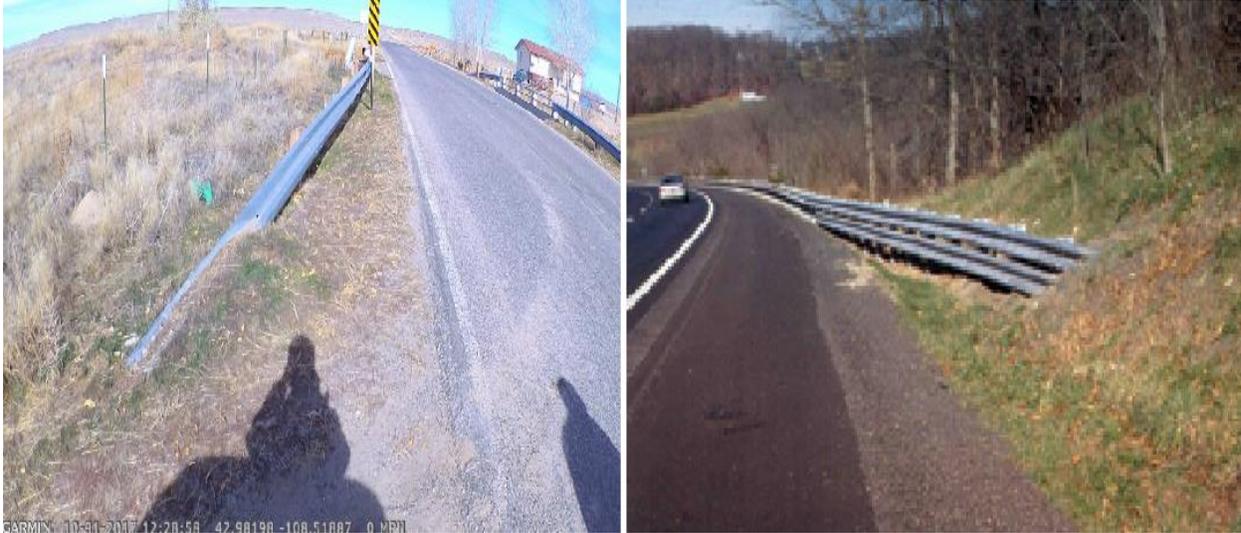
Figure 9. The comparison between the end-treatment in site No. 2 and the recommended design in AASHTO 2011.

End-treatments seemed to be in good condition. Despite the good shape of the guardrails, there was a serious problem regarding the height of the end-treatments due to improper installation. In fact, the existing end-treatments has a turned-down terminal which was popular in the early 1960; however, this type of the terminal failed based on tests done by Federal Highway Administration (FHWA) and it is not acceptable to use turned-down terminals since 1994 (Wiebelhaus et al. 2013). The existing end-treatment can be called as a “W-Beam Guardrail Anchored (Buried) in Backslope” with wrong installation. An ideal backslope of 1V:2H is suggested (AASHTO 2011) for this type of end-treatment, while the topography of the location has no backslope. In this situation, a different type of end-treatment is more appropriate. Figure 9 shows a comparison between the existing end-treatments and the acceptable type based on RDG (AASHTO 2011).

a. End-treatment in site No. 2

As another concern regarding the existing end-treatments, the bridge transition is not designed well. Bridge transitions are very important because they are mostly joined of two different type of barriers (usually a rigid barrier on the bridge and a guardrail system as the end-treatments) with different stiffness, strengths, and geometric features. In such cases, it is required to use adequate blockouts and additional posts or rail elements to provide a proper stiffness transition to remove the potential vehicles snag or pocketing near the bridge end (Wiebelhaus et al. 2013). The existing end-treatment due to its weak wooden posts will perform poorly in the transition in crashes.

At this point, no improvement is required for the bridge barrier and it is anticipated that the barrier would not face any serious issues at least in the next five years. However, it is required to improve the condition of the end-treatments. The post spacing near the bridge should be only 3' instead of the typical 6' spacing to provide a good transition between the rail and the bridge barrier. A Thrie-Beam is recommended to provide a smoother transition (from the semi-rigid

guardrail to the rigid barrier on the bridge). Figure 26 shows an example of a proper bridge transition installation.

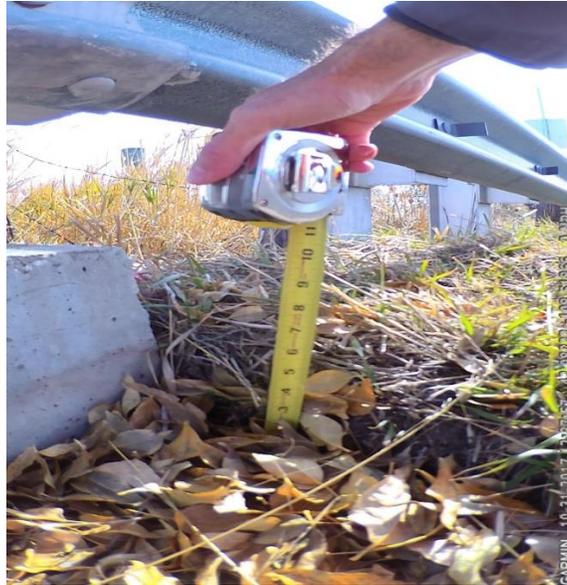
Figure 10. The elevation of accumulated dirt at the bottom of posts in site No. 2.

As a side note on site No. 2, approximately, 30 ft on Southbound (SB) and 20 ft on Northbound (NB) sections had around 5 inches of accumulated dirt at the bottom of the end-treatments' posts. For this reason, the height of end-treatment guardrail was measured as 26 inches at its highest level (at the start point and the end point of the bridge's barrier). This point is shown clearly in Figure 10.

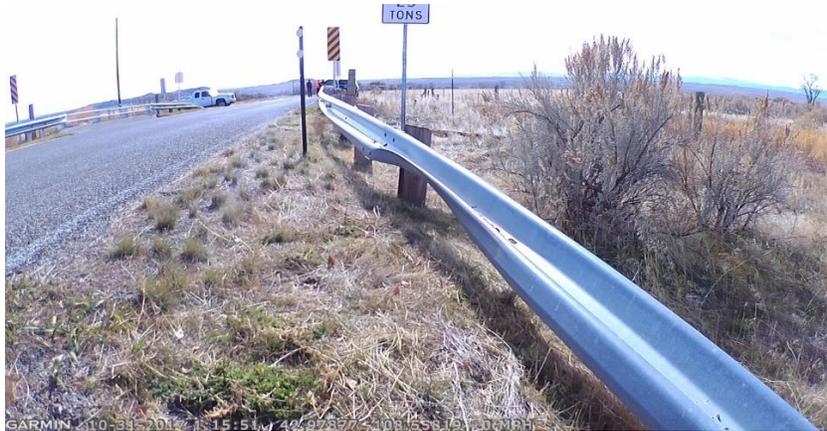
Figure 12. The lower rail cross-section height observed on site No. 3.

The first end-treatment on the SB of the road seemed to be hit by a vehicle. The rail cross-section height of the rail was measured as 7 inches, while the typical W-Beam rails have a width equal to 12 inches. Based on NCHRP report 656 (2010), the end treatment has medium-severity damage. Figure 12 shows the damage.

There are issues related to the installation of the end-treatments including the height, turned-down terminal, and the bridge transition. These issues are visible in Figure 12 and they were explained in site No. 2.

The same as site No. 2, site No. 3 does not need any improvement regarding its barrier on the bridge while the end-treatments should be replaced. Regarding the terminal section, a flared type of “ET-Plus,” “SKT-350,” or the “ELT” are recommended. All these end-terminals can be practical at the location.

The bridge transition is recommended to be considered as elaborated in section 3.2. Blocked-Out W-Beam (Strong Post), and MGS are also recommended for the new guardrail system.

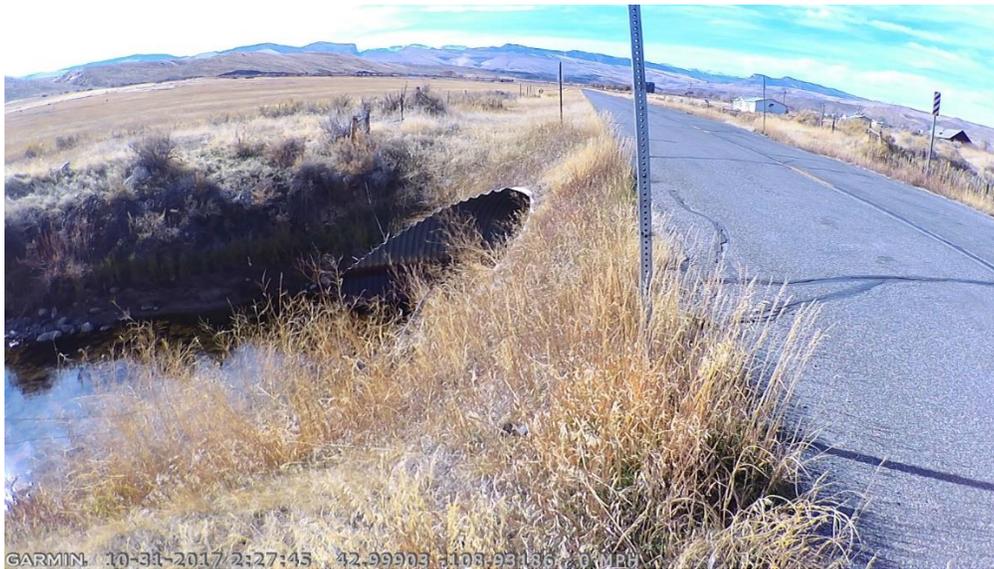
Figure 14. A general view of site No. 4.

Site No. 4 was the only site with no barrier system. Figure 14 shows a general view of the site.

Based on the recommendations of RDG (AASHTO 2011), fill section height, and the sideslope rate are two main parameters to determine whether a barrier system is needed. The method is also shown in Figure 15. Site No. 4 is by a river with a fill section height of 10 ft and the sideslopes about 2H:1V on each side. Therefore, according to Figure 15, a barrier system is warranted for both directions. Therefore, the assigned site score is 1.0 which means the highest priority for installing a barrier system.

A “Wyoming Two-Tube Bridge Railing” on the bridge with four W-Beam guardrail end-treatments (as end-treatments) are recommended at site No. 4. The Blocked-Out W-Beam (Strong Post), and MGS are suggested as the guardrail system at site No. 4 due to their lower lateral deflection (as shown in Table 2). The “ET-Plus,” “SKT-350,” or the “ELT” are recommended as the end-terminal as well. The height of the whole barrier system must be considered as a minimum of 31 inches.

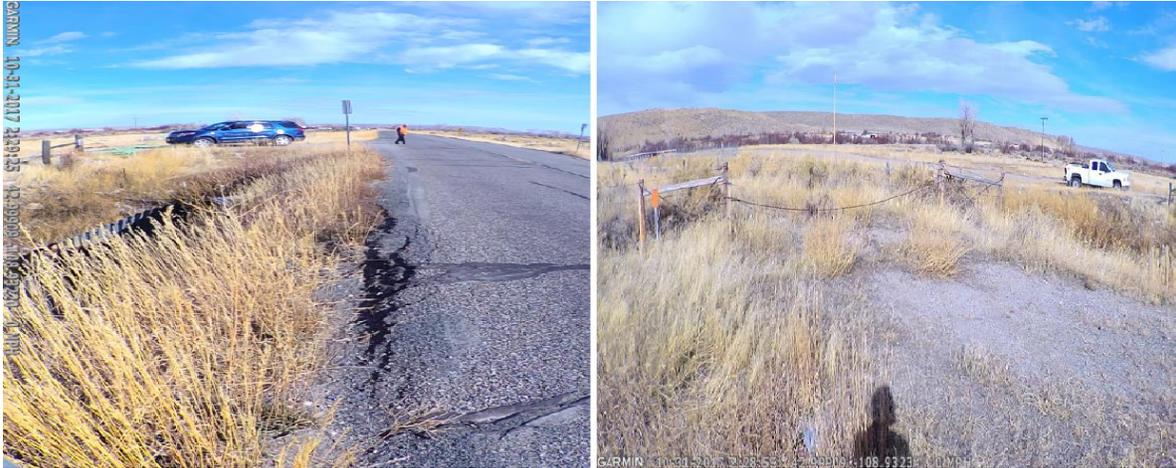
- The existing road had a pavement width of 24 ft. This width is adequate for having two proper traffic lanes; however, a minimum width of 2 ft on each side is required for establishing the new barrier system.
- Soil erosion (or shoulder drop-off) with a height of 5 inches was observed all along the bridge on each side. This point should be considered regarding providing proper height for the barrier.
- As a restriction in the design phase, there were four adjacent entrances (to private properties) which could limit the length of the barrier system.

The last two observations are illustrated in Figure 16. Chapter 3 of the report (Improvement Recommendations) will focus on the barrier design on this site.

a. Shoulder drop-off

b. Adjacent Entrances

A 25 ft- L_A , and 200 ft- L_R were measured at site No. 4. The short distance between the adjacent entrances does not provide enough space to meet all the design requirements provided in RDG (AASHTO 2011). For this reason, it is highly recommended to review the possibilities for removing the adjacent property entrances. In this way, the same design as presented on site No. 3 would be suggested at site No. 4. However, as the second alternative, the following information shows the recommended geometric features when removing the entrances is not possible:

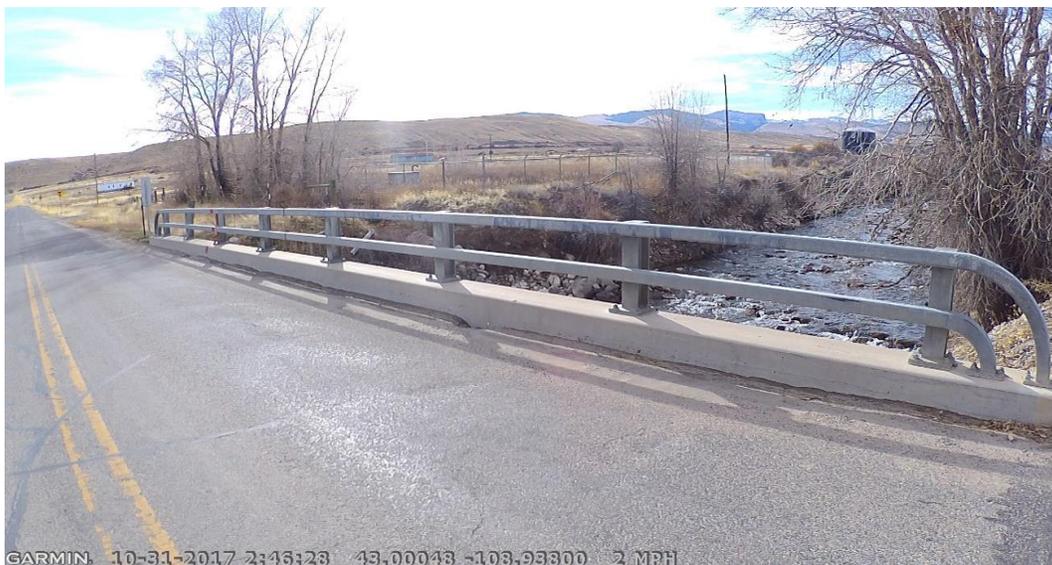
Figure 17. Good condition of bridge barrier on site No. 5.

Site No. 5 also has a “Wyoming Two-Tube Bridge Railing” on the bridge. As it is shown in Figure 17, the barrier has no serious damages on the hardware; however, there were no end-treatments at the beginning and the end point of the bridge. This fact poses a dangerous situation due to the presence of a wide river.

Side dozing also seemed required before installing any new end-treatment. No serious damage could be found during the field survey.

No improvement is required for the bridge barrier at site No. 5. The only required improvement is regarding adding new guardrail end-treatments. The same end-terminals as site No. 2, 3, or 4 (ET-Plus, SKT-350, and ELT) are recommended here as well. One of the advantages at site No. 5 is the available space for providing an appropriate length. Then, the design procedure at site No. 5 will follow all the requirements provided by RDG (AASHTO 2011).

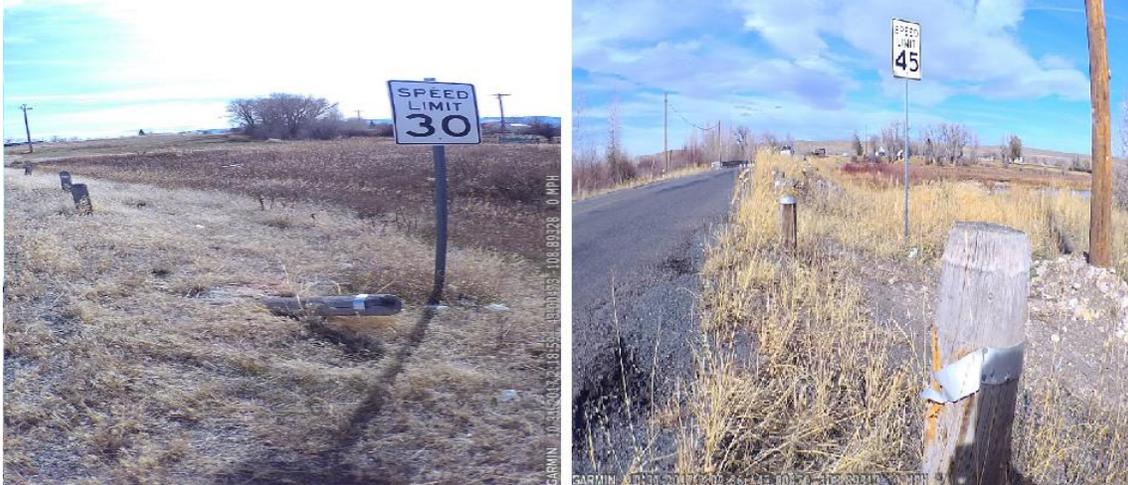
Figure 19. The poor condition of wood-posts at site No. 6

The barrier system on site No. 6 consists of an old steel barrier with steel posts (no blockout) on the bridge. As shown in Figure 19, there were some wood-posts (without any rail) before and after the bridge. However, they could not be considered as end-treatments due to the lack of stability. It is predicted that the wood-posts will act as hazardous fixed-objects in case of crashes. Figure 19 shows the threat of fixed-objects (utility poles and the traffic signs) behind the weak wood-posts.

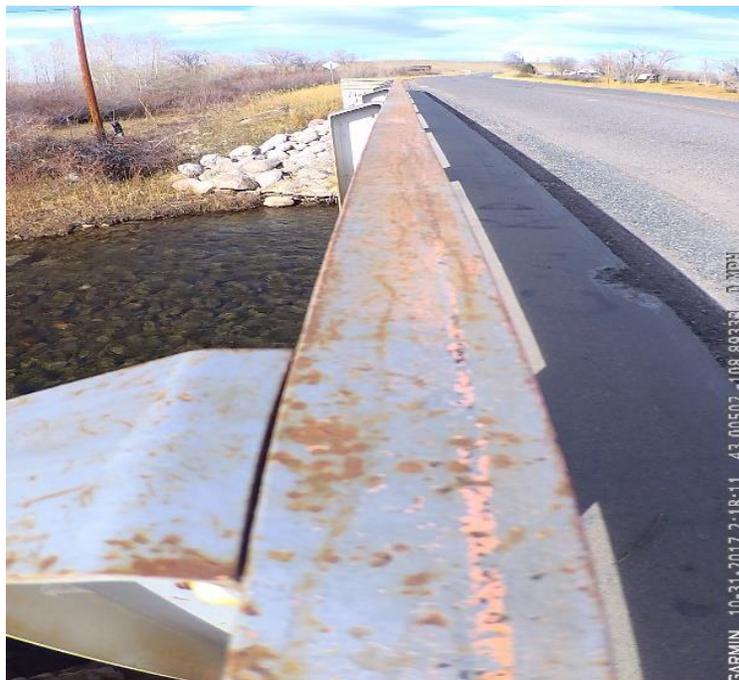
Figure 20. The deterioration observed in site No. 6.

- The height of the bridge steel barrier is 21 inches which is well below the acceptable level (typically 30-32 inches).
- Figure 20 shows the significant aging of the bridge barrier.

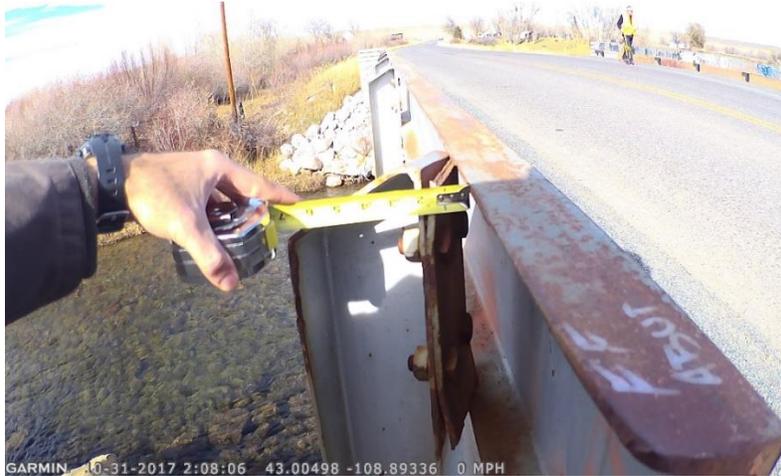
Figure 21. The separated post from guardrail in site No. 6

- As it is clear in Figure 21, one of the posts was separated about 2 inches from barrier. However, the damage is not significant since a separated distance less than 3 inches would be acceptable with no need to repair according to NCHRP report 656 (2010).

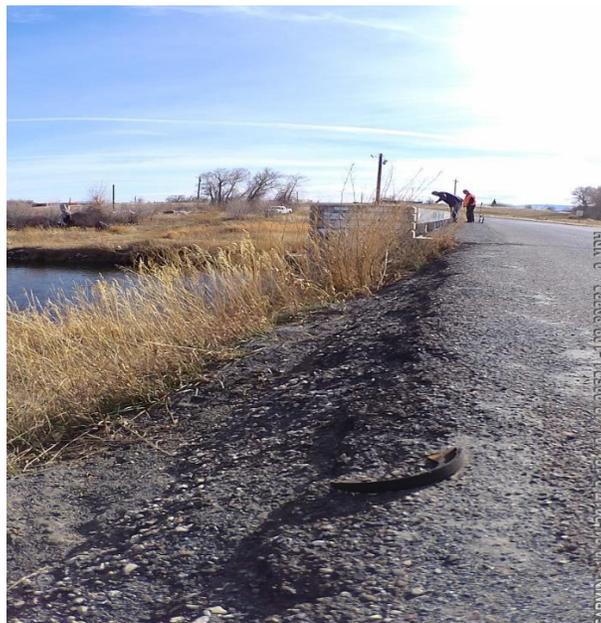
Figure 22. Soil erosion of shoulder site No. 6.

- The soil erosion on the sides was estimated about 8 inches which would increase the severity of ROTR crashes. This point is shown clearly in Figure 22.

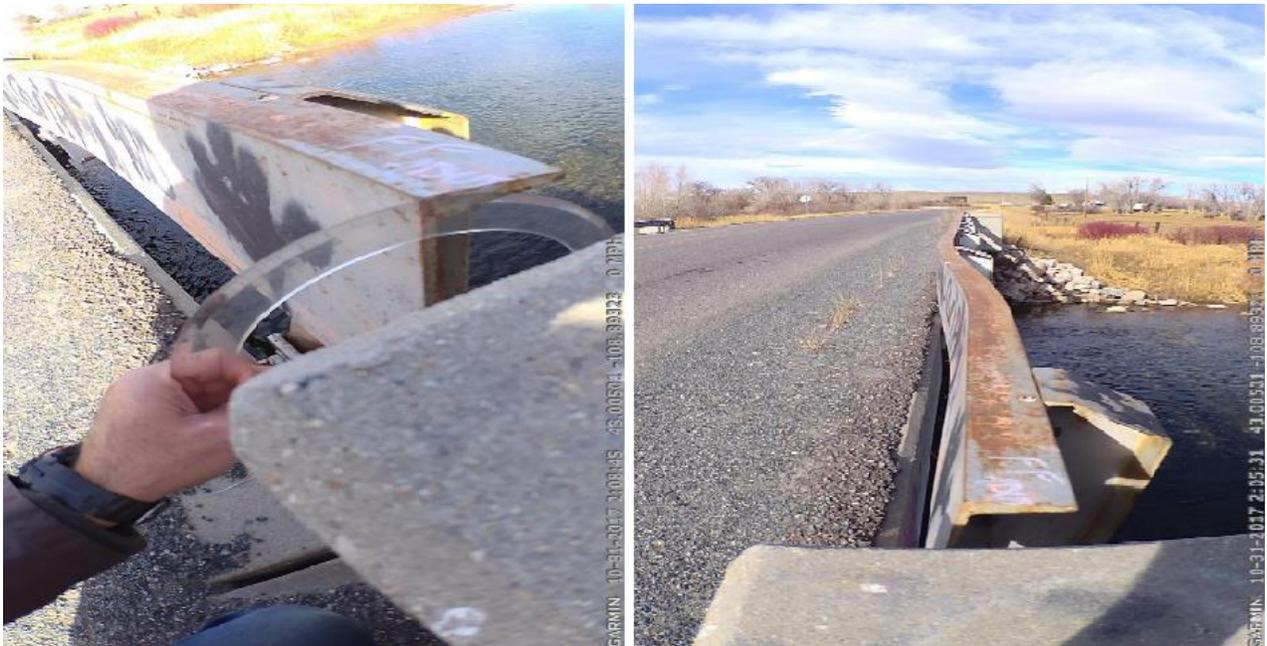
Figure 23. The deflections on the NB of site No. 6.

- There were vertical and lateral deflections on 3 ft of the barrier segment in the north bound direction. The values of vertical and lateral deflections were examined as 10 degrees and 3 inches, respectively. The deflections were placed in the low-severity damages based on NCHRP report 656 (2010). Figure 23 shows the deflections observed during the field study.
