Example property shows

CONSIDERATIONS FOLLOWING WILDFIRE

The Fire:

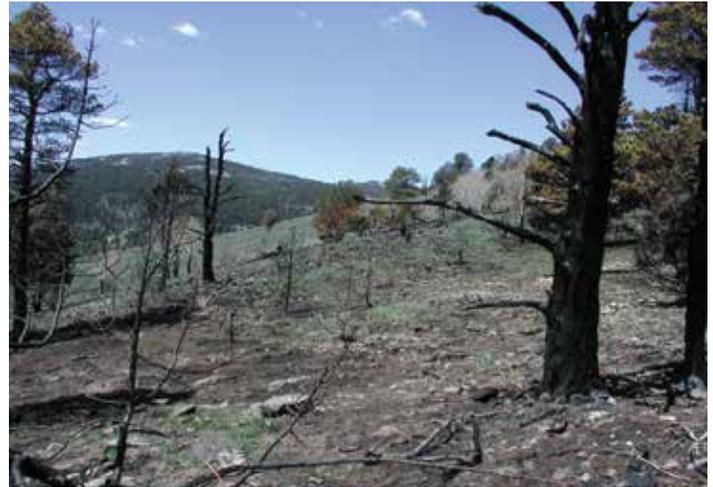
After the fire in that area, the grassland area quickly rebounded due to the nature of the fire, which did not destroy the roots of the grasses and forbs. The snowfall that followed the fire provided water that helped them re-sprout and grow quickly after temperatures warmed. The sagebrush plants were killed. This will free up resources (sunlight, nutrients, water) for the grasses and forbs. After consulting with the landowners on the goals for the property and viewing the regrowth two months after the fire, natural resource experts recommended that, for now, the landowners just monitor most of this area of the property. Unless the landowners start to see existing plant populations decline and significant erosion, no further action would be needed.

This picture taken in May shows how quickly grass and forbs are returning to many parts of the burned area.

Resource experts suggested reseeding before fall to stabilize the area and to help keep weeds out. They suggested using a hand-operated broadcast seeder for reseeding because the area is too rocky for a drill seeder. This area is not used for livestock grazing so forage production was not an issue. Therefore, a native seed mix was suggested at a rate of 10 to 20 pounds (lbs) of pure live seed (PLS) per acre. To calculate pounds of PLS, the percentage of PLS listed on the seed packet label was used. For example, for a 15-pound bag with a PLS percentage of 90, .9 times 15 equals 13.5 lbs of PLS in the bag.

The landowners were advised to rake the soil where possible after seeding to ensure good soil-to-seed contact and to exercise patience while waiting for germination. Many landowners become concerned and frustrated if the seed does not grow after the first growing season; however, three years may be needed to see results and for the seeding to become established.

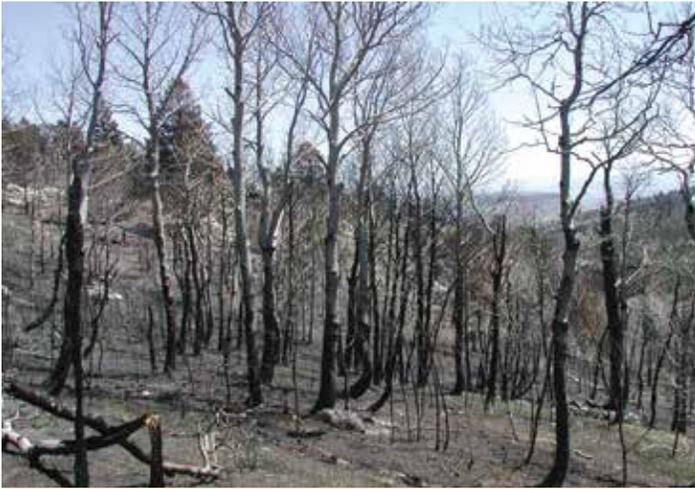
These aspen trees were killed as a result of trunk scorch; however, the root system was not killed

Although many of the aspen trees trunks and canopies perished in the fire, the root systems survived. A beneficial aspect of the timing of the fire was that it occurred before the aspens leafed out. Therefore, most of the aspens' stored food reserves were still in their root systems. These reserves were being mobilized, and aspen suckers had already begun to emerge by the time the property was examined two months later. The dead standing conifer and aspen trees could be harvested for firewood (if adequate safety precautions were complied with); however, the location of the stands made access by vehicle difficult. Based on these factors, foresters recommended the landowners just monitor the site.

Aspen suckers are often eaten by livestock and wildlife. The landowners were advised that, if they saw evidence of heavy browsing that would keep the suckers from growing, fencing or other alternatives, such as felling dead aspen and leaving them on site (the trunks and branches act as a barrier and deter browsing), could provide protection until the stand was older.

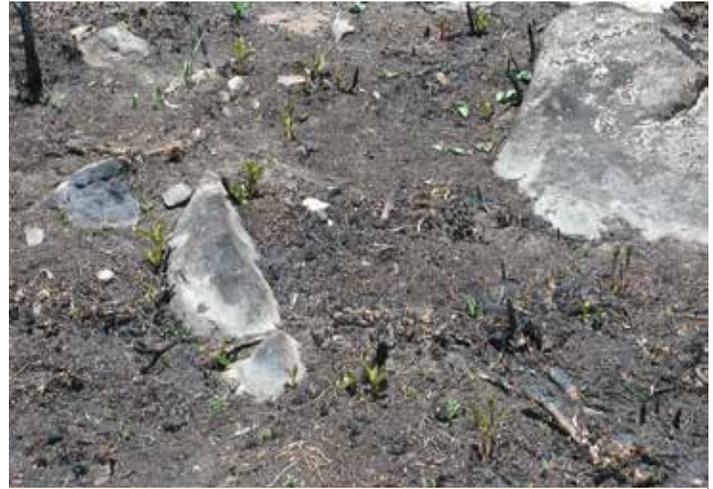
Aspen suckers (small glossy shoots) are emerging and prevalent in and around the burned aspen trees.

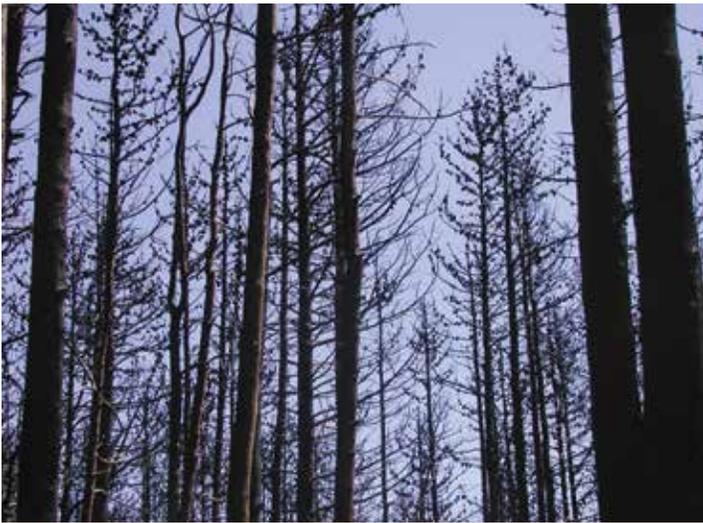
The tops of these trees were consumed by a crown fire.

The foresters recommended that all dead trees within the lodgepole pine stand be felled that summer or as soon as possible to improve conditions for natural regeneration. By removing the skeleton stand, more sunlight would reach the forest floor and aid in pine tree regeneration and development. Trees should be felled and marketable stems (for post and poles, and firewood) 4 inches in diameter and larger should be removed from the property. Trees smaller than 4 inches in diameter and treetops should be chipped back into the stand. The wood chips help stabilize the soil and improve soil moisture levels. Trees with 25-percent live crown or greater should be left standing and monitored for the next few years. They also recommended that scorched trees with red needles should be closely observed to see if green needles had started growing at the tips of the branches. If tips are green, they recommend those trees remain standing and be monitored over the next few years

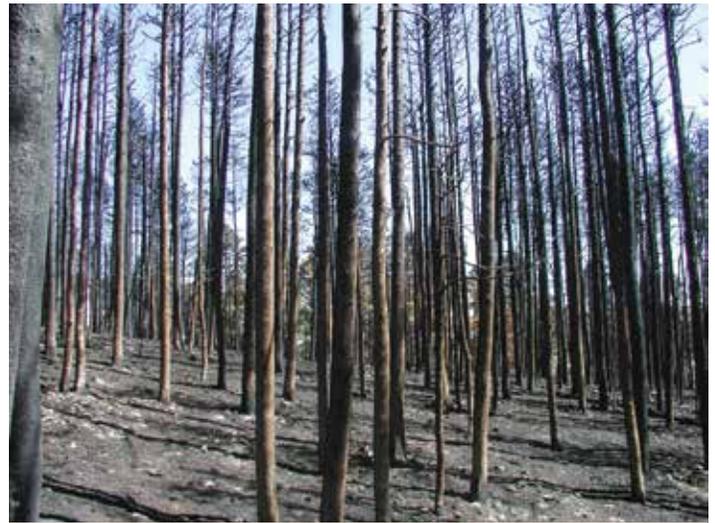
These trees have been scorched; however, the wood is still suitable for posts and poles or firewood.

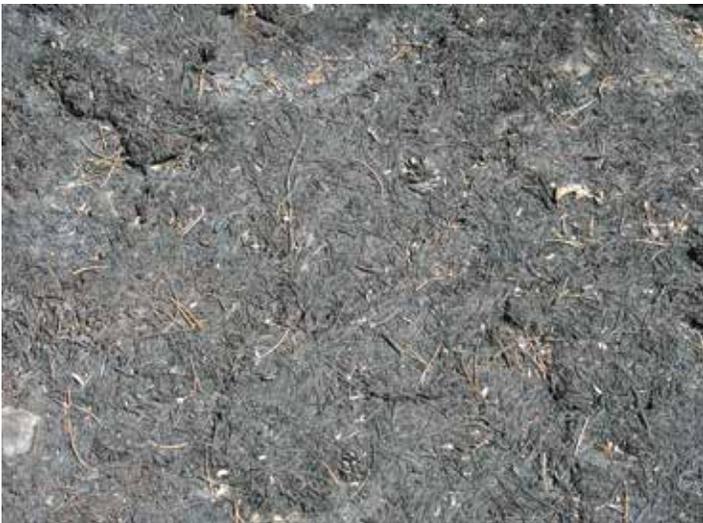
The lodgepole pine will not rebound as quickly as other vegetation types, although the prognosis was good for regeneration. Foresters found an abundance of pine seed on the forest floor. This meant that, if adequate moisture was received during the summer, seedlings could emerge as early as late summer; however, regeneration could be delayed up to three years if moisture is not received. If adequate regeneration did not take place within three years, foresters recommended that potted seedlings (lodgepole pine and Douglas fir) be planted.

Many small pine seed wings are visible laying on the thin layer of duff

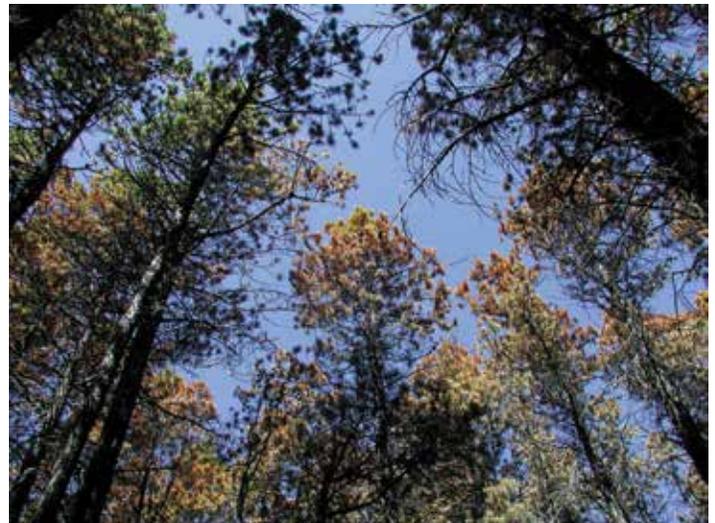
These lodgepole pines suffered different degrees of scorch. Some may survive, but many more will perish.
