Appendix 3: Preliminary Bat Surveys of White Grass and Bar B C Ranches, Grand Teton National Park

by
Douglas A. Keinath
Senior Zoologist, Wyoming Natural Diversity Database

May 2005

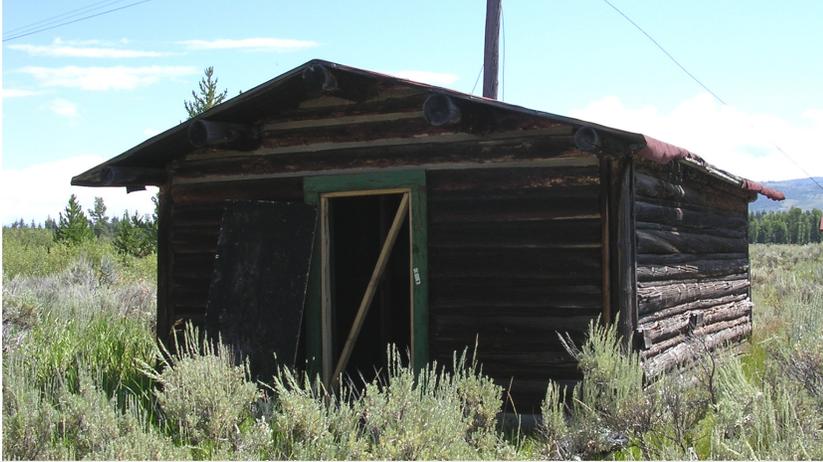
L	Building ID: BBC-b	GPS Location (E, N):	0524589	4838070	Location Error: 6 m
<p>Description:</p> <p>Small (4m X 4m) long cabin with chinking. Sheet-shingle roof. One door on west and one window.</p> <p>Beam and plank ceiling. One room. Contains: shelves, extra doors. Several yellow-jacket nests (ouch!).</p> <p><u>Bat habitat Notes:</u> Main bat entry point is a gap in roof planks in southwest corner.</p>

Bat Use: Low bat use based on scatter guano. Possible night roost or sparsely-used day roost.					
Recommendations: Could conduct ANABAT® survey of main emergence point, but follow-up not critical.

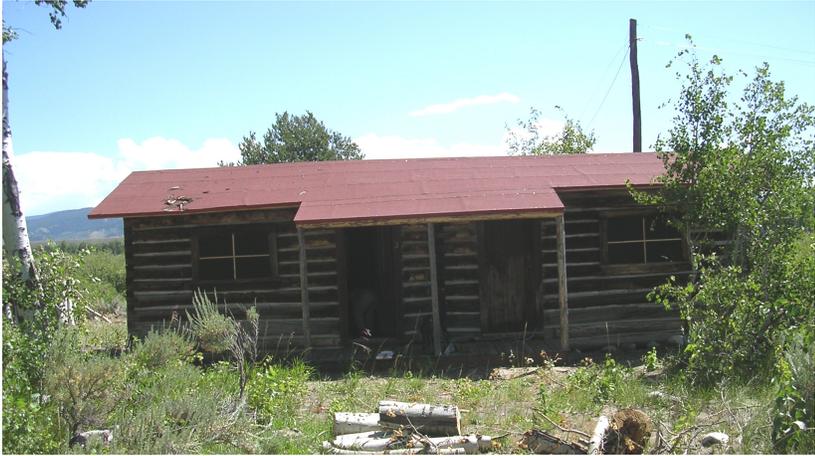
M	Building ID: BBC-c	GPS Location (E, N):	0524600	4838122	Location Error: 3 m
<p>Description:</p> <p>Small cabin (5m X 12m). Two entry doors with porch on west side. Sheet-shingle roof and chinked logs.</p> <p>Beam and plank ceiling. Two rooms. Spare lumber, table, and shelves.</p> <p><u>Bat habitat Notes:</u> Many possible entrance holes; main one being on the northeast corner of the cabin.</p>

<p>Bat Use: Moderate level of bat use based on scattered guano. Likely a night roost, but possibly a day roost during other times of the season.</p>					
<p>Recommendations: Conduct ANABAT® survey of main emergence point on the NE corner of the cabin.</p>

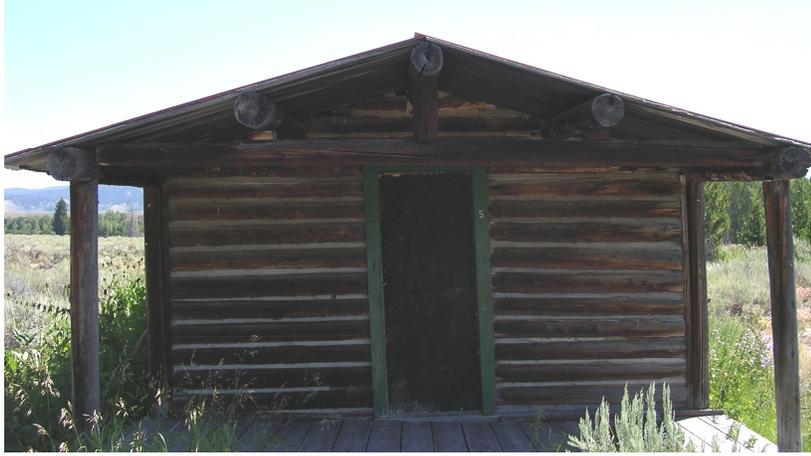
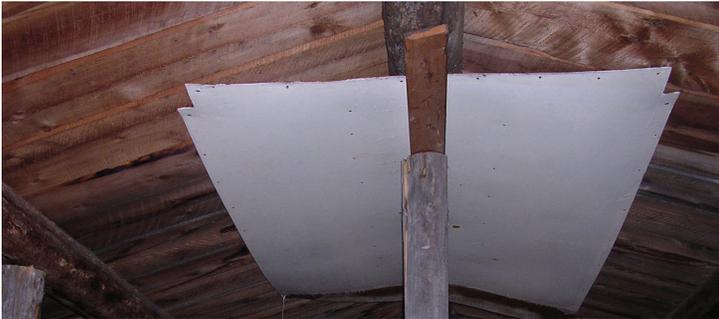
M	Building ID: BBC-d	GPS Location (E, N):	0524588	4838053	Location Error: 11 m
<p>Description:</p> <p>"Cabin 5." Small (4m X 7m) log cabin with chinking. Tin roof. One door on south and four windows.</p> <p>Beam and plank ceiling with a large board nailed to center beam forming an 'attic' space. Two rooms.</p> <p><u>Bat habitat Notes:</u> Large gap on base of south wall and possible entry point at roof joint on southwest wall.</p>

<p>Bat Use: Moderate bat activity based on guano accumulations. Likely a night roost or day roost earlier in the season, since no bats were seen during inspection.</p>

<p>Recommendations: Conduct follow-up survey with ANABAT® to determine level and timing of bat activity, as well as species composition.</p>

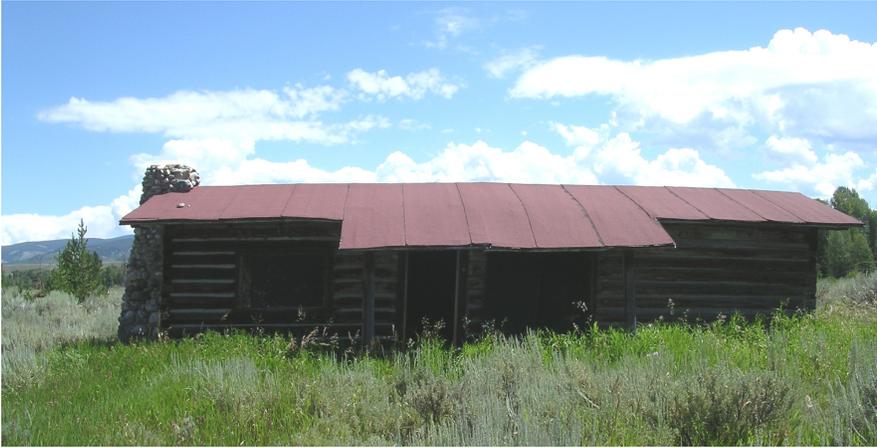
M	Building ID: BBC-g	GPS Location (E, N):	0524649	4838059	Location Error: 2 m
<p>Description:</p> <p>Small (4m X10m) log cabin. Sheet-shingle roof with stone chimney on north side. Two entrance doors with porch on the west. 4 windows.</p> <p>Beam and plank ceiling. Two rooms. Contains shelves.</p> <p><u>Bat habitat Notes:</u> Openings in northeast corner, south west corner, and through the chimney.</p>

<p>Bat Use: Moderate bat use based on guano accumulations, mainly near chimney. Likely a night roost, but possibly a day roost during other times of year.</p>					
<p>Recommendations: Conduct ANABAT® surveys of the chimney emergence point.</p>

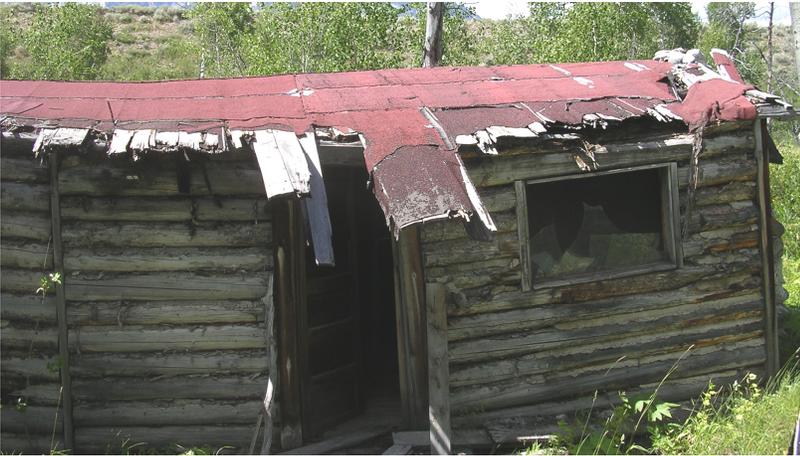
L	Building ID: BBC-n	GPS Location (E, N):	0524431	4838046	Location Error: 6 m
<p>Description: Small (4m X 8m) log cabin. Sheet-shingle roof with chimney. Somewhat unstable. Beam and plank ceiling. Two rooms. One fireplace with blocked chimney. <u>Bat habitat Notes:</u> Possible bat entrance through stovepile hole and upper corners of walls.</p>

Bat Use: Low bat use based on some guano. Likely a night use for a small number of bats.					
Recommendations: Possible ANABAT® to determine level of use and species of bats present, but follow-up not critical.

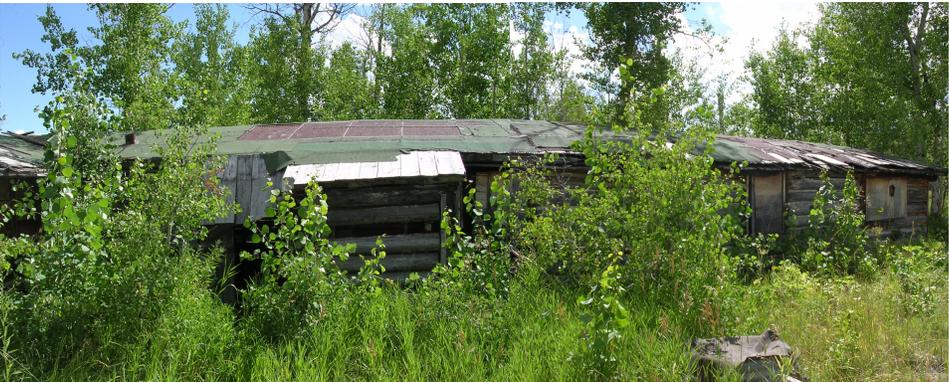
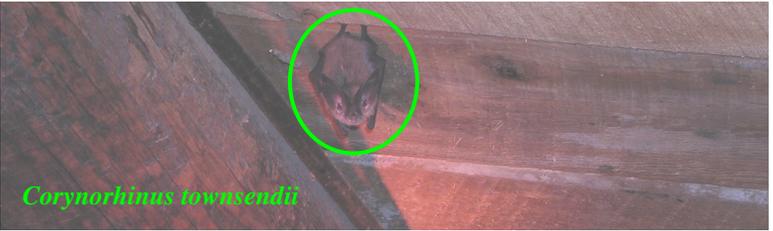
H	Building ID: BBC-p	GPS Location (E, N):	0524440	4837927	Location Error: 6 m
<p>Description:</p> <p>Large (8m X 12m) log cabin with an L-shaped layout. Sheet shingle roof with two chimneys.</p> <p>Beam and plank ceiling. About 9 rooms and a cellar. Two fireplaces.</p> <p><u>Bat habitat Notes:</u> Many emergence holes throughout building, plus a even-temperature, cave-like cellar.</p>

<p>Bat Use: Moderate bat use based on scattered guano throughout house. Roosting male Townsend's big-eared bat (<i>Corynorhinus townsendii</i>) found in southeast room (see photo).</p>

<p>Recommendations: Definitely conduct active ANABAT® surveys at several points in the season to determine level of use and species composition. <i>C. townsendii</i> often difficult to record, so also conduct low-disturbance diurnal roost survey early and late in the season. Consider preserving this building as bat habitat.</p>

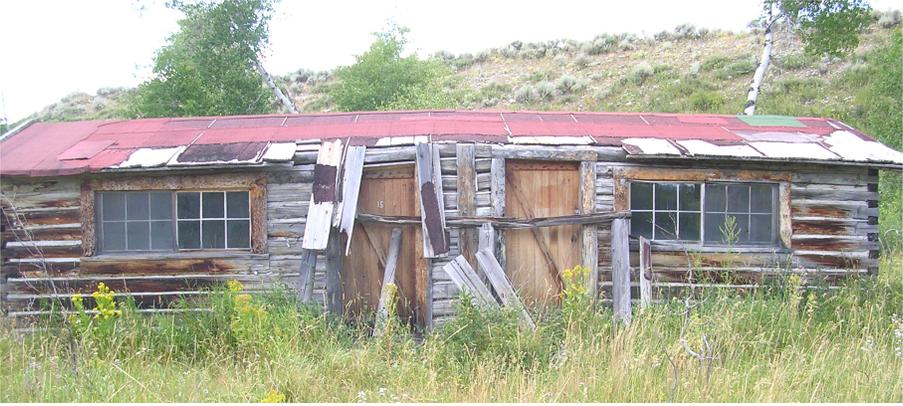
H	Building ID: BBC-q	GPS Location (E, N):	0000000	0000000	Location Error: 00 m
<p>Description:</p> <p>Small (4m X 8m) log cabin with chinking. Worn shingled roof. Two entrance doors facing east with collapsed roof. Two windows.</p> <p>Beam and plank ceiling. Two rooms.</p> <p><u>Bat habitat Notes:</u> Building interior noticeable warmer than others. Main entrance points are the window on the northeast side and an old chimney hole in the ceiling of the south east room.</p>

<p>Bat Use: High bat activity based on large amount of guano. One <i>Myotis lucifugus</i> seen roosting by the ceiling peak on the southeast wall. Definitely a day roost and possibly night roost as well.</p>					
<p>Recommendations: Conduct ANABAT® survey of main emergence points and possibly harp-trap the entrance and/or do an emergence count to determine abundance of bats.</p>

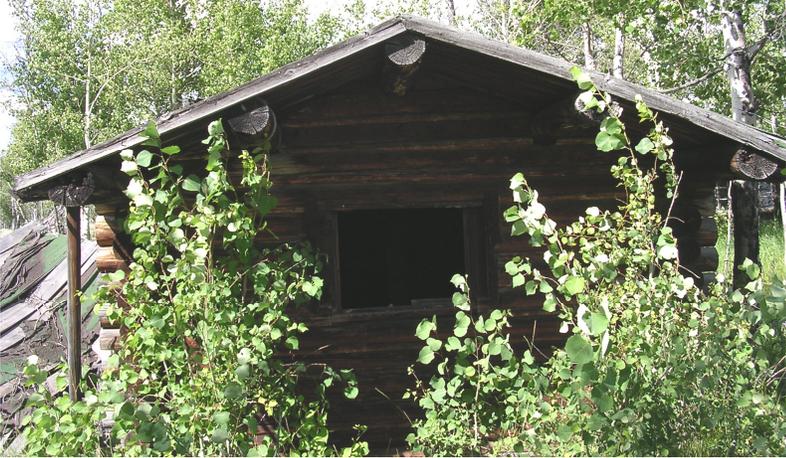
L	Building ID: BBC-r	GPS Location (E, N):	0524409	4837915	Location Error: 10 m
<p>Description:</p> <p>Small (4m X 4m) log cabin. wood roof. One door and one window.</p> <p>Beam and plank ceiling. one room.</p> <p><u>Bat habitat Notes:</u> Possible bat entrance through south-facing window.</p>

<p>Bat Use: Low bat use based on some guano. Likely a night use for a small number of bats.</p>					
<p>Recommendations: Possible ANABAT® to determine level of use and species of bats present, but follow-up not critical.</p>

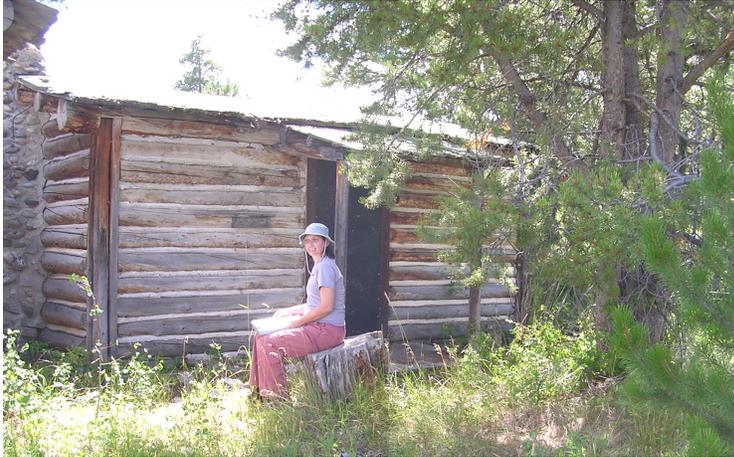
L	Building ID: BBC-s	GPS Location (E, N):	0524487	4838001	Location Error: 3 m
<p>Description:</p> <p>Small (4m X 5m) log cabin with chinking. One door with porch on the east. Two windows. Close to BBC-u on the west. Worn shingled roof.</p> <p>Beam and plank ceiling. Blocked chimney on east side of building.</p> <p><u>Bat habitat Notes:</u> Emergence points through crack in east wall and by the south window.</p>

<p>Bat Use: Low bat use based on scattered guano by west window. Size of guano suggests use by <i>Eptesicus fuscus</i>. Age of guano suggests no recent activity.</p>					
<p>Recommendations: No follow-up necessary.</p>

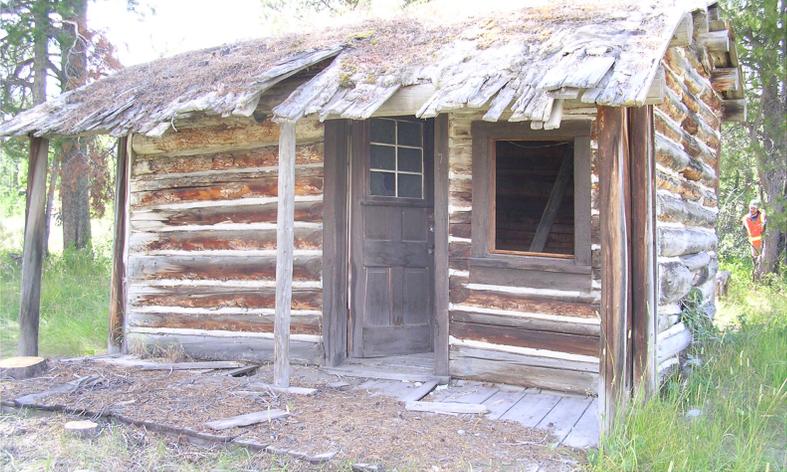
H	Building ID: BBC-u	GPS Location (E, N):	0524491	4838008	Location Error: 4 m
<p>Description:</p> <p>Small (4m X 5m) log cabin with chinking. Entrance door with porch on east side. Chimney used to be on the north. Two windows. Crumbling sod roof.</p> <p>Beam and plank ceiling. One room. Door is wide open.</p> <p><u>Bat habitat Notes:</u> Large openings through door and windows. Sod roof likely regulates temperature of building.</p>

<p>Bat Use: High level of bat use based on guano accumulation. Size of guano suggests use by <i>Eptesicus fuscus</i>. Likely an active night roost.</p>					
<p>Recommendations: Conduct ANABAT® survey with visual observation at entrances. Possibly mist net nearby.</p>

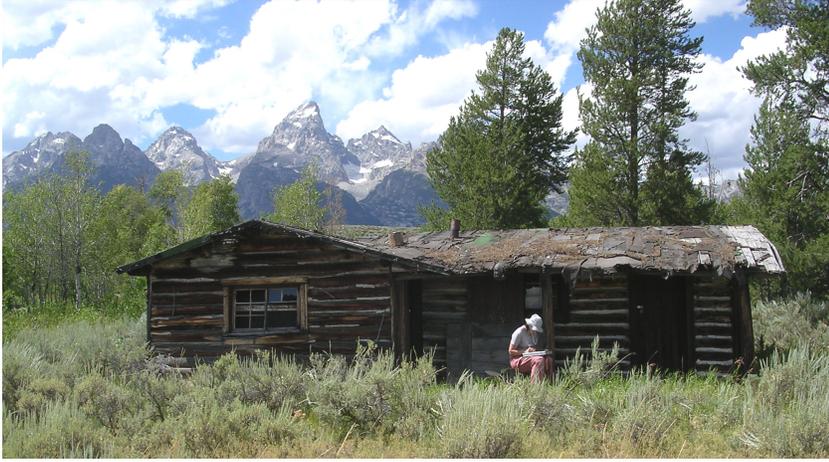
L	Building ID: BBC-w	GPS Location (E, N):	0524490	4837971	Location Error: 1 m
<p>Description:</p> <p>Small (5m X 9m) log cabin with chinking. Plank and tarp roof with remnants of sod. Two doors (east and north, with porch). Four windows.</p> <p>Two doors enter separate and unconnected rooms.</p> <p><u>Bat habitat Notes:</u> Main entrance point would be a large hole over the north door.</p>

Bat Use: Low bat use based on scattered guano. No bats seen, so likely used as a night roost.					
Recommendations: Could ANABAT® the main emergence point, but follow-up not critical.

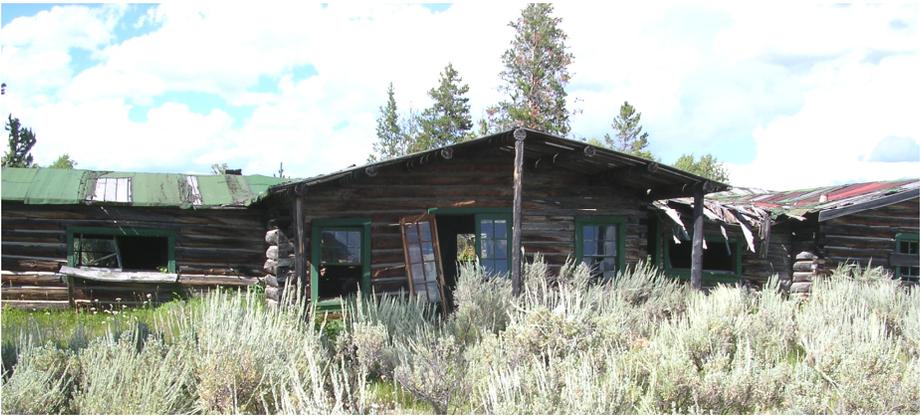
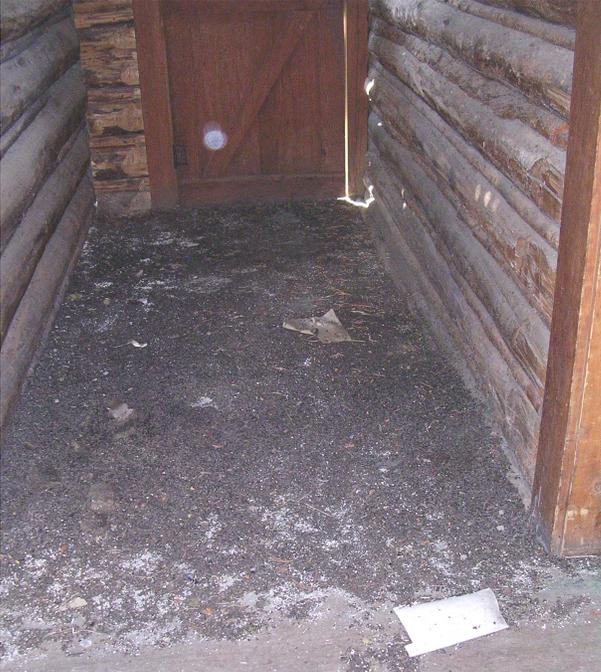
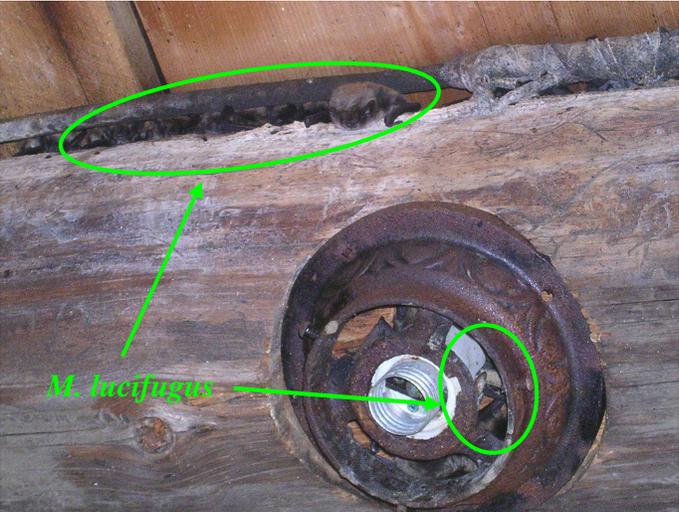
H	Building ID: BBC-y	GPS Location (E, N):	0524531 4838031	Location Error: 1 m
<p>Description:</p> <p>Large (roughly 25m X 37m) log building with worn chinking. Deteriorating, sheet-shingle roof. Several doors (one on north with porch). Many windows. Collapsed chimney on north side and boarded-up chimney on south side.</p> <p>Beam and plank ceiling, collapsed in places. 8+ rooms.</p> <p><u>Bat habitat Notes:</u> Many emergence points through roof, doors and walls.</p>

<p>Bat Use: High bat use based on guano accumulation and visual and audible confirmation of at least 21 roosting little brown bats. Definitely used as a day-time roost and probably a maternity roost.</p>

<p>Recommendations: It would be hard to conduct a comprehensive ANABAT® survey, since there are many possible emergence points. However, active acoustic survey of several emergence points might document use by additional species. Also, an internal count early in the breeding season might yield a count of pups and confirm its status as a maternity colony. Consider preserving this building in its current state as a bat roost.</p>

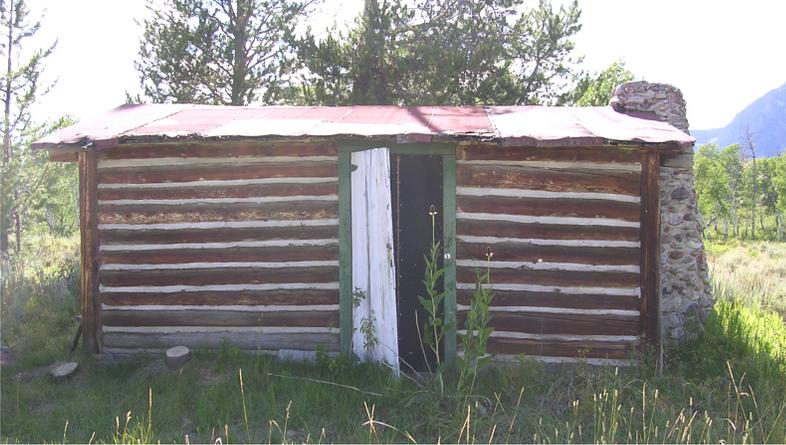
L	Building ID: BBC-bb	GPS Location (E, N):	0524516 4838076	Location Error: 7 m
<p>Description:</p> <p>Small log cabin. One door and 3 windows. Sheet-shingle roof with chimney.</p> <p>Beam and plank ceiling. Stovepipe hole in ceiling. Chimney open.</p> <p><u>Bat habitat Notes:</u> Possible entrance points through the stovepipe hole and chimney.</p>

<p>Bat Use: Low bat activity based on scatter guano. Likely a night roost or day roost for a few bats during other parts of the season.</p>				
<p>Recommendations: Conduct active ANABAT® recordings to document level of use and species composition, but follow-up not critical.</p>

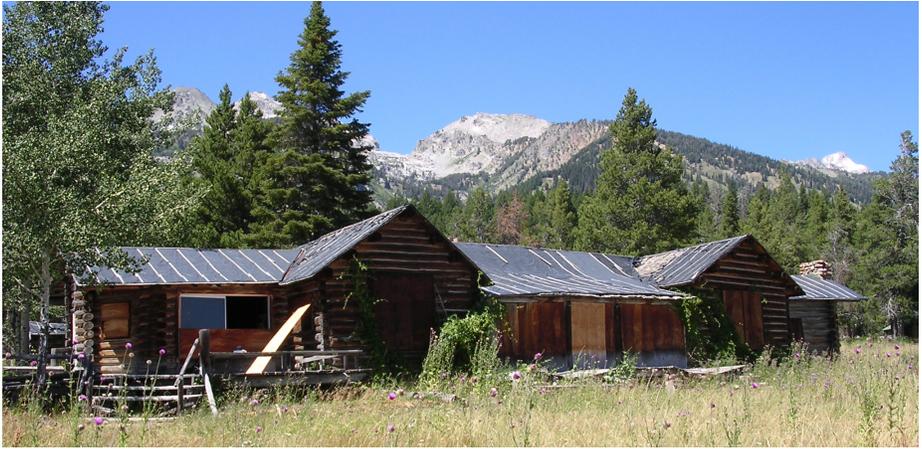
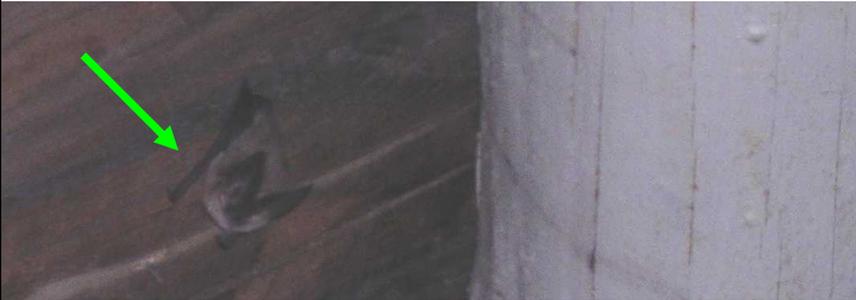
H	Building ID: WGa	GPS Location (E, N):	0518226	4833773	Location Error: 6 m
<p>Description:</p> <p>Large (main?) cabin. Chinked log construction. Plastic over wood-shingled roof. Chimneys on north and west. Porches on east.</p> <p>Beam and plank A-frame ceiling. 7 rooms.</p> <p><u>Bat habitat Notes:</u> Many internal hiding spaces for bats. Many exit points through holes in roof. Difficult to passively ANABAT due to number of exit points.</p>

<p>Bat Use: Light to moderate use based on guano accumulation. However, a bachelor <i>Corynorhinus townsendii</i> was observed day-roosting on the ceiling in the large northern room (see photo), making it an important building for local bats.</p>			
<p>Recommendations: This building should be left intact and undisturbed. <i>C. townsendii</i> is recognized as a sensitive species by most state and federal agencies in Wyoming (e.g., BLM, USFS, WYNDD, WYGFD). They require large, open roosting structures and are sensitive to disturbance.</p>

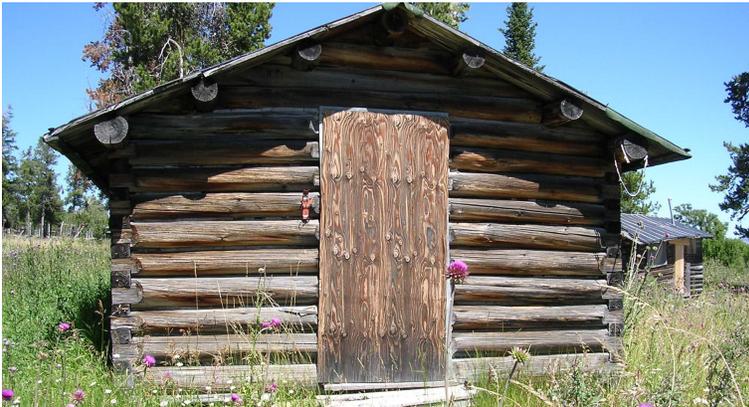
L	Building ID: WGb	GPS Location (E, N):	0518252	4833826	Location Error: 5 m
<p>Description:</p> <p>Small (3m X 15m) cabin. Chinked log construction. Plastic sheet over wood-plank roof. Main entrance faces south.</p> <p>Beam and plank A-frame ceiling. Two rooms and collapsed bathroom.</p> <p><u>Bat habitat Notes:</u> Main emergence point through gap over north door.</p>

<p>Bat Use: Light use based on scattered guano. No visual or audible identification of bats. Probably a night roost for foraging bats. Not likely a critical roost building.</p>					
<p>Recommendations: None.</p>

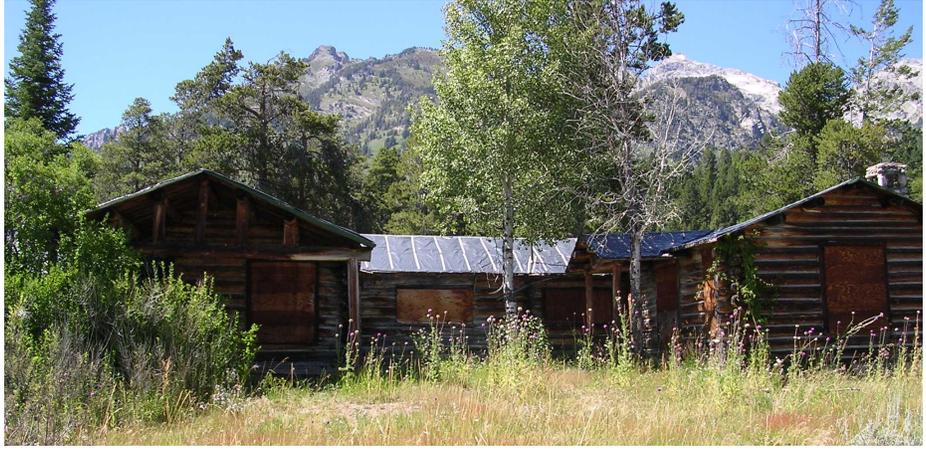
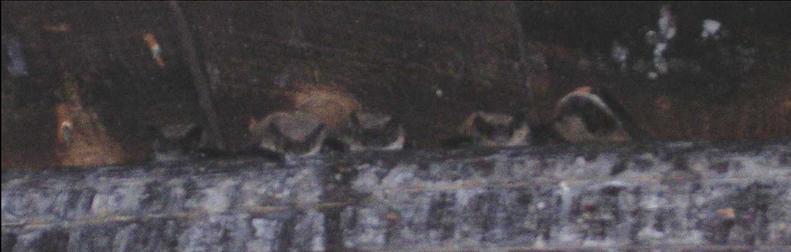
H	Building ID: WGc	GPS Location (E, N):	0518301 4833847	Location Error: 7 m
<p>Description:</p> <p>Large cabin. Chinked log construction. Plastic sheet over wood-shingled roof. Chimneys on north and west. Insulation in one room.</p> <p>6+ rooms. Beam and plank A-frame ceiling.</p> <p><u>Bat habitat Notes:</u> Many roosting places and emergence points. Warm interior. Hard to ANABAT due to numerous openings.</p>

<p>Bat Use: High bat use based on substantial guano accumulation and numerous bats seen flying and roosting along ceiling beams and walls (see photo), which appeared to be <i>Myotis lucifugus</i>. Based on its warm temperature and the number of bats seen, it is likely maternity colony for over 100 bats.</p>		
<p>Recommendations: This seems to be a substantial maternity colony and therefore worth preserving. Emergence counts may be valuable to determine number of bats present, but difficult due to the number of emergence points. Other bats can cohabitate with <i>M. lucifugus</i>, so follow-up surveys with ANABAT® should be done to determine species composition.</p>

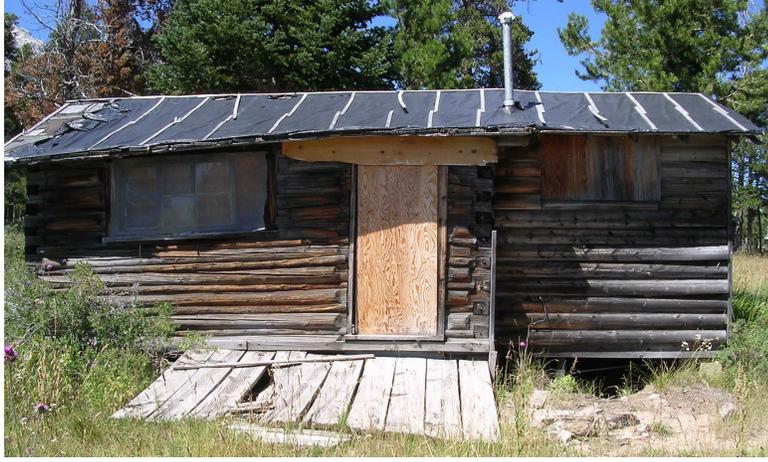
M	Building ID: WGd	GPS Location (E, N):	0518266 4833829	Location Error: 5 m
<p>Description:</p> <p>Small (4m X 7m) cabin. Log construction. Plastic sheet over wood-plank roof. Main entrance faces southeast.</p> <p>Beam and plank A-frame ceiling. Two rooms. Wood stove.</p> <p><u>Bat habitat Notes:</u> Two main emergence points; above the front door and in the wall where the bathroom addition joins the main room.</p>

<p>Bat Use: Moderate bat use based on scattered guano with one area of accumulation underneath the main roof beam. However, no bats were seen or heard. It could be a day roost that was recently vacated, or it could be a night roost.</p>				
<p>Recommendations: Maybe valuable to search again to determine day-night use and conduct acoustic monitoring to determine species composition.</p>

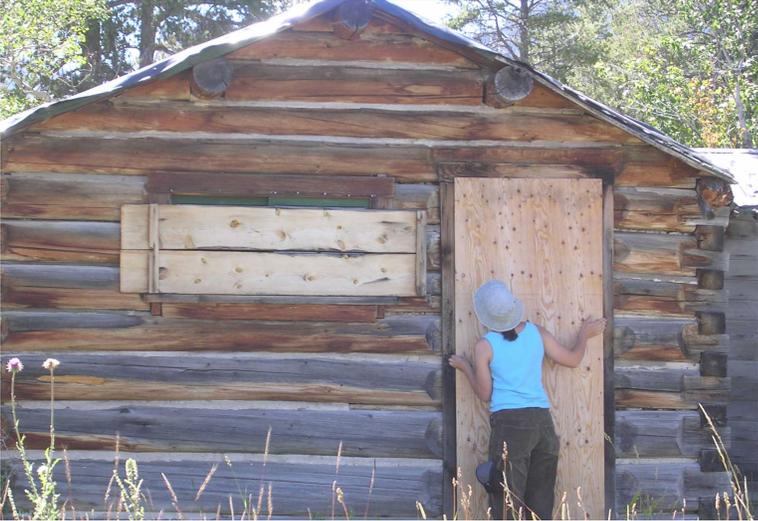
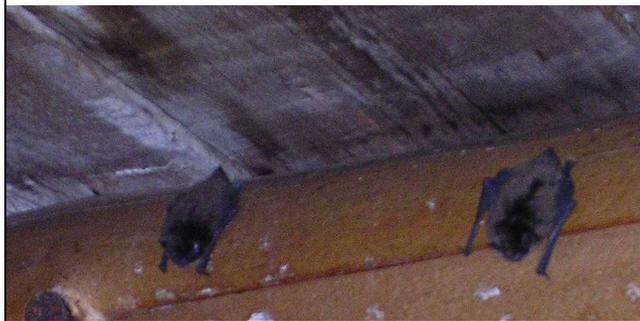
M	Building ID: WGe	GPS Location (E, N):	0518290	4833870	Location Error: 8 m
<p>Description: Small (4m X 6m) cabin. Chinked log construction. Plastic sheet over wood-plank roof. Beam and plank A-frame ceiling. Two rooms.</p> <p>Bat habitat Notes: There are several emergence points; stovepipe hole in roof and cracks in the ceiling.</p>

Bat Use: Light to moderate bat use based on guano accumulation. A few bats seen; most likely *Myotis lucifugus*, making it a day roost but not necessarily a maternity roost.

Recommendations: Maybe valuable to search again earlier in the season (e.g., early July) to determine whether it is a maternity colony. Other bats may cohabitate with *M. lucifugus*, so follow-up surveys could be done to determine if sensitive species are present. An emergence count could be done to estimate the number of bats roosting in the building.

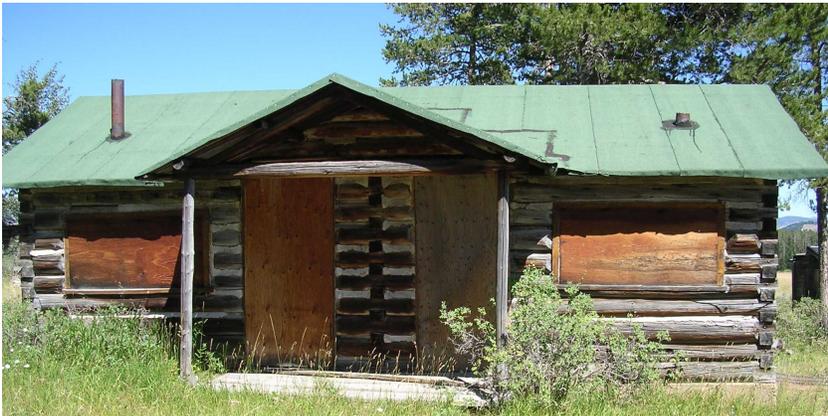
L	Building ID: WGf	GPS Location (E, N):	0518271	483380	Location Error: 6 m
<p>Description: Small (7m X 9m) duplex cabin. Chinked log construction. Asphalt sheet roof with 3 stovepipes. Main entrance faces southwest. Beam and plank A-frame ceiling. Ceiling in bathroom partially collapsed.</p> <p>Bat habitat Notes: Main emergence point is likely the stovepipe in the south room.</p>

<p>Bat Use: Low level of bat use based on scattered guano and insect parts in south room. Most likely a night roost where bats stop to digest food. Based on size of guano, the bats could be <i>Eptesicus fuscus</i>.</p>					
<p>Recommendations: Likely not a major roost. Maybe valuable to use acoustic monitoring to determine species composition.</p>

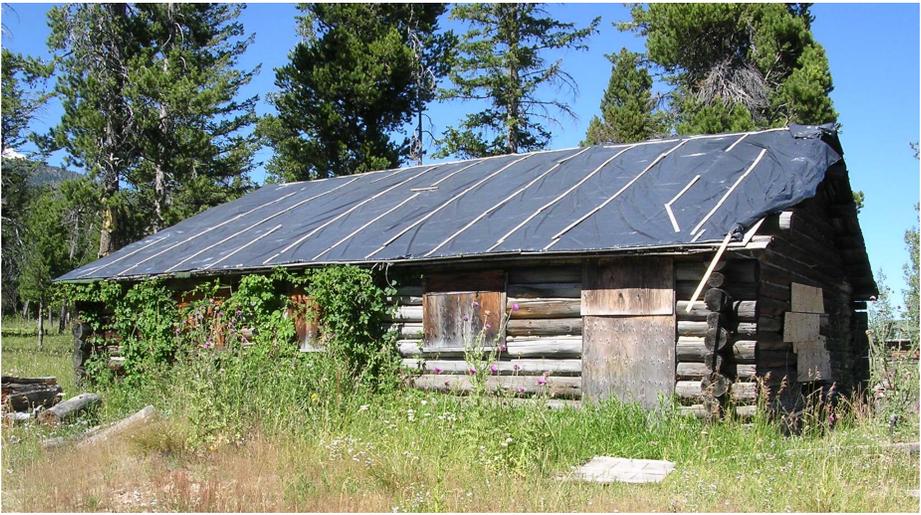
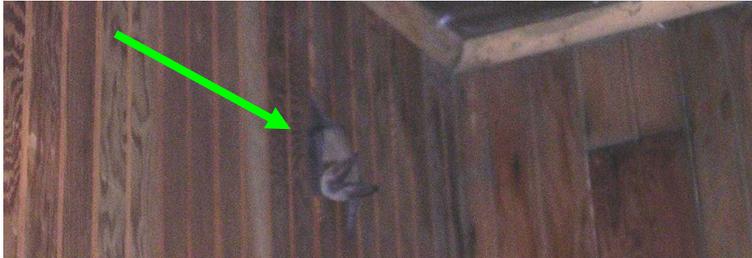
H	Building ID: WGh	GPS Location (E, N):	0518263	4833905	Location Error: 2 m
<p>Description:</p> <p>Larger building, possibly the main showers. Chinked log construction, with 4 doors. Plastic sheet over plank roof.</p> <p>Various ceiling structures with attic space. Many rooms; boiler room, shower stalls, laundry facilities.</p> <p><u>Bat habitat Notes:</u> Many emergence points, but largest two are an open door on the east and a broken wall on the south. Attic is hot (good for maternity roost) but does not have much guano. Possibly difficult to ANABAT due to many holes.</p>

<p>Bat Use: Moderate to high bat use based on scattered guano throughout the building. Visual observations were made of two <i>Myotis lucifugus</i> and one <i>Corynorhinus townsendii</i> (see photo). <i>M. lucifugus</i> were seen the attic and the main shower rooms, while <i>C. townsendii</i> was seen roosting in a large, open "closet" off the "linen room" in the west side of the building.</p>

<p>Recommendations: <i>C. townsendii</i> is recognized as a sensitive species by most state and federal agencies in Wyoming (e.g., BLM, USFS, WYNDD, WYGFD). They require large, open roosting structures and are sensitive to disturbance. Also, it seems to be a fairly consistent day and/or night roost for other species. Try to conduct acoustic monitoring at the western door and/or re-survey earlier in the season to determine species composition. Consider leaving this building intact and undisturbed.</p>

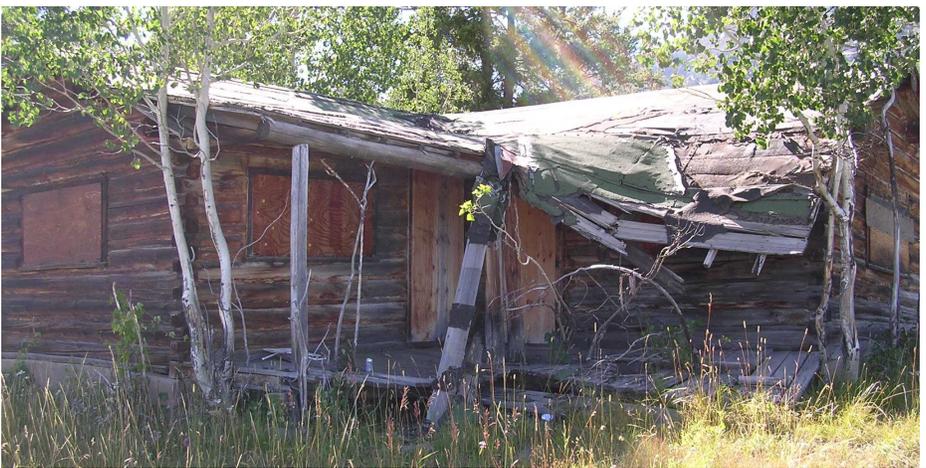
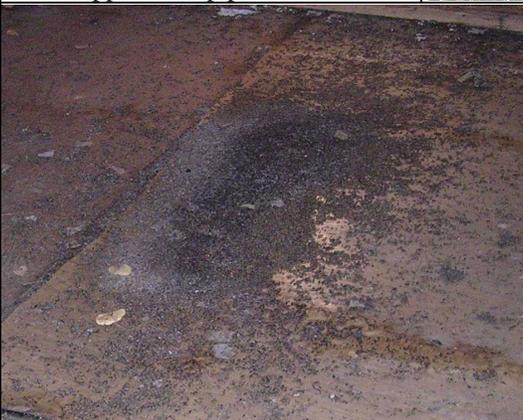
H Building ID: WGj	GPS Location (E, N):	0518291 4833944	Location Error: 2 m
<p>Description:</p> <p>Medium-sized cabin. Log construction. Asphalt sheet roof with 2 stovepipes. Porch and 3 exterior doors, with the main entrance facing east.</p> <p>Beam and plank A-frame ceiling. 3 rooms and a bathroom.</p> <p><u>Bat habitat Notes:</u> Roosts mainly along center ceiling beams, but guano scattered everywhere. Emergence points are likely through 2 un-capped stovepipe holes.</p>

<p>Bat Use: High bat use based on guano piles (see photo) and scattered guano throughout the building. No visual or audible observations. Probably a long-term night roost, but could easily be a day roost that was used earlier in the summer. Some guano is large, suggesting <i>Eptesicus fuscus</i>. ANABAT® recordings were attempted on 10 Aug 2004, but equipment malfunction resulted in only a few calls early in the evening, which included <i>M. lucifugus</i>, <i>E. fuscus</i>, and <i>M. thysanodes</i>.</p> <p>Recommendations: This roost structure should be kept intact. It seems to be a significant roost and one of the few that receive regular <i>E. fuscus</i> use. For further information, one might consider unobtrusively visiting it earlier in the season to confirm night versus day use and conducting emergence counts to determine the number of bats currently using it.</p>

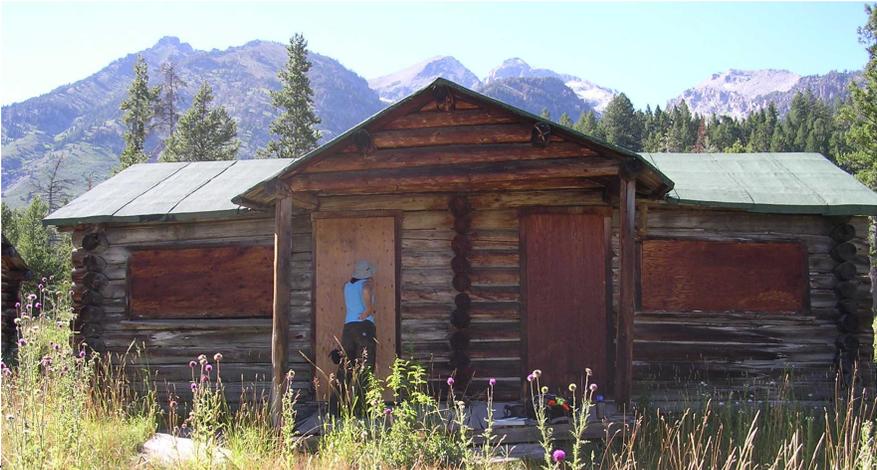
L	Building ID: WGk	GPS Location (E, N):	0518242	4833911	Location Error: 9 m
<p>Description:</p> <p>Small (4m X 7m) duplex cabin. Chinked log construction. Asphalt sheet roofing with one stovepipe.</p> <p>Beam and plank A-frame ceiling with some insulation. Two rooms and a bathroom.</p> <p><u>Bat habitat Notes:</u> The un-capped stovepipe represents the main emergence point.</p>

<p>Bat Use: Low bat use based on some guano. Not likely a valuable roost structure.</p>					
<p>Recommendations: None.</p>

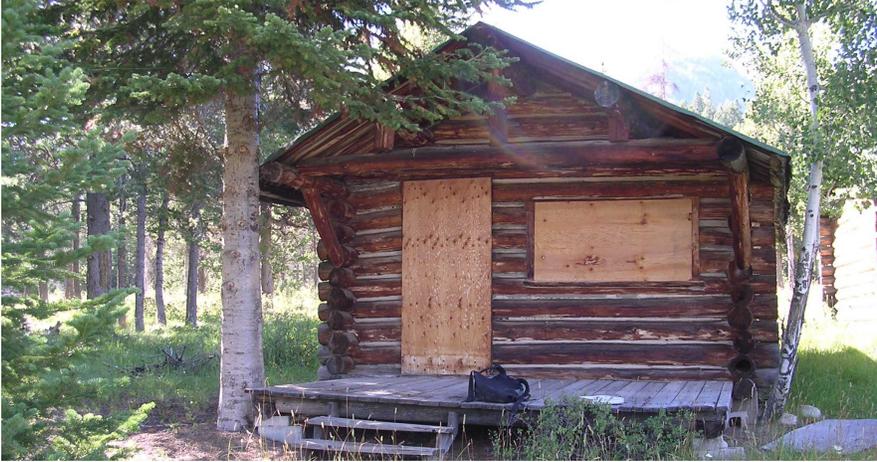
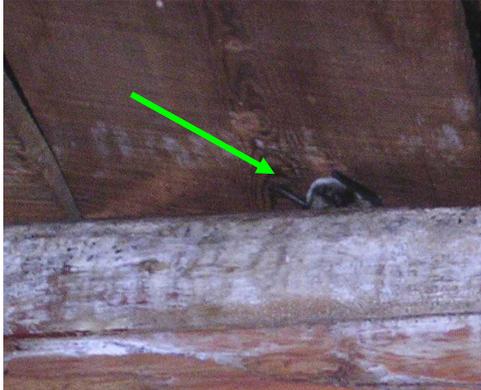
M	Building ID: WGI	GPS Location (E, N):	0518223	4833881	Location Error: 1 m
<p>Description:</p> <p>Small cabin with large east-facing front porch. Chinked log construction. Asphalt sheet roofing.</p> <p>Beam and plank A-frame ceiling with some insulation. One room and a bathroom.</p> <p><u>Bat habitat Notes:</u> Stovepipe holes and holes in the bathroom are likely the main emergence points.</p>

<p>Bat Use: Moderate bat use as a day roost based on scattered guano and visual identification of three <i>Myotis lucifugus</i> roosting along the main ceiling beam (see photo). There is, however, much old staining on the ceiling beams suggesting it may have been more heavily used in the past.</p> <p>Recommendations: Conduct acoustic monitoring and or another site visit early in the summer to determine level of current use and species composition.</p>

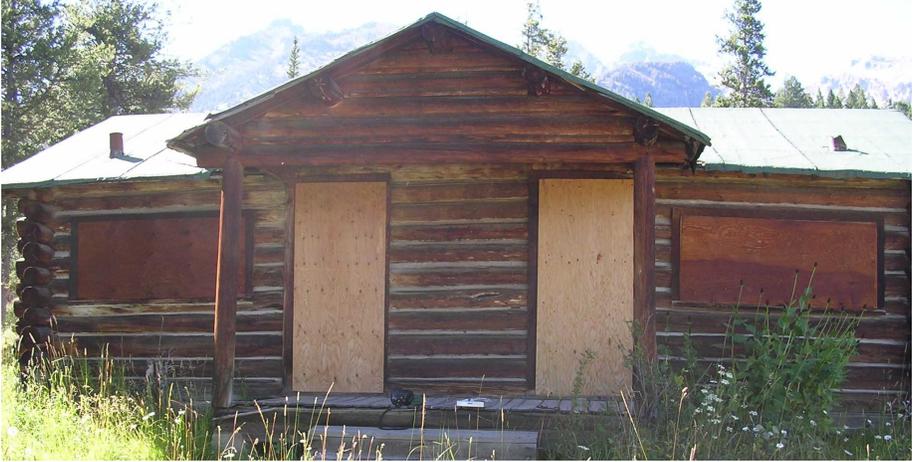
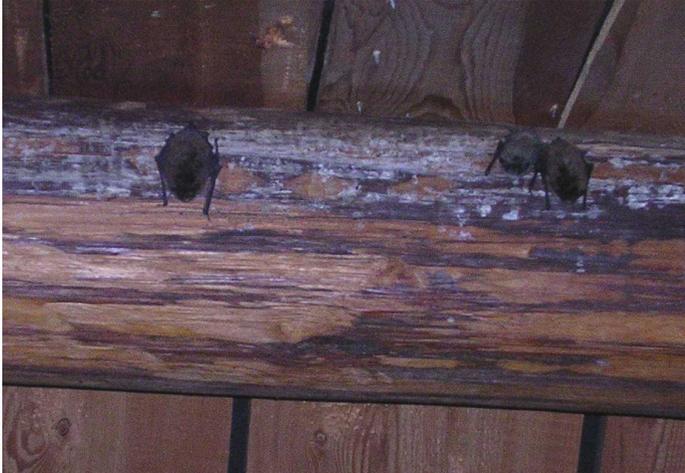
H	Building ID: WGm	GPS Location (E, N):	0518237 4833900	Location Error: 10 m
<p>Description:</p> <p>Small (4m X 8m) duplex cabin. Chinked log construction. Asphalt sheet roofing with 4 stovepipes.</p> <p>Beam and plank A-frame ceiling with some insulation. Two rooms and a bathroom.</p> <p>Bat habitat Notes: The un-capped stovepipes and a hole do to collapsing ceiling represent the main emergence points.</p>

<p>Bat Use: Moderate to High bat activity based on much guano accumulation and direct observations of at least 10 <i>Myotis lucifugus</i> (see photo).</p> <p>Recommendations: Maybe valuable to search again earlier in the season (e.g., early July) to determine whether it is a maternity colony. Other bats may cohabitate with <i>M. lucifugus</i>, so follow-up surveys could be done to determine if sensitive species are present. An emergence count could be done to estimate the number of bats roosting in the building.</p>
