II. Existing Conditions

1. Existing Central Energy Plan System Configuration

b) Existing Central Energy Plant Condition Assessment

b) Existing Steam and Condensate Distribution System Configuration and Condition Assessment

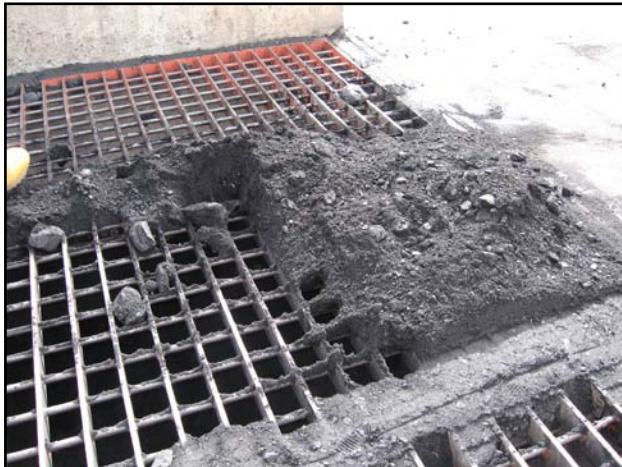
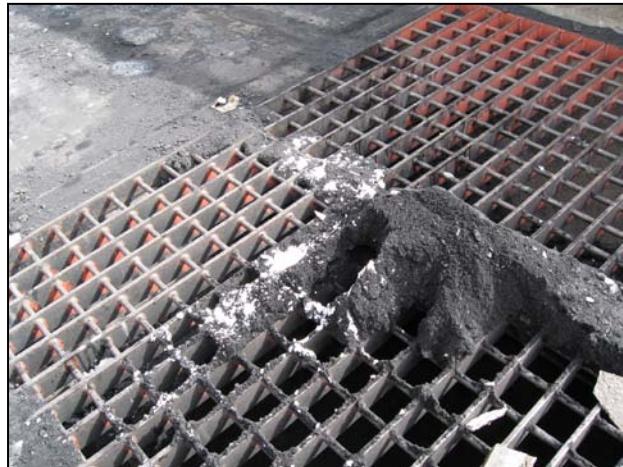
As previously stated in this study, the primary issue with the operation of the CEP is the large percentage of coal fines that is received from the existing coal mine in relation to the design requirement of the boiler spreader stokers and ash handling system. The **wet** condition of the coal exacerbates the problem causing the pneumatic coal conveying system to operate excessively and inefficiently. The following photographs illustrate the inconsistency of the coal which is not optimum in size for spreader stoker boilers (2" – 1/4" recommended) and that some of the coal arrives snow-covered.

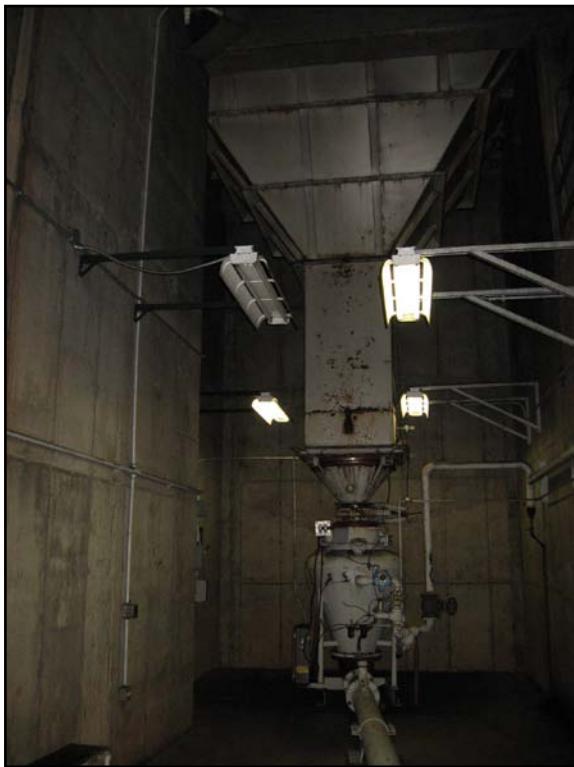
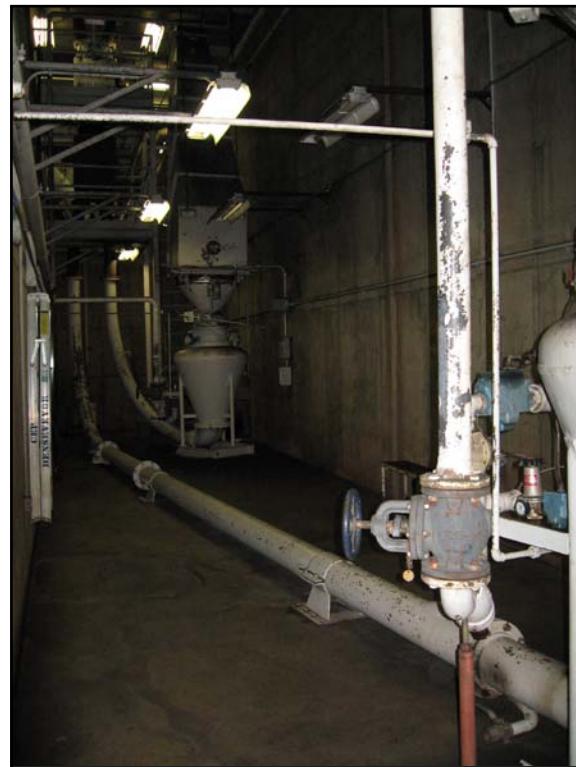
During the time of the site survey, it was noted that the Denseveyors and associated air compressors ran excessively during coal deliveries. Over two days, it was noted that the coal arrived to the site extremely wet. The high moisture content is not recommended for the Denseveyors shown below.

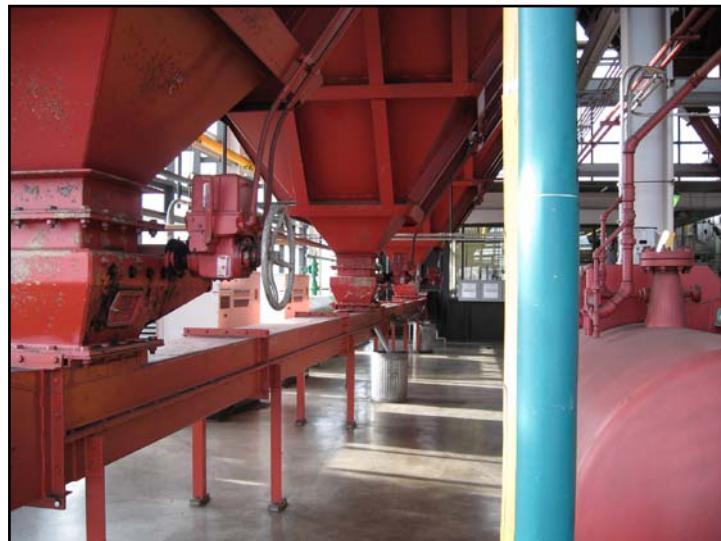
Figure II-B-8

Once the wet coal is sluggishly conveyed to the coal storage silos, moisture in the coal can drain to the bottom of the silo hoppers and mix with the excessive coal fines forming a "mud-like"

consistency that will clog the hoppers. As can be seen from the photo below in figure II-B-8, the silo hoppers and knife-gate valves are clogged and often require “hammering” on the exterior of the equipment in an attempt to loosen the coal.

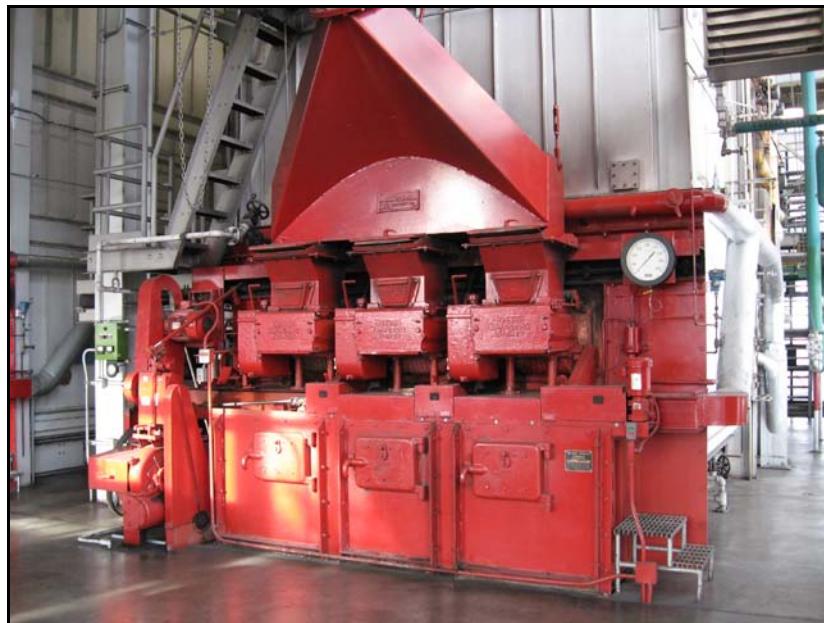
Figure II-B-9

Boiler Nos. 2 through 4 each have three existing Rotograte underthrow spreader stoker feeders as can be seen from the photograph below.

The recommended stoker grade coal size for these feeders is 2" to 1/4" with a maximum of 40% fines, dry. The actual coal size

delivered is anywhere from 6" in diameter to pulverized dust that is primarily wet. Underthrow spreader stoker feeders of this vintage are not designed to "throw" pulverized coal, and the current distribution air (overfire air) is not designed to "blow" pulverized coal. Coal chunks that are too large can bind and break the feeders, and coal fines can collect inside the distributor box itself and combust causing stoker fires, hopper fires, etc.

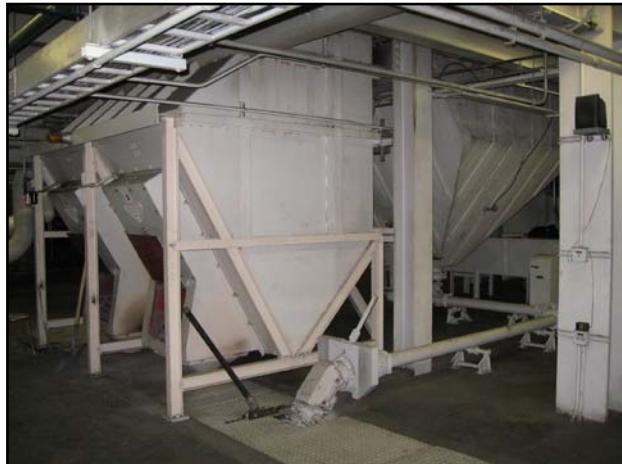
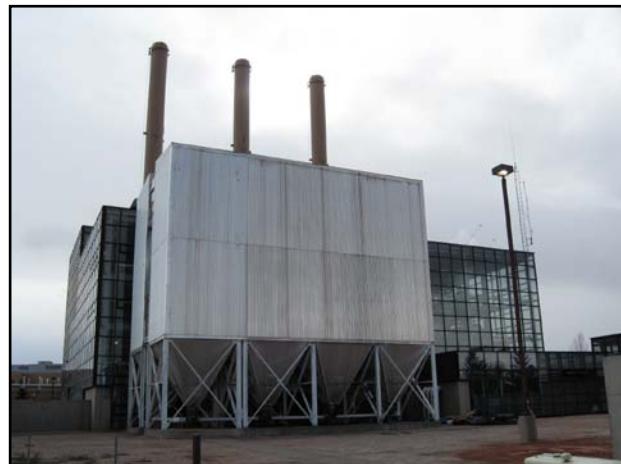
The overall condition of the ash system, ash silo, hoppers, baghouse, and stacks appeared to be in good condition given the age of the equipment as can be seen in the photographs below. However, a thorough internal inspection of the equipment was not conducted at the time of the assessment.

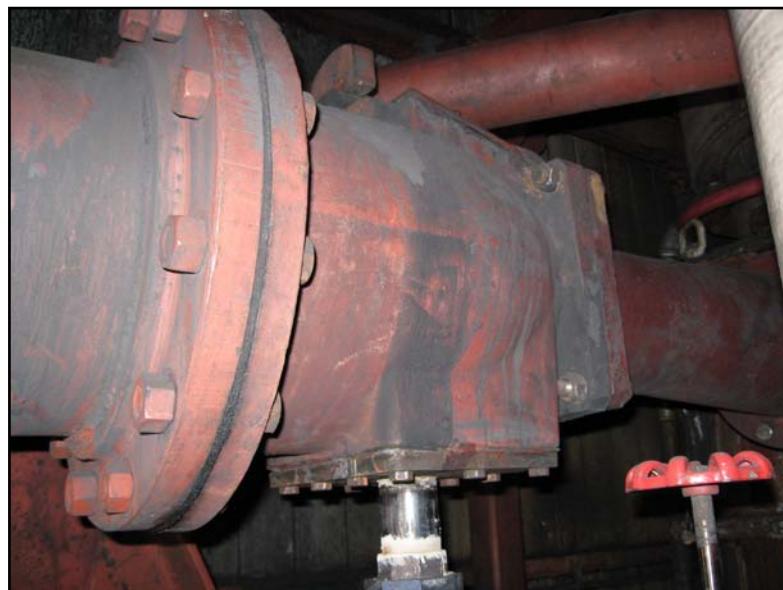
Figure II-B-12

An item of concern is the existing steam exhauster for the ash conveying system. Currently, the exhauster is the single point of failure for the entire system. If the steam exhauster is down for maintenance or repair, the CEP cannot pull ash and subsequently, cannot burn coal. The steam exhauster is nearing the end of its remaining useful life and is shown below in Figure II-B-12.

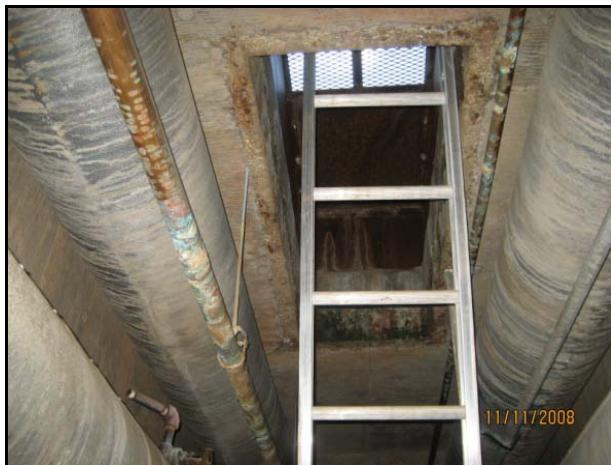
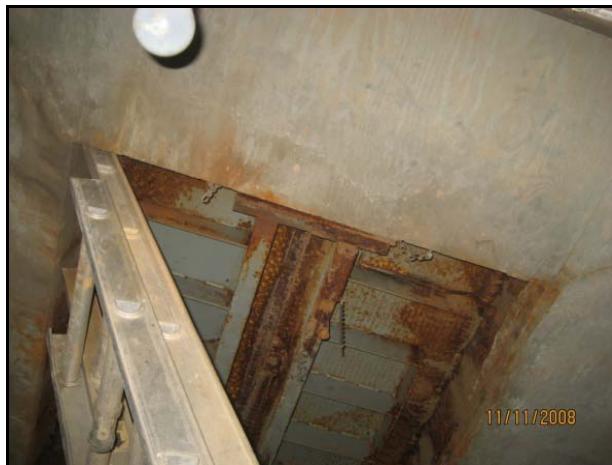
Access Egress Shaft Photos

Currently access ways are limited in number, location, and separation to access/egress the tunnel. Most of the current locations access ways are padlocked and open directly upward into a pedestrian sidewalk or into existing building mechanical rooms that restricts personnel exit paths from the tunnels under emergency conditions. Additionally, the current surface access/egress doors are not waterproof and allow infiltration of debris and natural elements which cause corrosion to the internal utilities. Photos of existing access/egress surface hatches are shown on the following page.

It is recommended to add access points throughout the tunnel system that would have a hinged locked hatch with a panic bar at the top. The structure would also contain louvers and ducting to allow natural ventilation to occur. Examples of access hatches are shown in the photos below. Cost for a vertical access point connected to the side of the existing utility tunnel structure is estimated at \$12,000 each. If piping is located on each side of the tunnel the cost will be in the range of \$40,000 (+/-) due to required piping modifications.

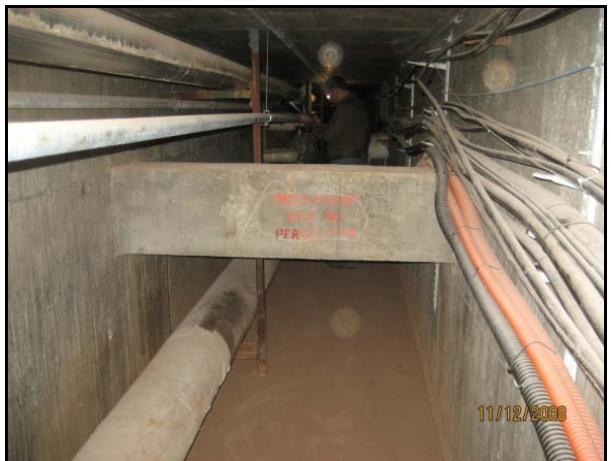
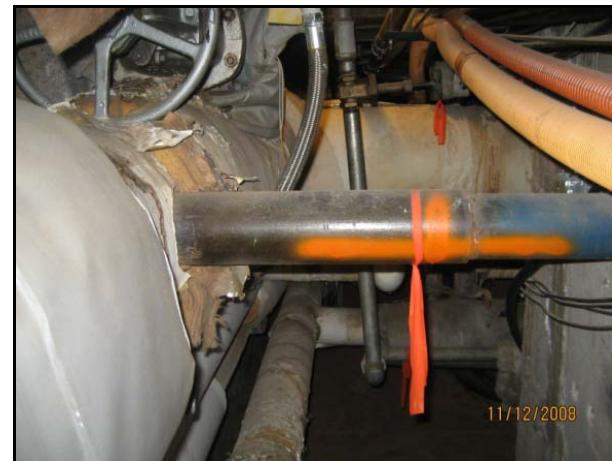
Horizontal Utility Crossing Photos

Another item which affects access/egress within the tunnels is the routing of civil utilities, electrical and telecom wiring. In some locations, these utilities are routed perpendicular through the tunnel at knee to shoulder level causing personnel to crawl over or pass under. Examples of perpendicular utilities through the tunnel that limit egress are represented in the photos below.

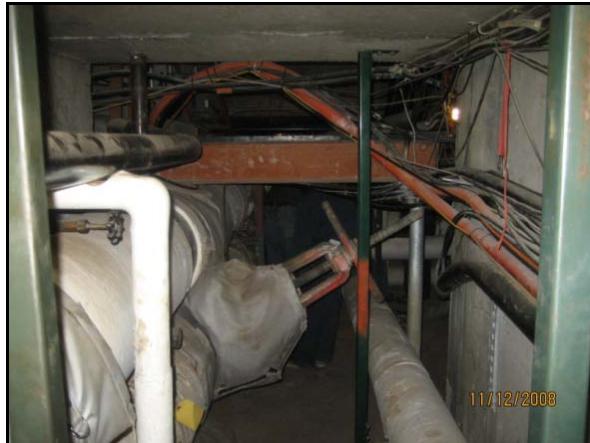
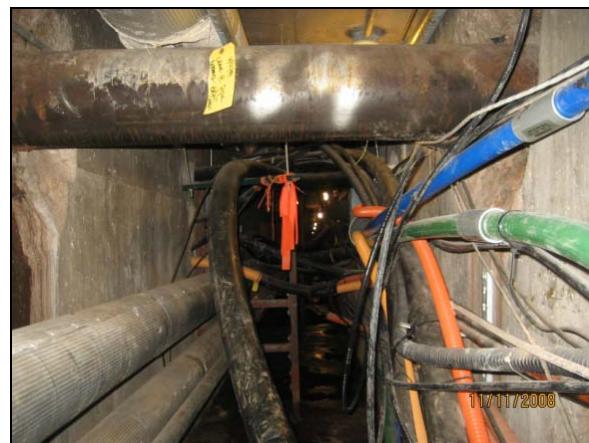
Paralleling Utility Photos

Some areas of the utility tunnel are very congested and narrow and do not allow personnel to negotiate the tunnel system swiftly without crouching or turning sideways for extended lengths of tunnel. Photos of this restriction are defined in the paralleling utility photos indicated below.

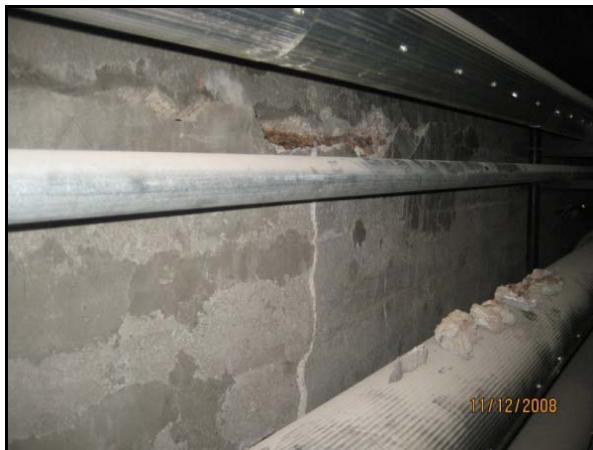
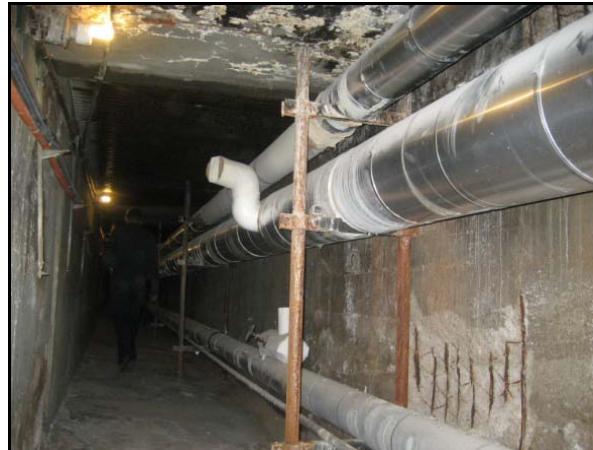
Structural Deficiency Photos

There are multiple high priority structural deficiencies throughout the tunnel identified below through descriptions and the following photos.

- The concrete floor, walls and ceiling are spalling and large cracks and mineral deposits are visible.
- Aggregate and rebar are visible in failing sections.
- There are high moisture levels from infiltration of surface and ground water through cracks in the roof and the walls. Open surface grating and utility penetrations are also a source.
- Investigation of tunnel age indicates portions of the tunnels have extended past the useful acceptable life of the concrete materials.
- Portions of the tunnel have steel and wood bracing installed to support the failing tunnel structure of which is also currently failing.

- *Upgrades or replacement to existing tunnel segments to avoid tunnel structural failure.*

Approximately 760 ft of the segment from Biological Sciences to Knight Hall is recommended to be replaced in the same location of the existing tunnel. At the same time it is recommended to place a set of ductbanks along side of the new tunnel structure to remove the primary power and telecom wiring from this tunnel section.

It is recommended to replace and relocate the tunnel segment out from under the Engineering, Agricultural and Education buildings to prevent structural failure from cutting service to a portion of the campus. The existing piping can serve as a back feed to serve Engineering, Agricultural and Education buildings. The cost to reconstruct the existing tunnel under the buildings would be cost prohibitive compared to relocating the tunnel and services to Lewis St. Analysis, estimates of, and recommendations of upgrades to the existing tunnel structure will be required to be performed by a licensed structural engineer.

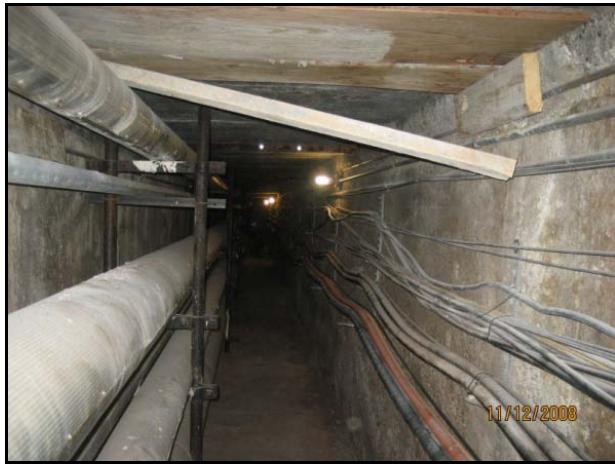
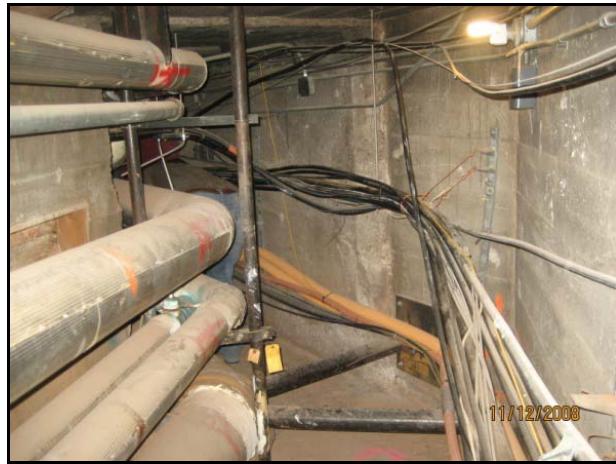
Structural Deficiency Photos

The portions of utility tunnels identified as needing immediate structural work are the segments between Biological Sciences to Knight Hall and the tunnel segment under Engineering, Agricultural and Education buildings. The replacement of these tunnel segments are critical to maintain a safe tunnel environment for personnel and to ensure the distribution piping, primary power and telecom systems are not compromised by a structural failure as can be seen in the following photos.

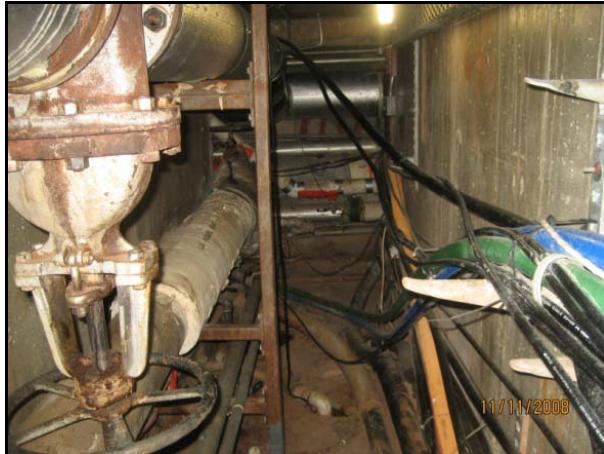
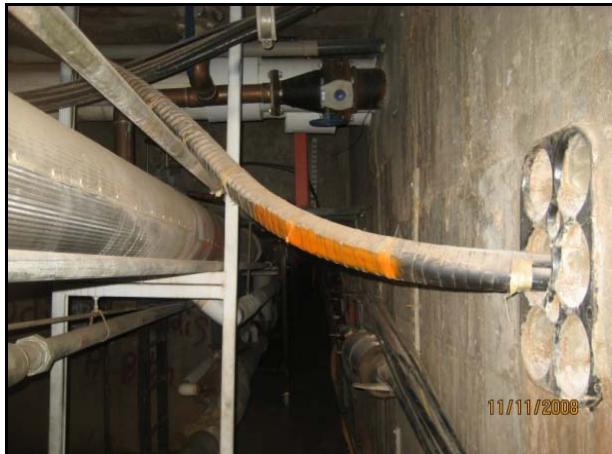
Egress Deficiency Photos

Most of the steam tunnel segments are utilized for fiber optic, computer network wire routing and in some areas, primary power cabling. These utilities add a significant quantity of poorly placed pull, splice, and junction boxes, and have reduced the free area for rapid egress travel in an emergency situation. Cabling is routed on top of steam and condensate piping and routed along the floor that place personnel are in contact with energized primary electrical and telecom cabling while walking on a floor with standing water. Some branch takeoffs are difficult to access from the main tunnel due to the fiber optic cabling mounted along the wall and across the branch opening. The cables pass by the branch takeoffs without transferring routing to the ceiling and leaving an opening to enter the branch tunnel.

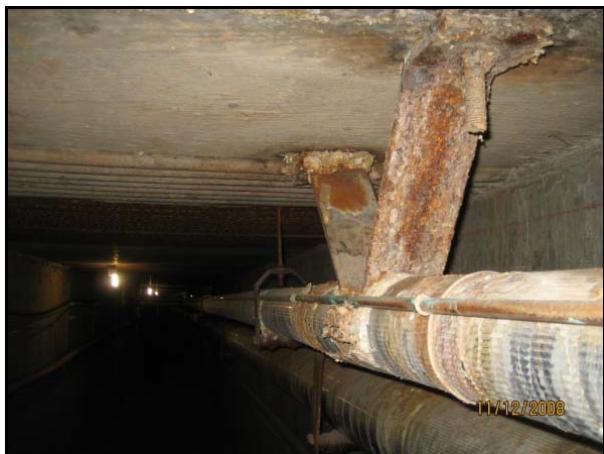
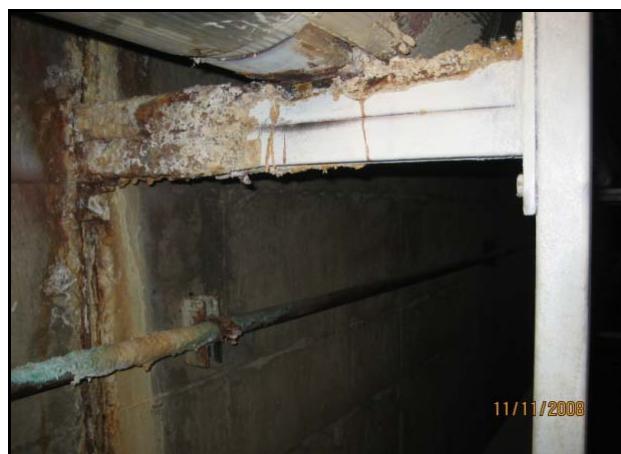
Structural Support Deficiency Photos

A majority of the existing pipe support systems use bolted unistrut design with some engineered welded structural steel. Most of the existing supports are painted steel and are corroding due to high humidity, pipe leaks, or water infiltration from tunnel structural deficiencies. Some portions of the utility tunnel have stanchions corroded to the point they no longer support the pipe and need immediate attention. Select support locations have the lower 6" – 12" of the unistrut cut off and replaced with galvanized steel. Some areas in the tunnel have had the entire unistrut steel support replaced with a galvanized unistrut. The replacement steel has started to corrode since the new galvanized steel has been bolted directly to the floor. Examples of structural support deficiencies are included in the following photos.

- *Upgrade deteriorating or failing supports.*

Any pipe support stanchions with corroded feet should be replaced to maintain adequate support for piping. The lower 12" should be replaced and reinstalled with galvanized steel unistrut mounted on a 2" grouted concrete base. The estimated cost for each replacement is \$400 per location.
