Restoration of Sagebrush Landscapes Impacted by Energy Development Jonah Field

Josh Sorenson
Reclamation Supervisor
Jonah Energy LLC
Jonah Field

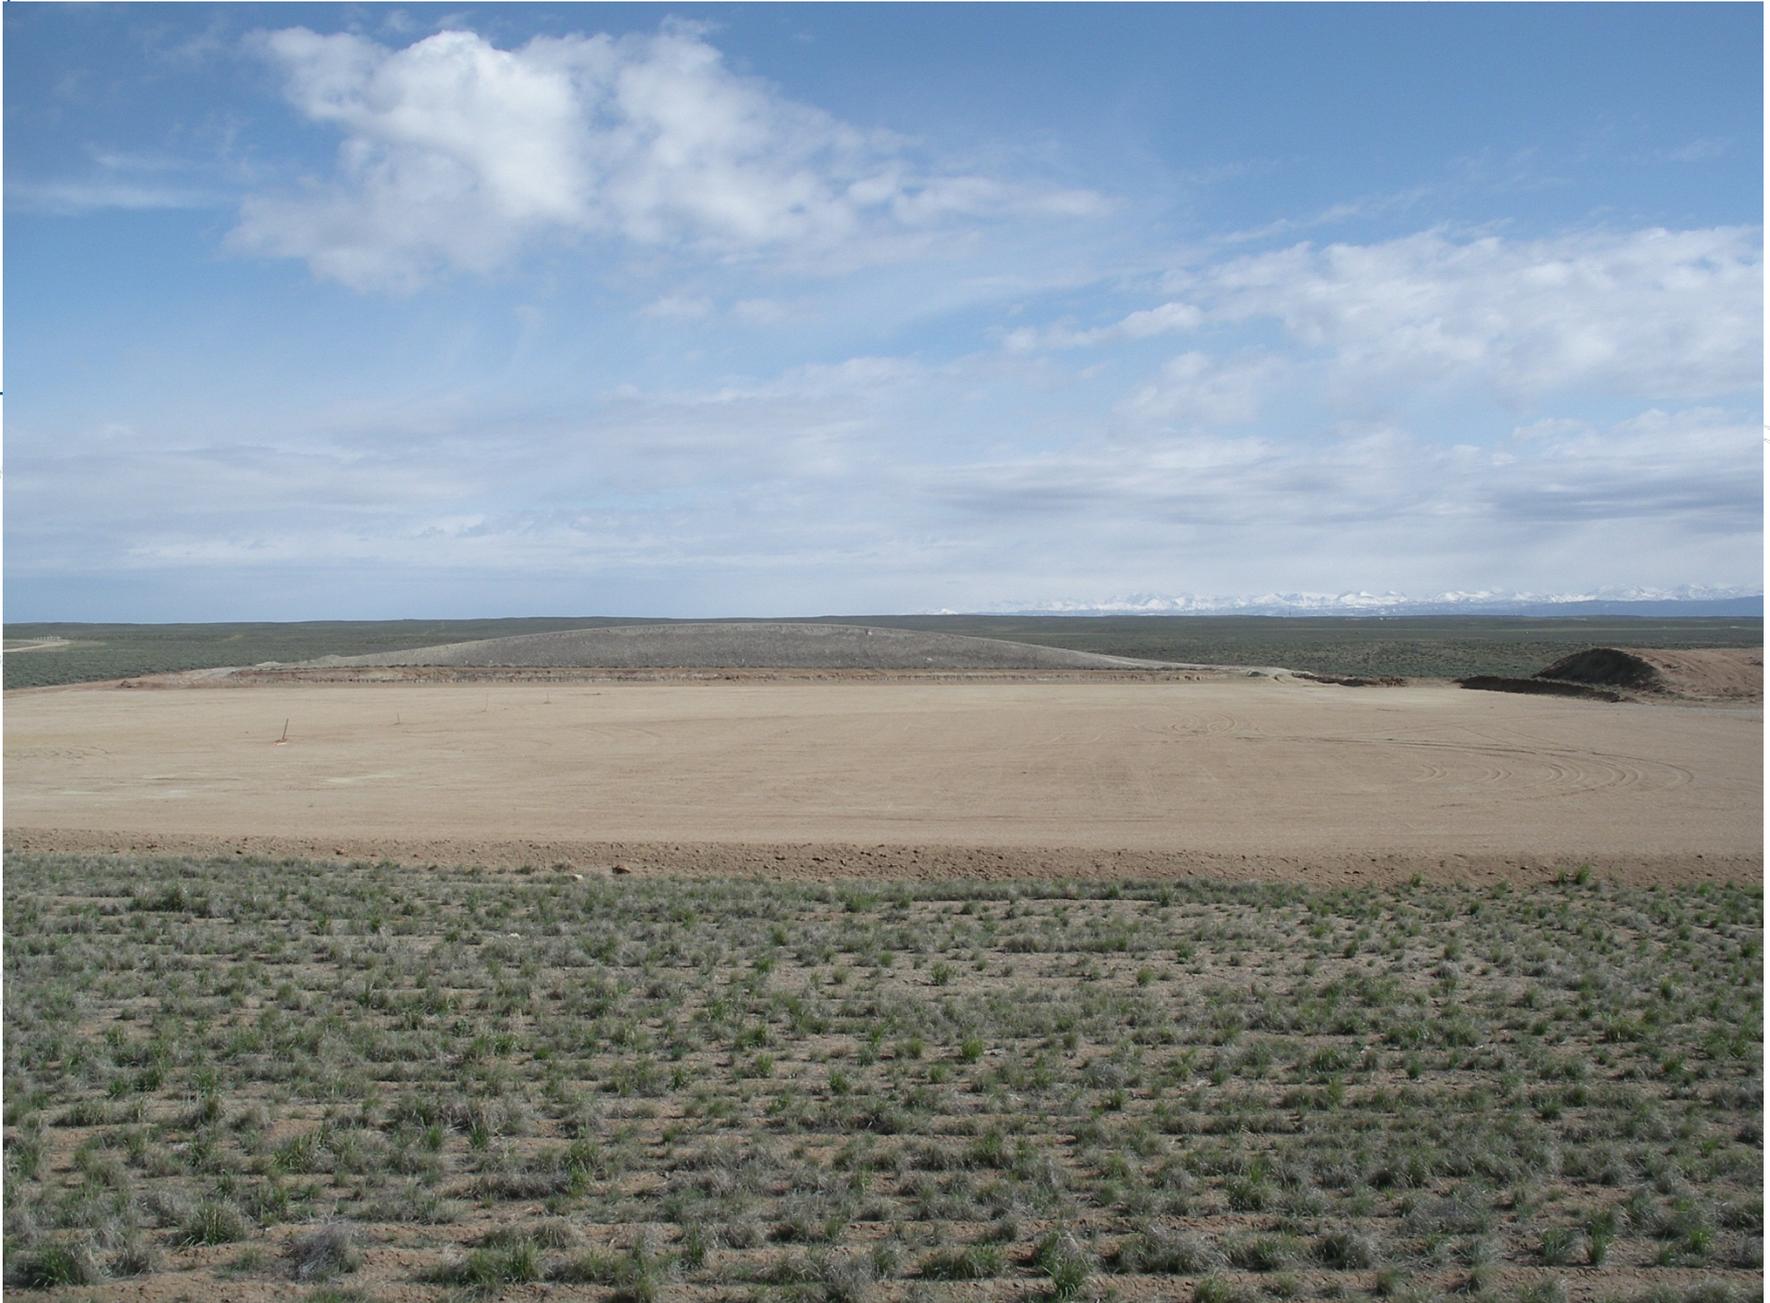
CONVENTIONAL EARTH PAD – SHB 44-11(multi-well)

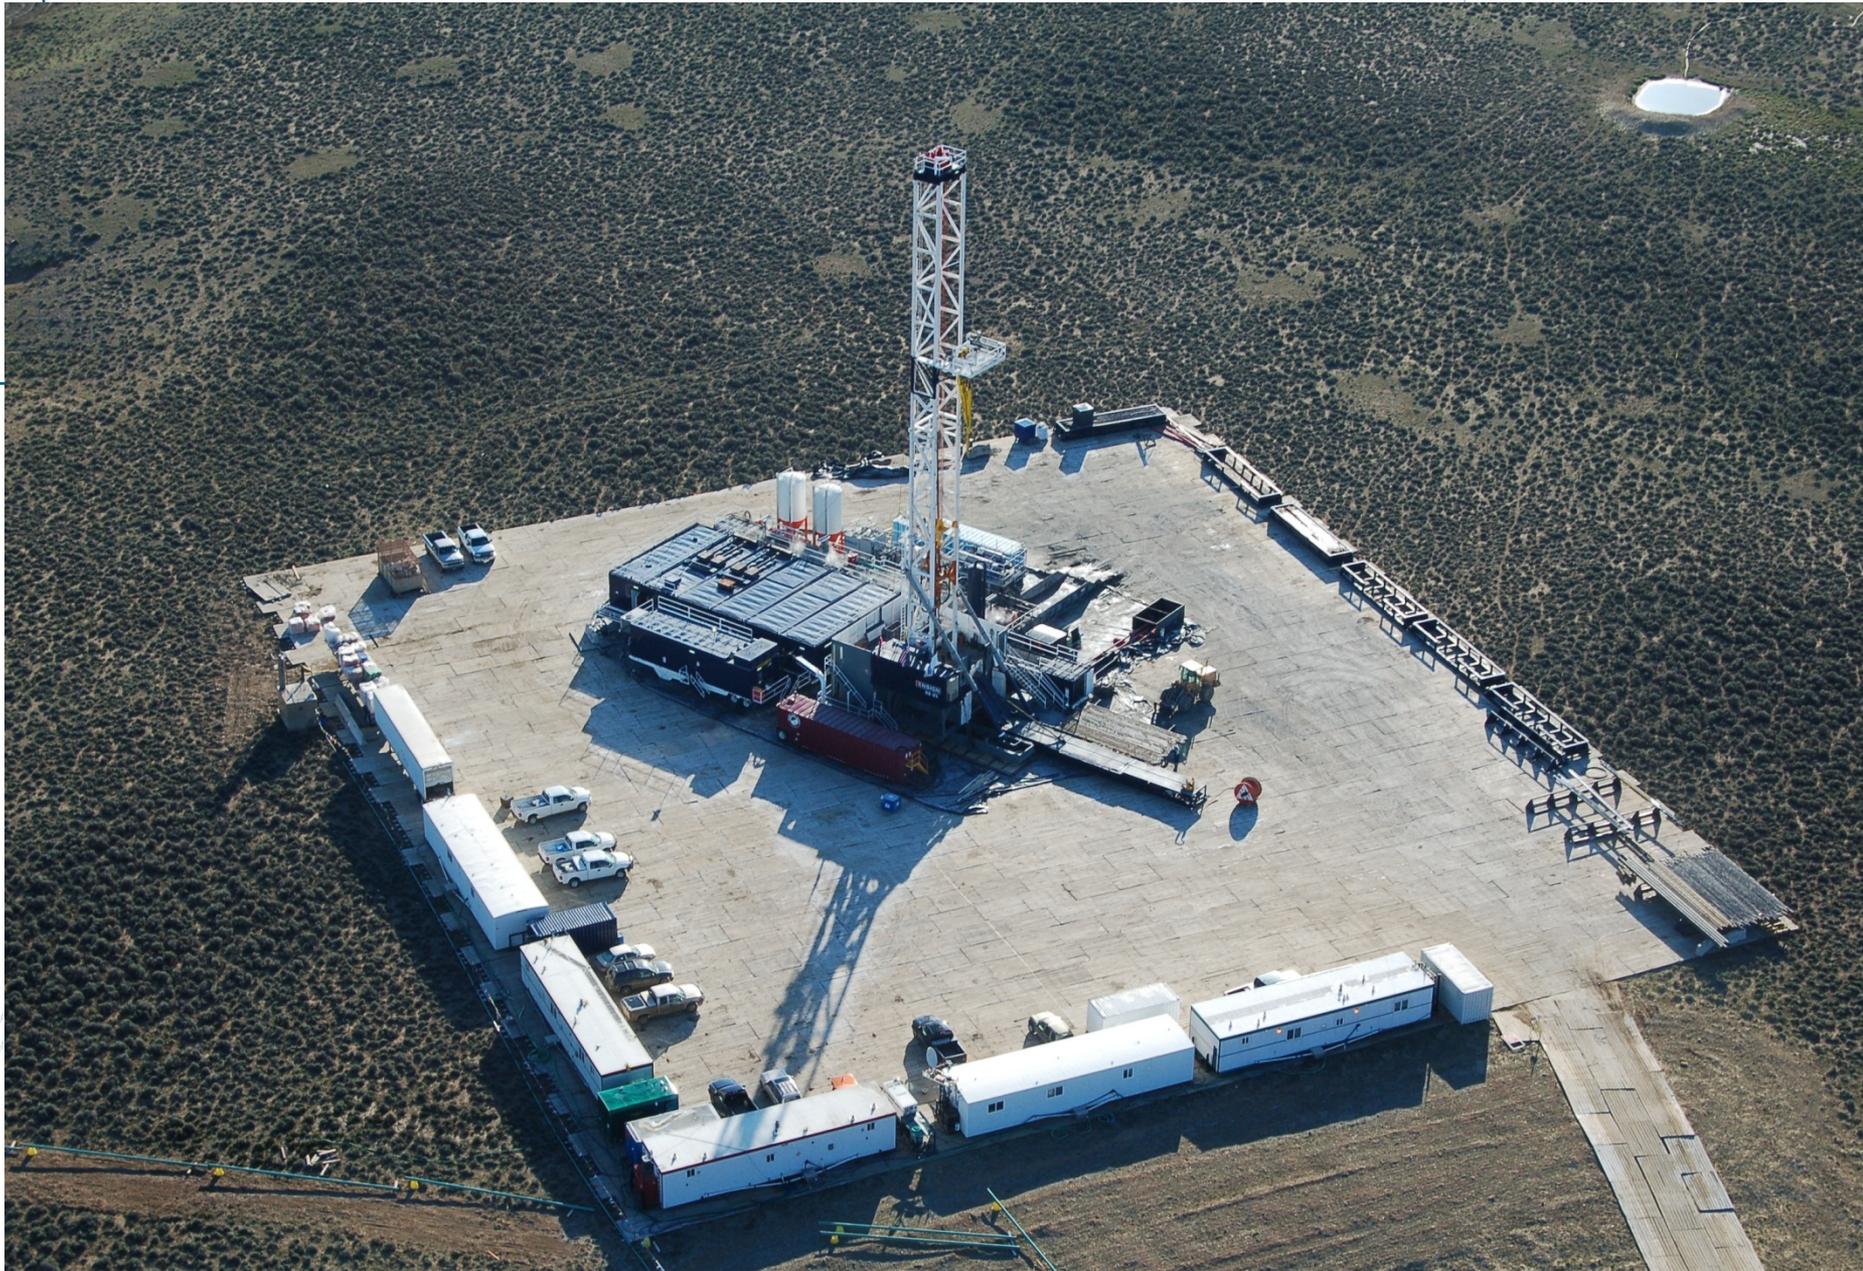
MAT PAD DRILLING LOCATION

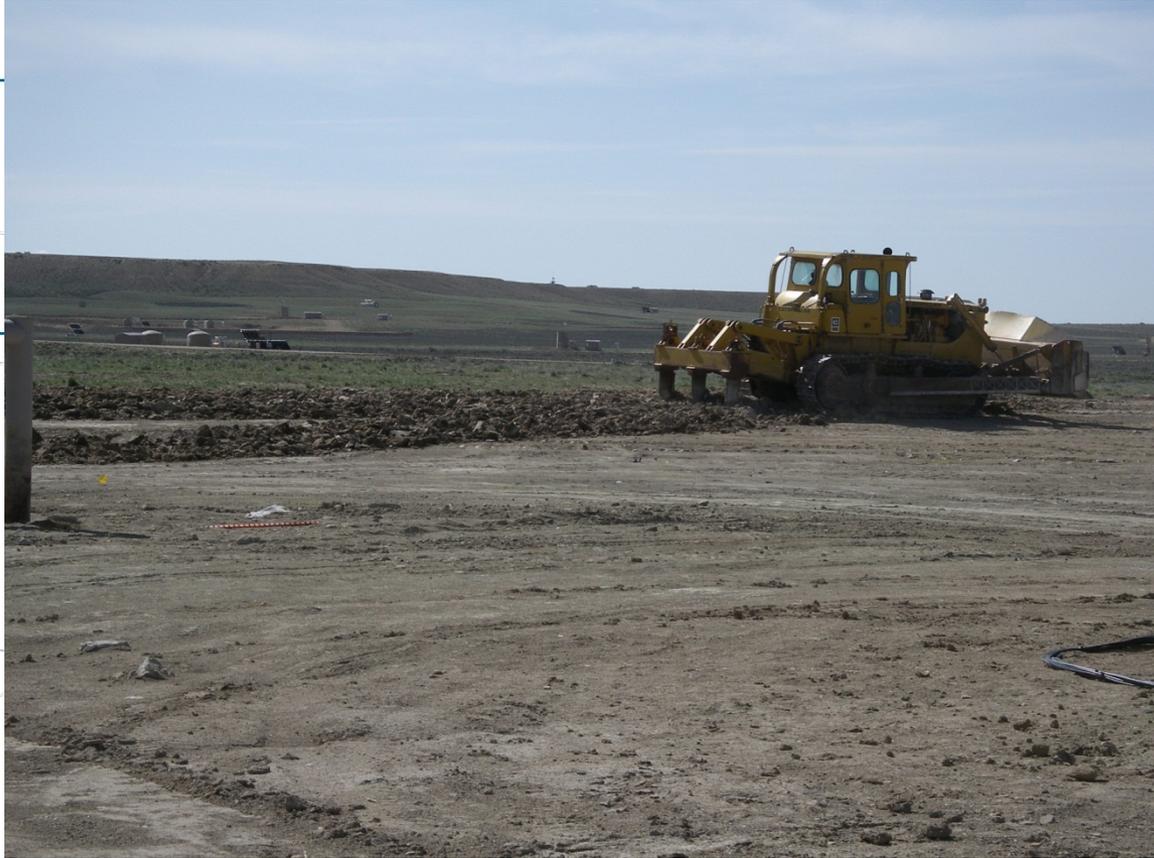
Deep ripping of subsoil prior to topsoiling

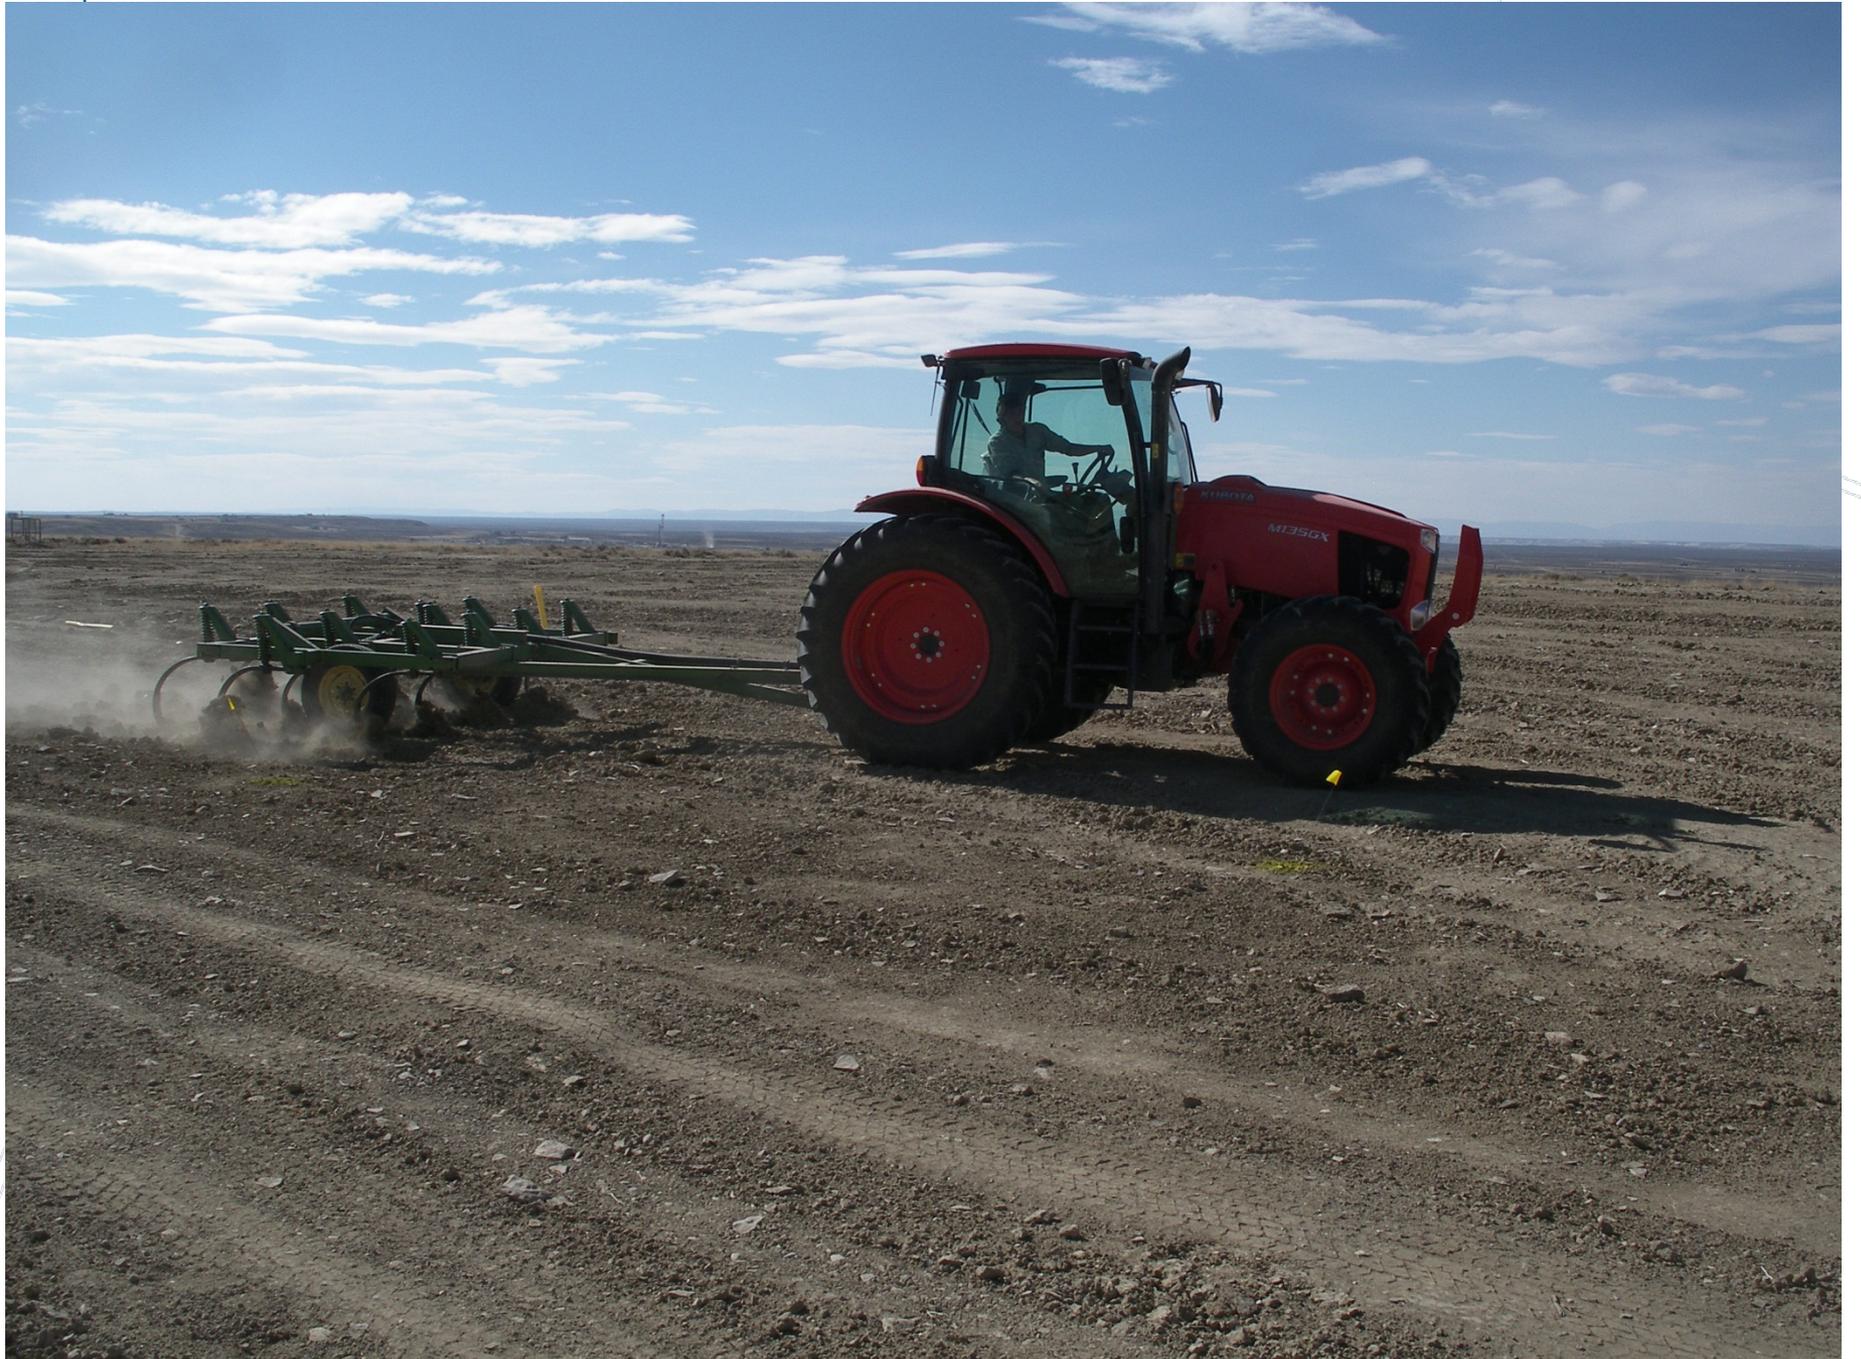
TRUAX RANGELAND DRILL WITH 12 INCH ROW SPACING

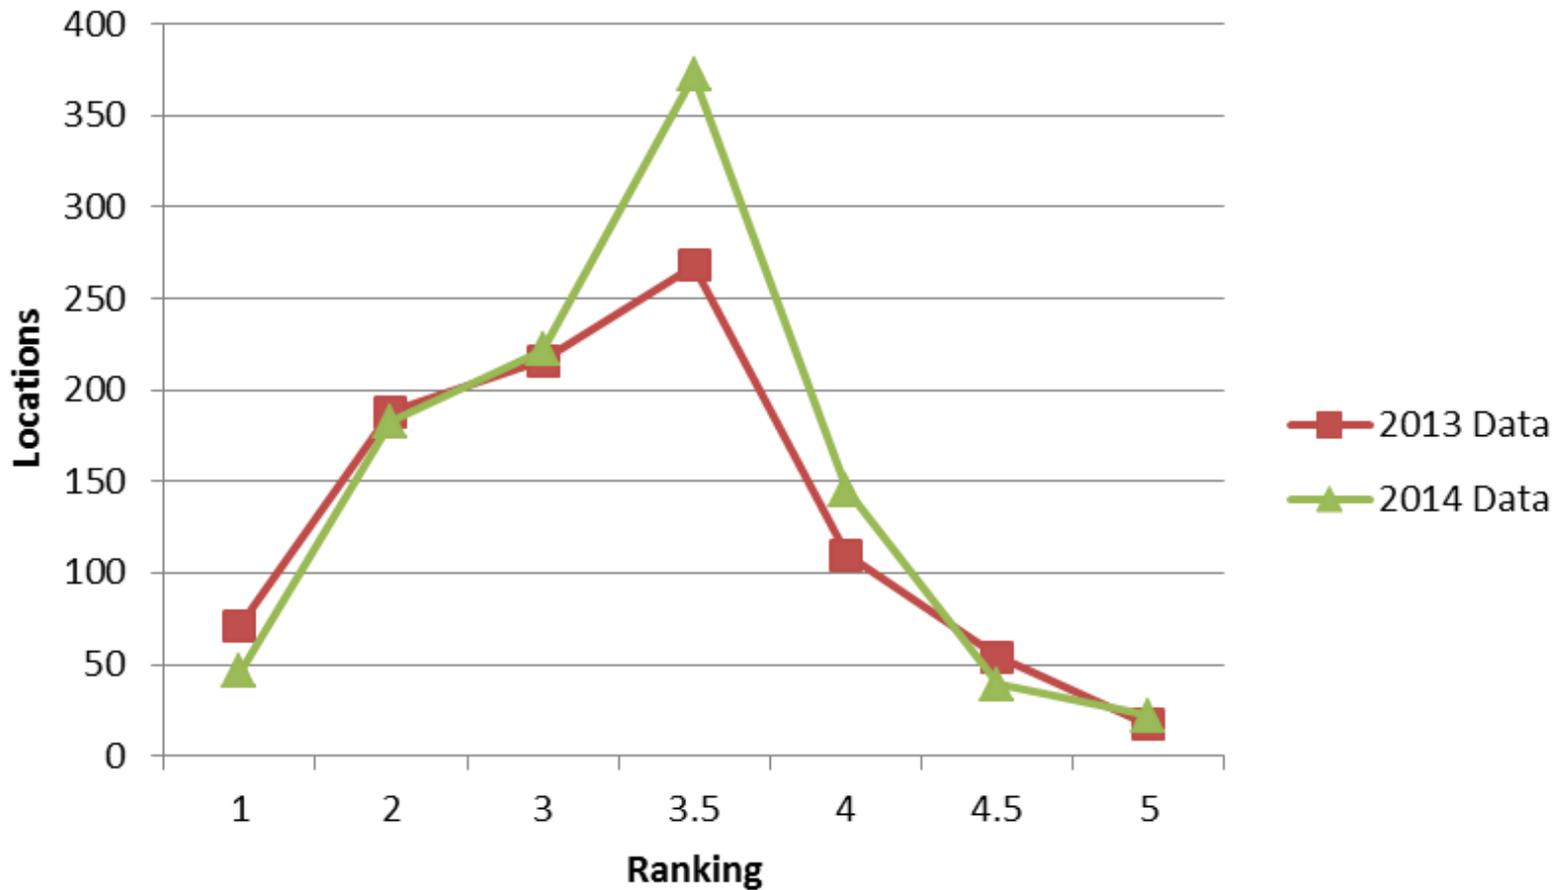
Location Rating Distribution

1. Majority of location lacks a minimum of two species of grass and needs remediation seeding.
2. Location has some cover on over 50% of location with 3 grass species and a least some perennial forbs but needs watching for additional seeding work
3. Location is stable throughout has three or more grass species has forbs and shrubs scatted over location but lacks sagebrush seedlings.
- 3.5. Location is stable throughout and has three or more grass species, has forbs and shrubs scatted over location and has some sagebrush seedlings.
4. Location is stable throughout and has three or more grass species, has a variety forbs and shrubs scatted over location and has good population of sagebrush seedlings.
5. Meets roll over criteria

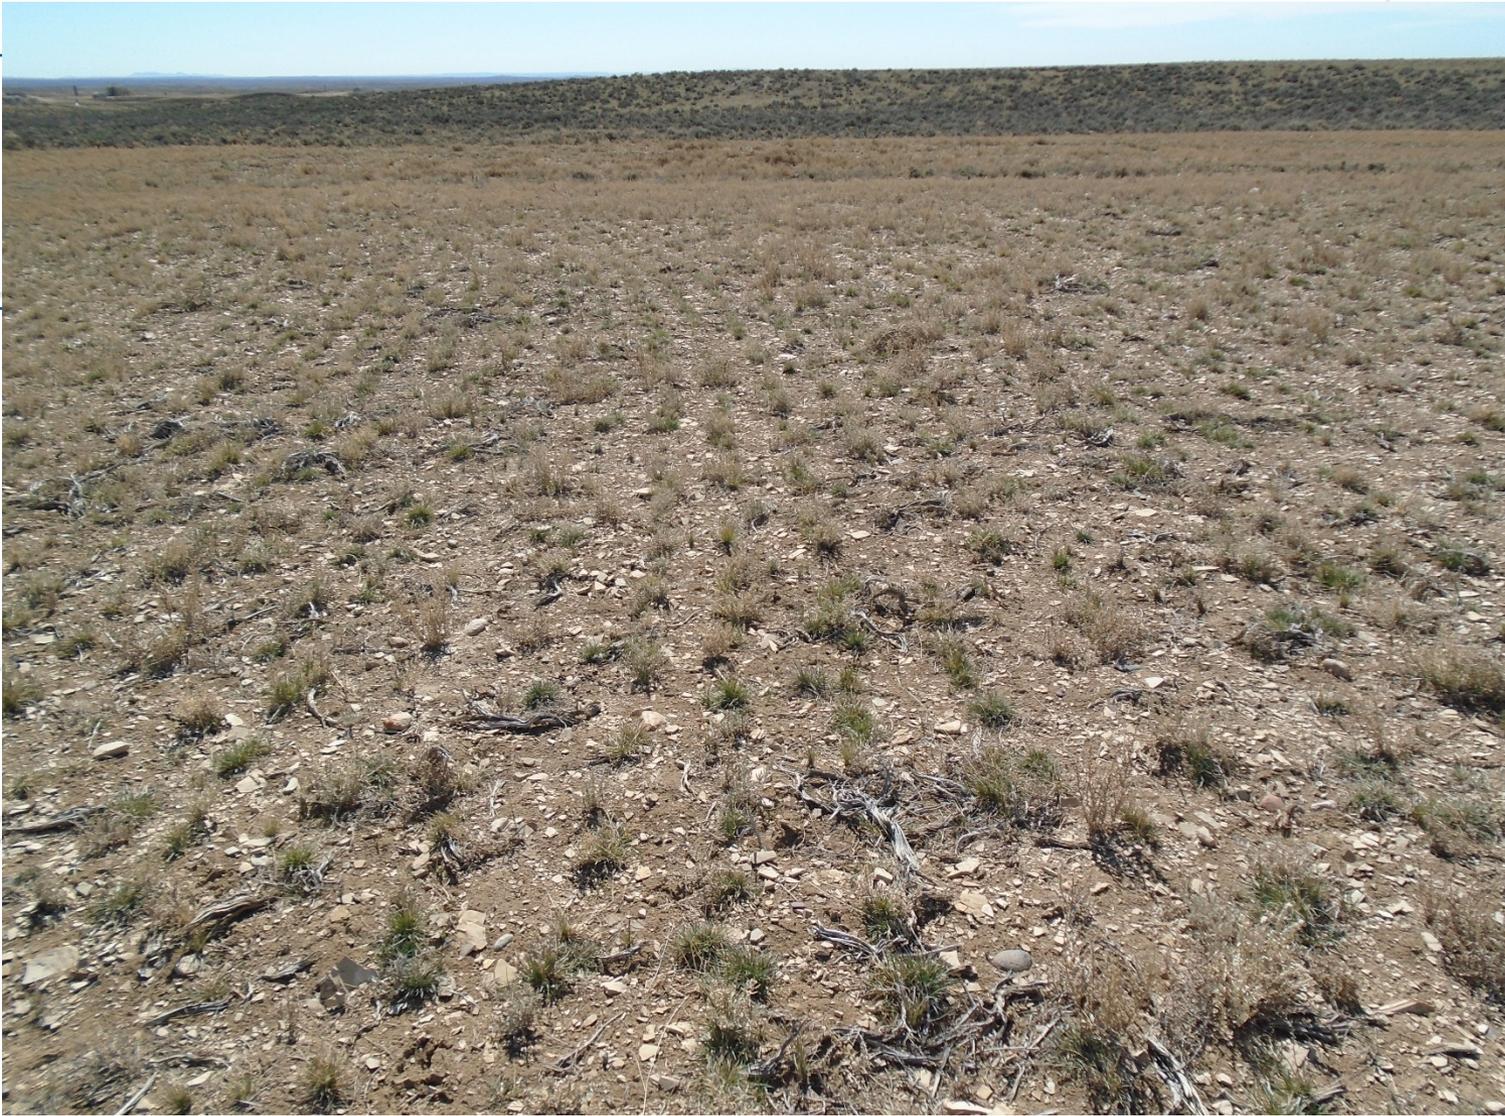
SHB 70-34 – planted fall 2012

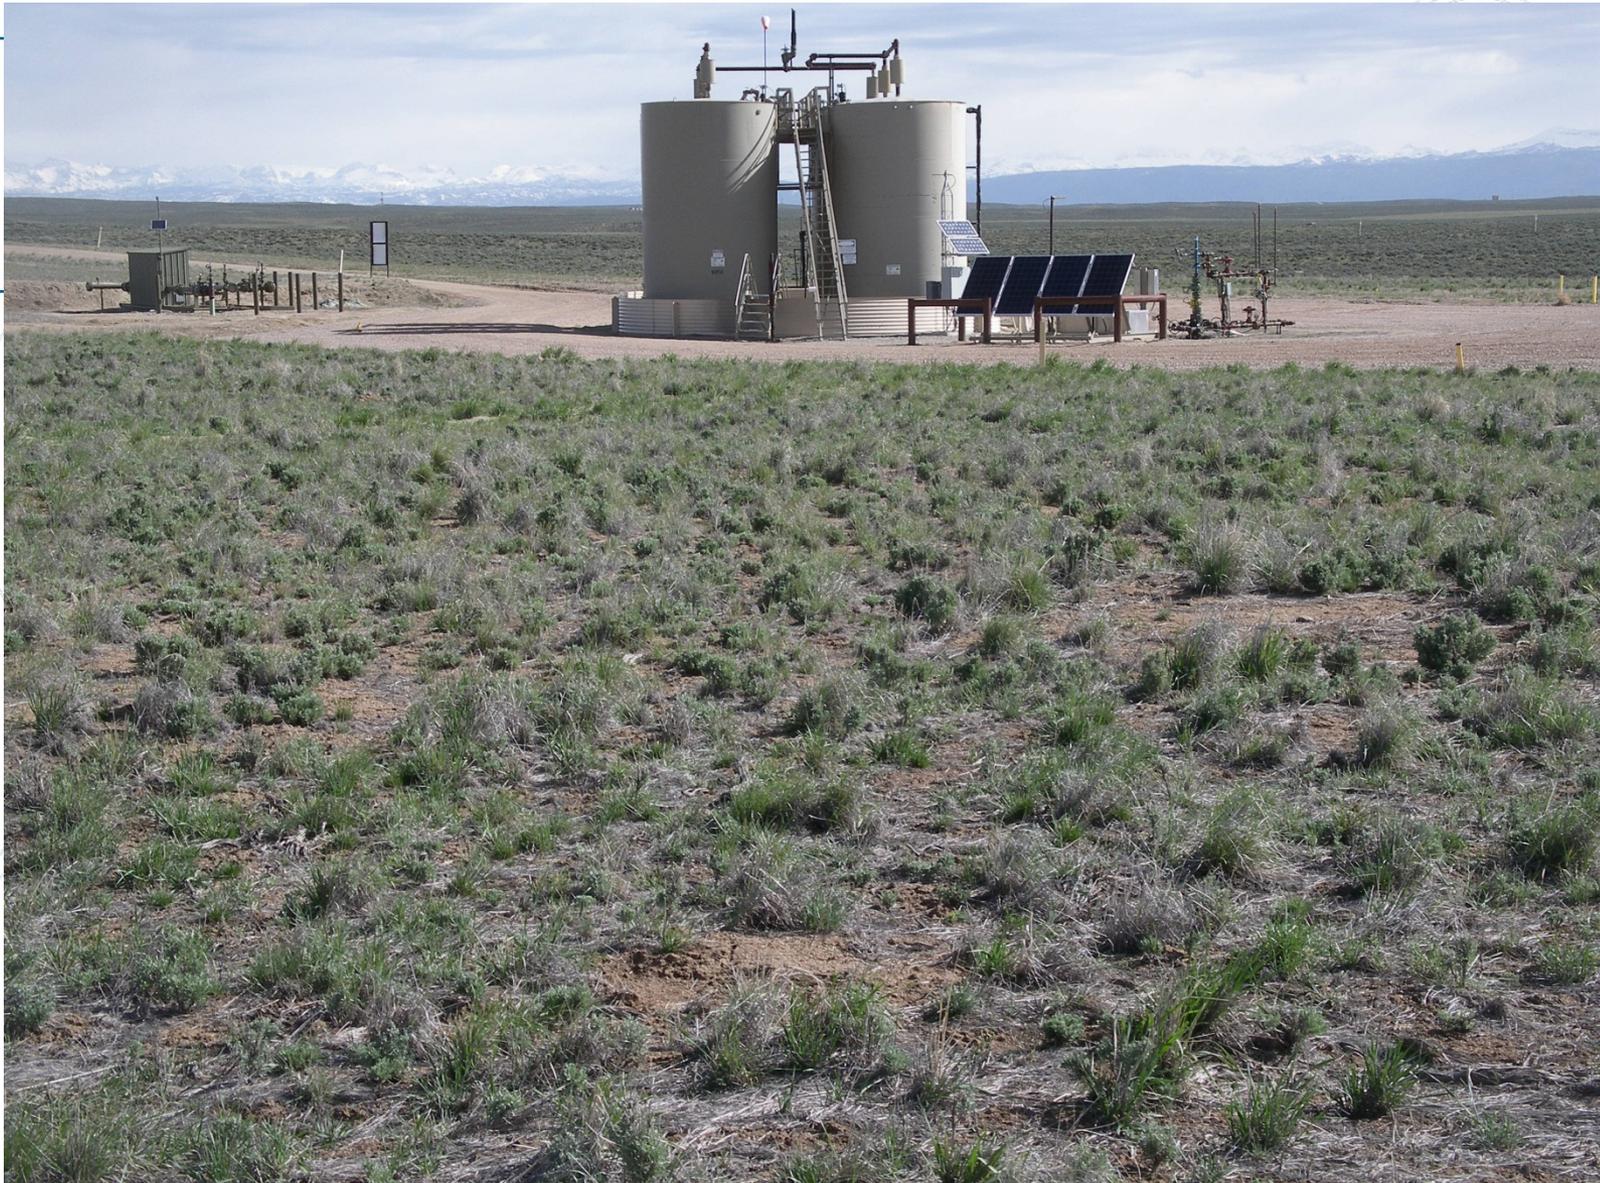
SHB 32-10 – granted rollover 2013

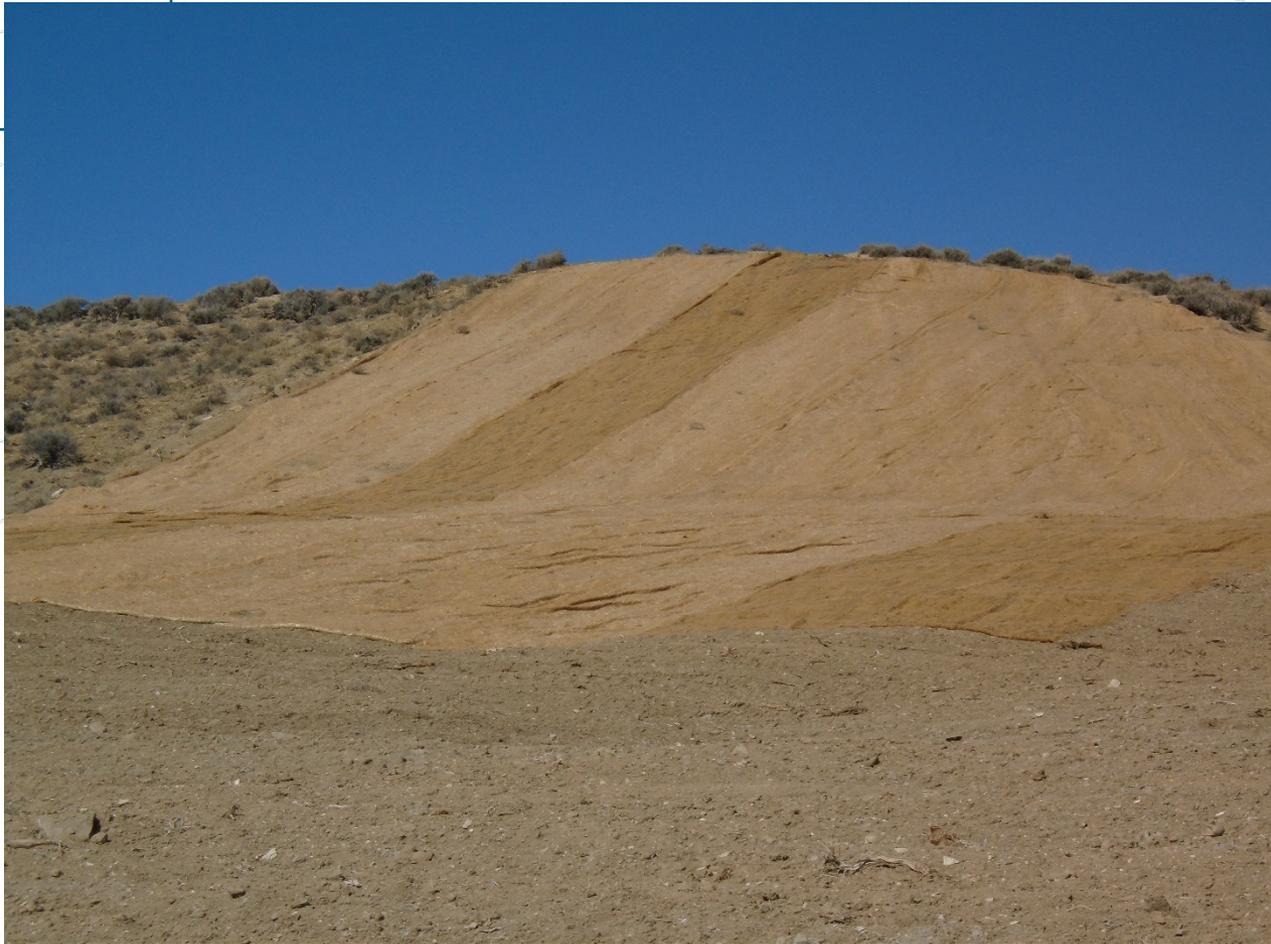
SHB 66-26 Reclaimed Fall 2014

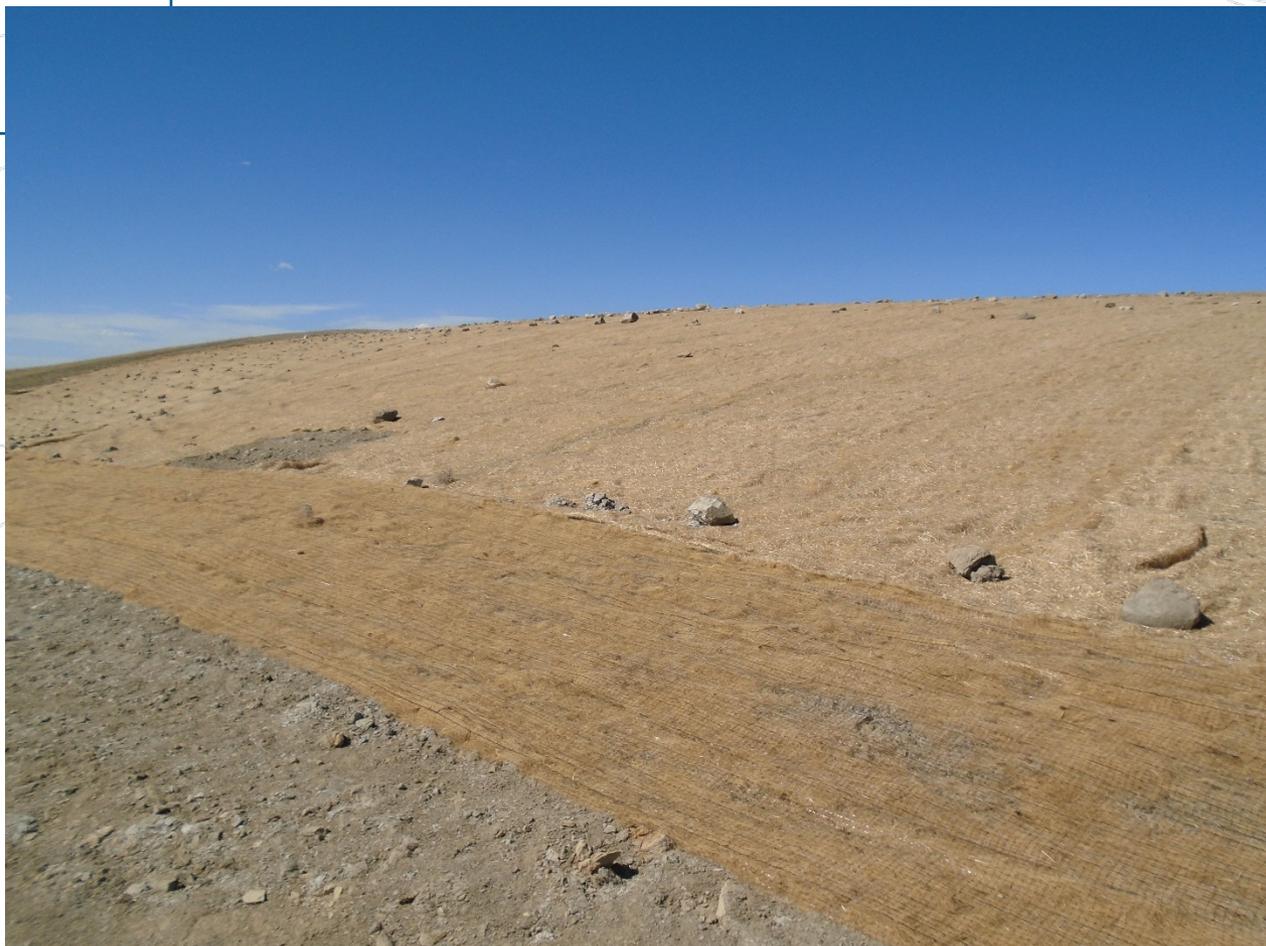
SHB 84-36X Reclaimed Fall 2014

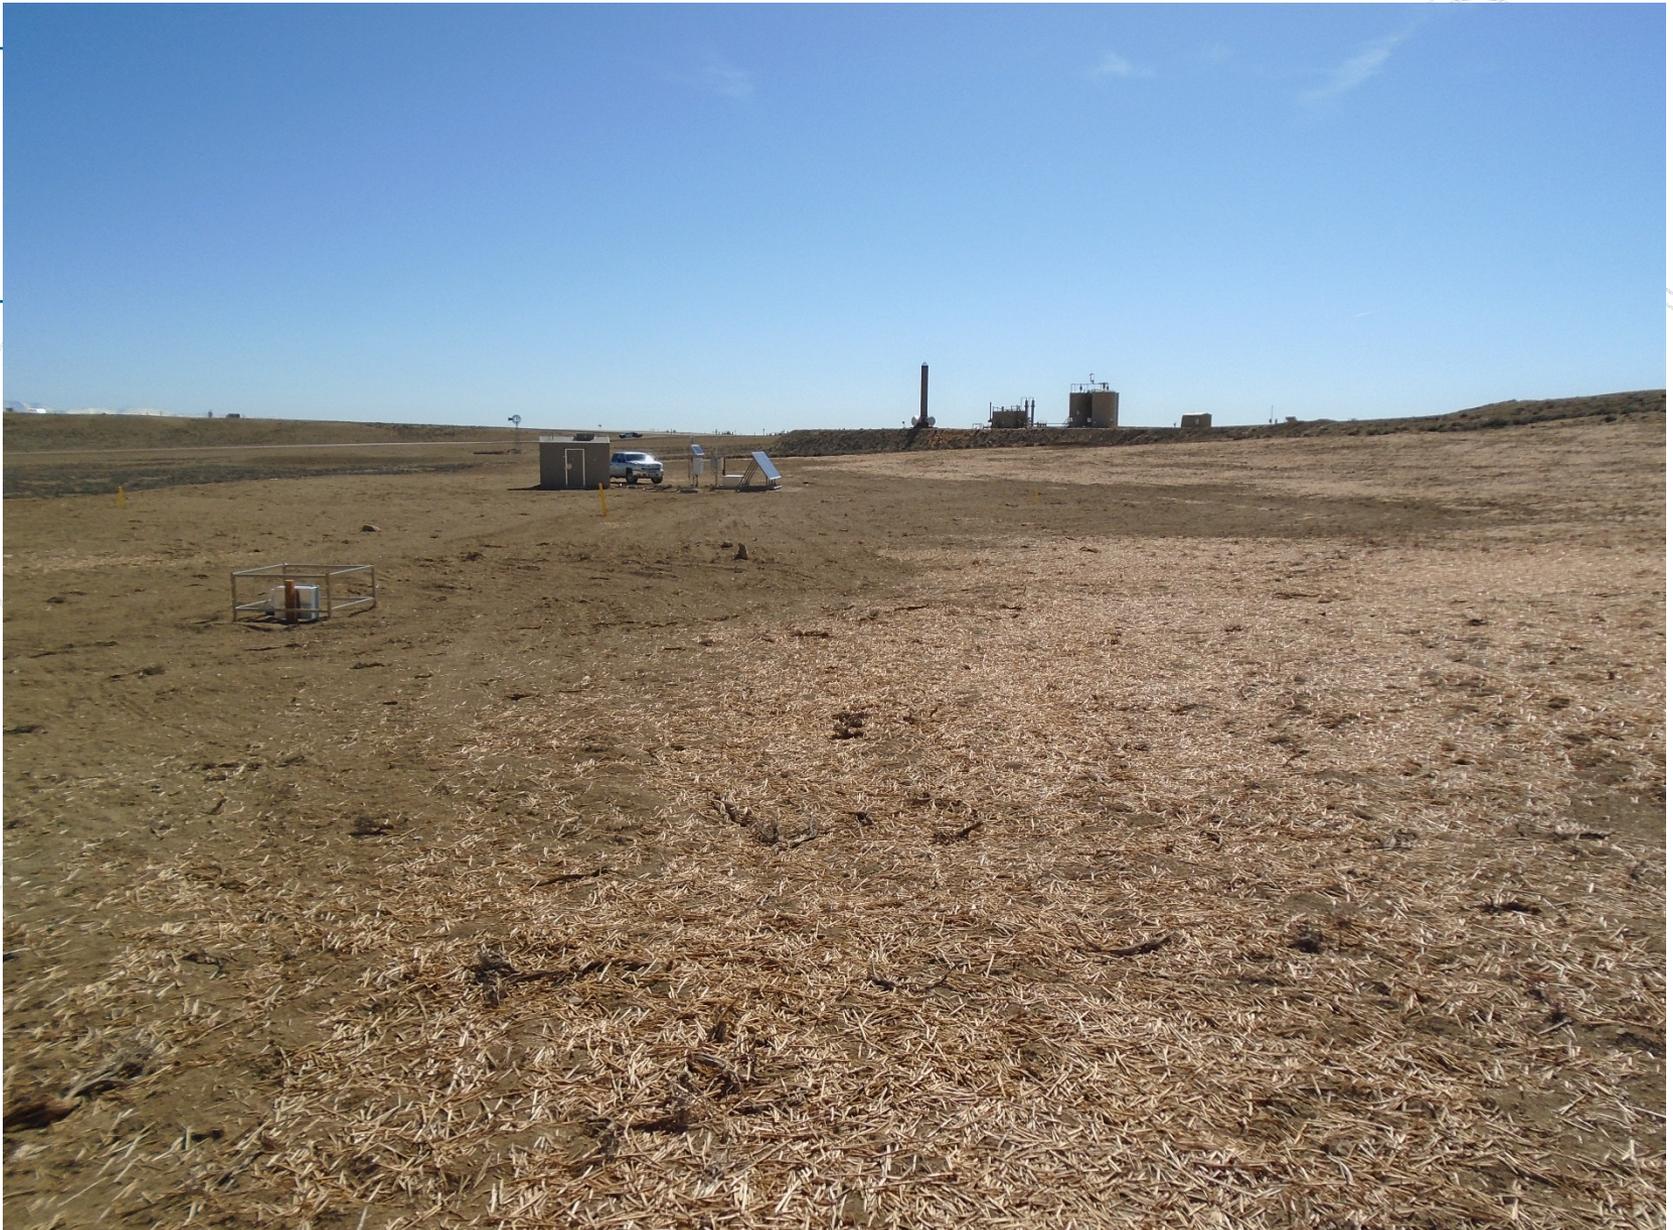
JF 22-5 Mulched and reclaimed Fall 2014

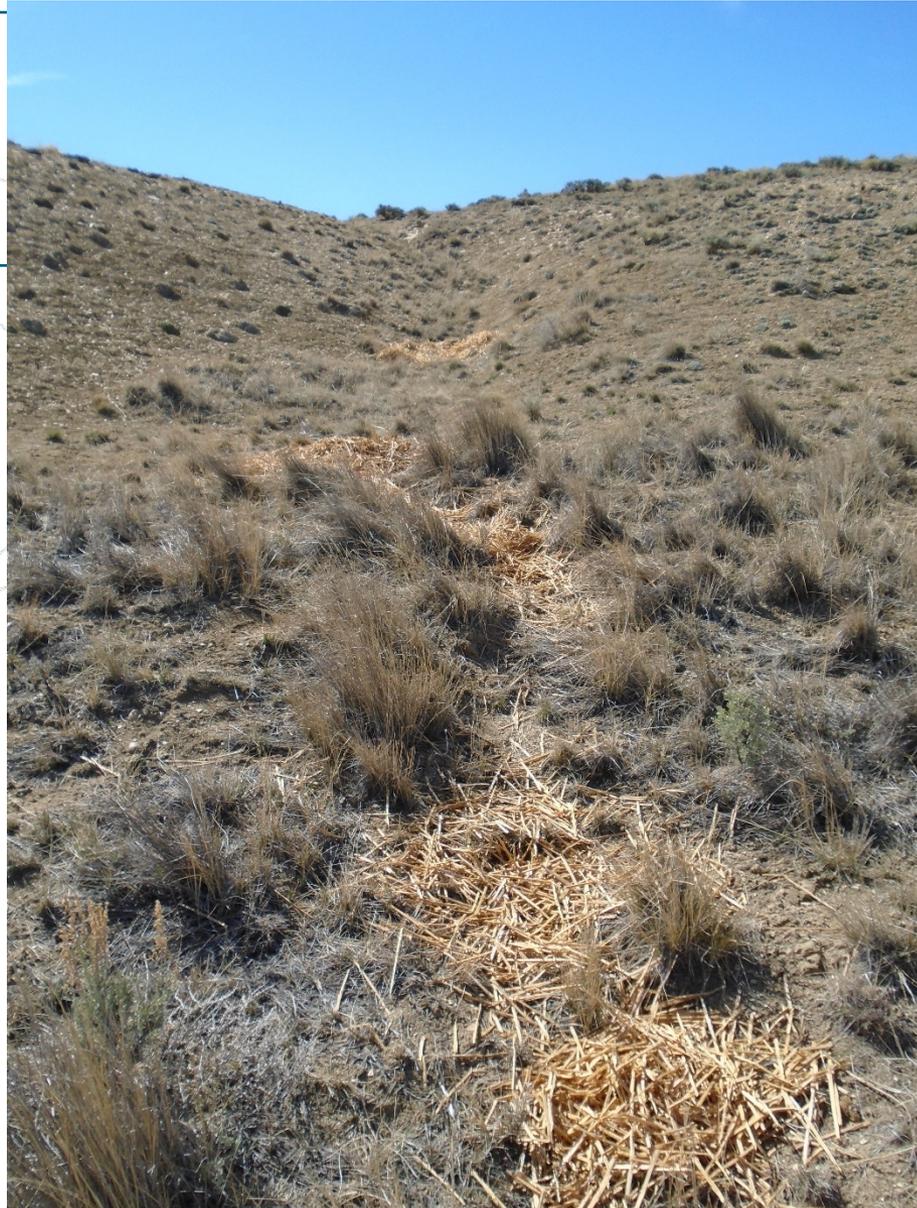
Stabilize Drainages

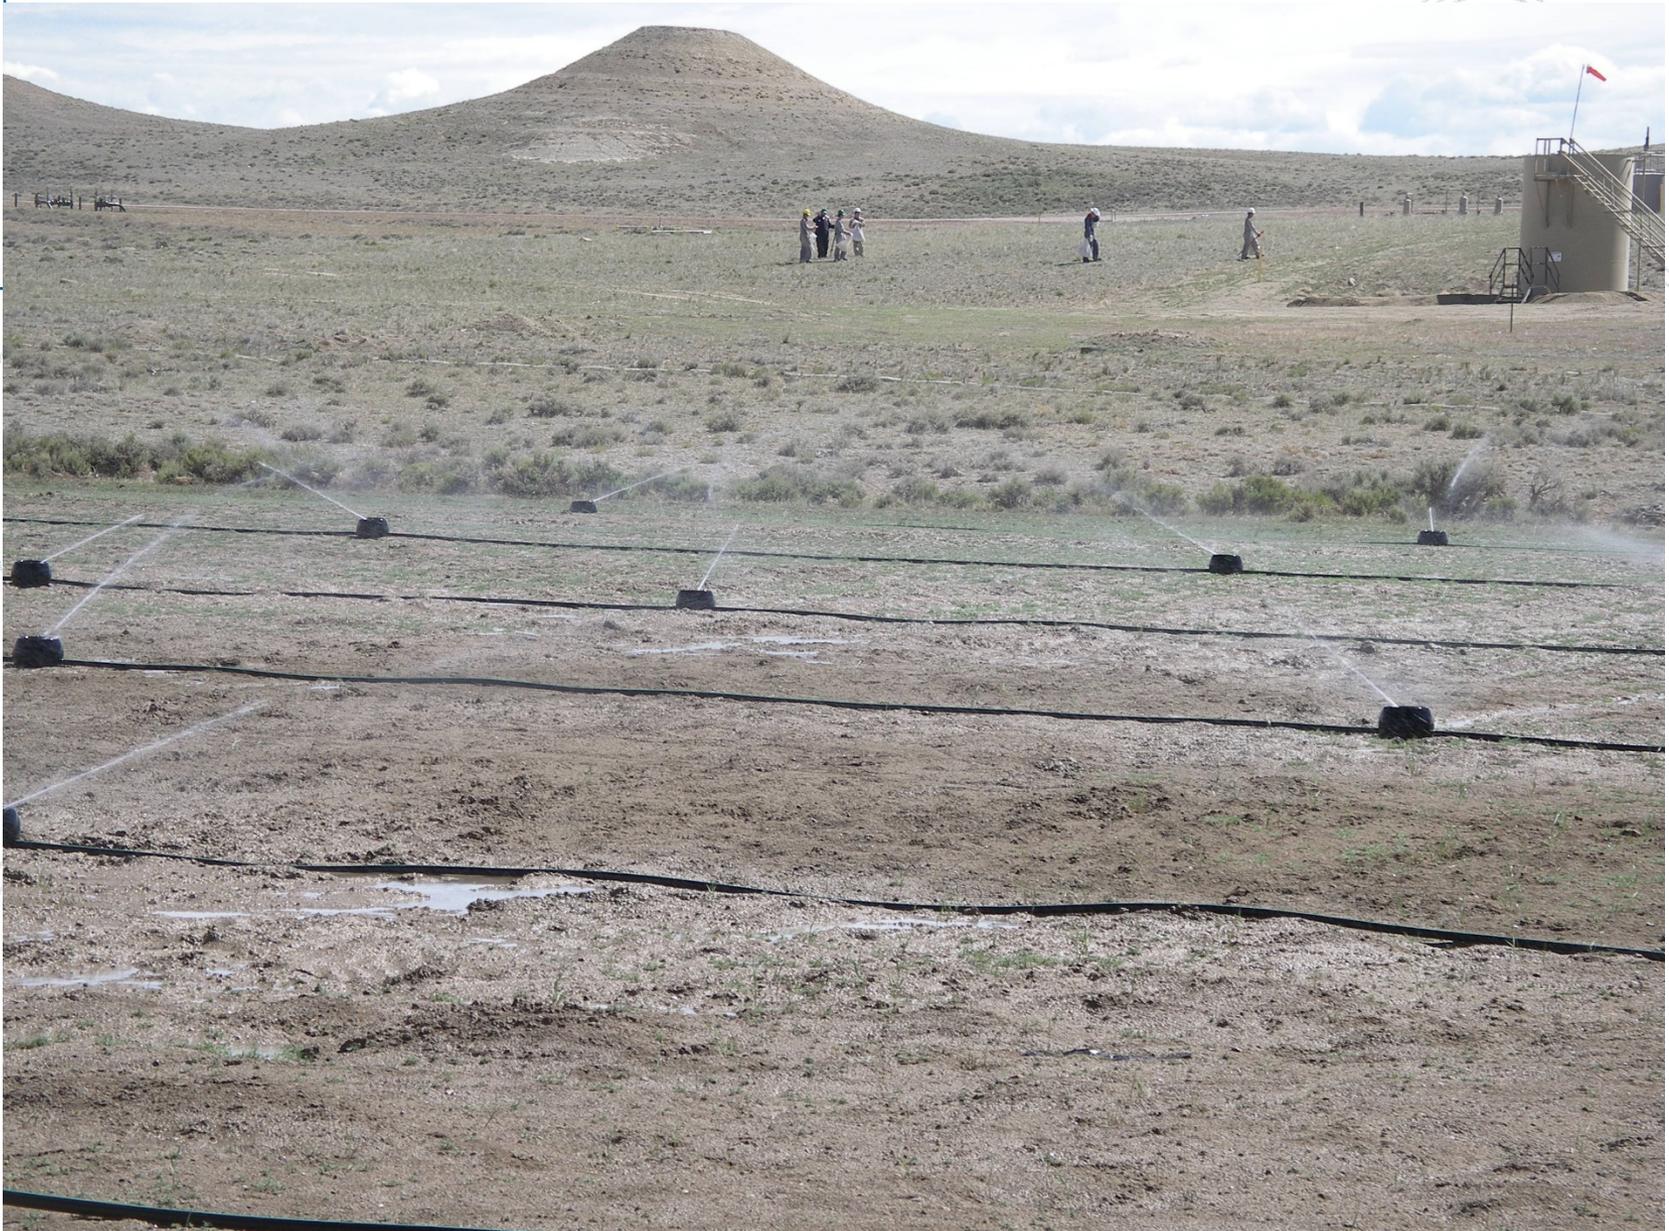
Irrigation

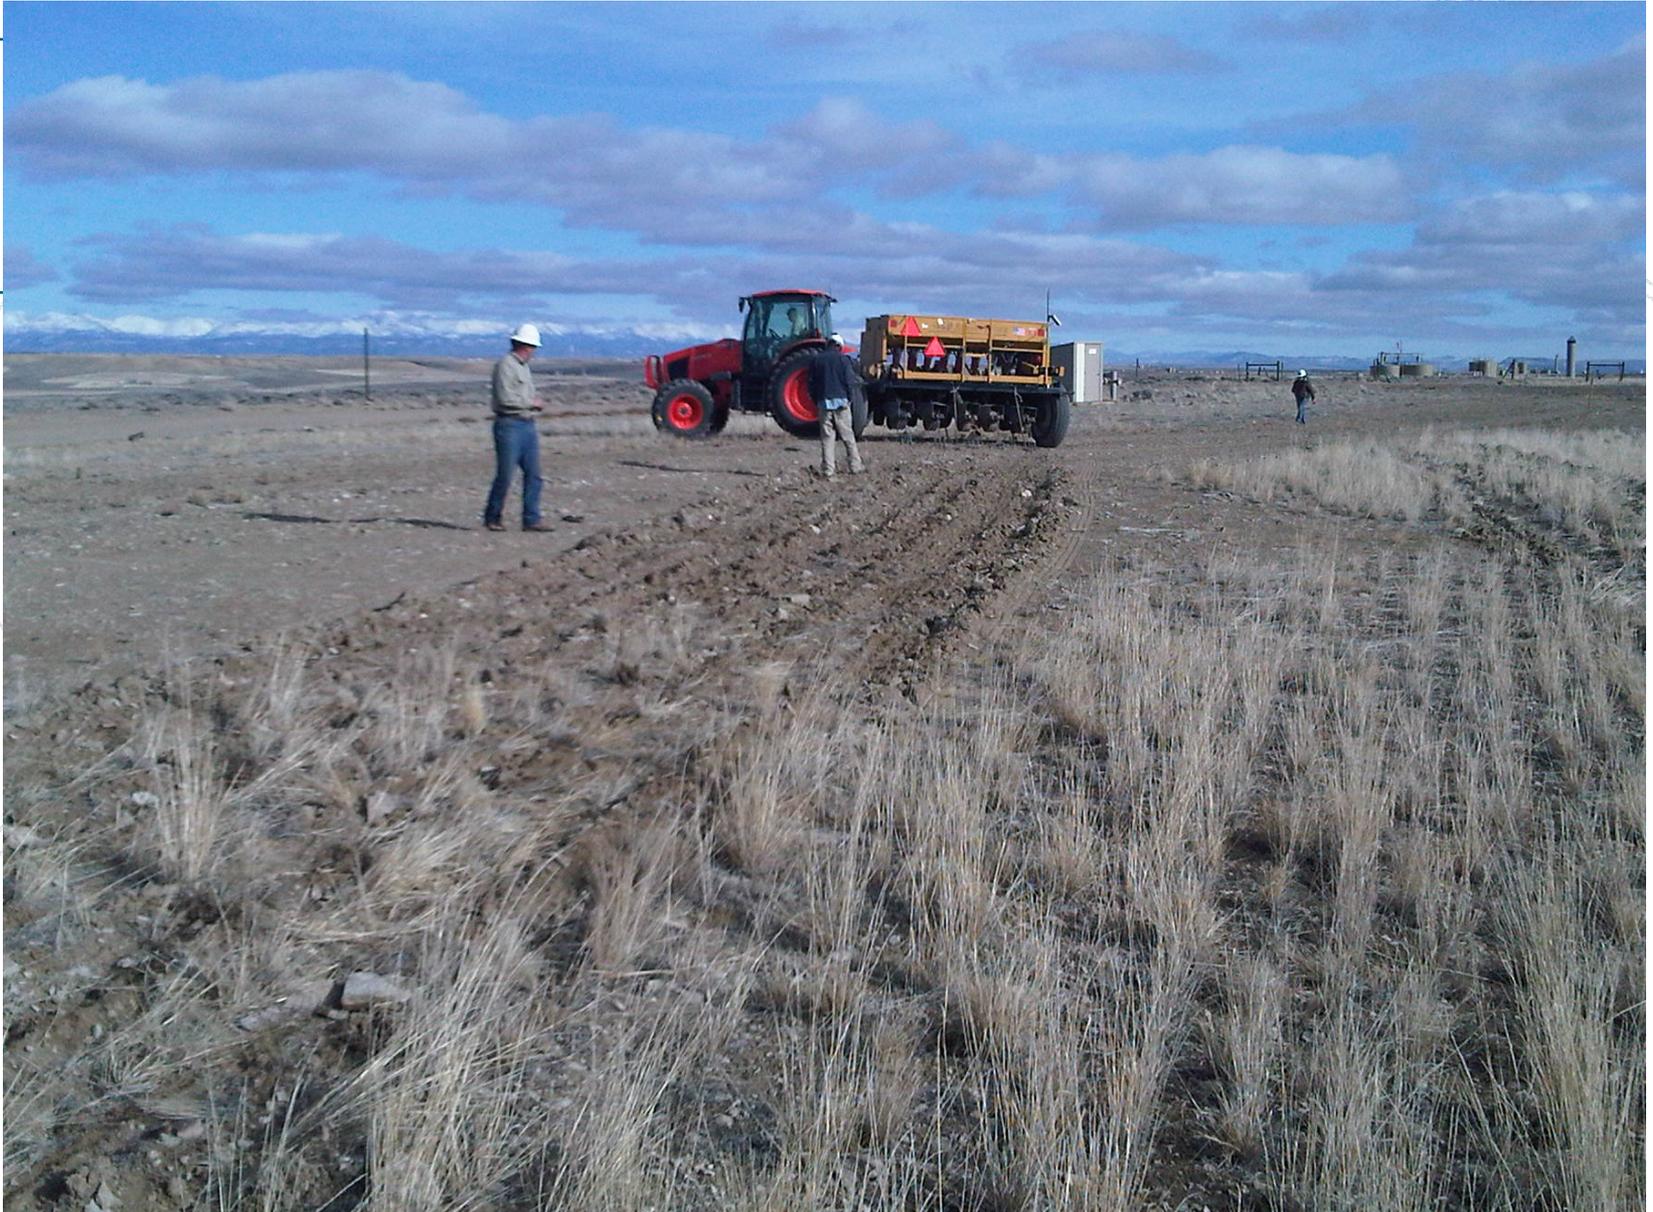
Interseeding
