A Bat Conservation Evaluation for White Grass Ranch, Grand Teton National Park, Wyoming

Prepared by
Doug Keinath
Wyoming Natural Diversity Database
University of Wyoming
Laramie, Wyoming

29 September 2005

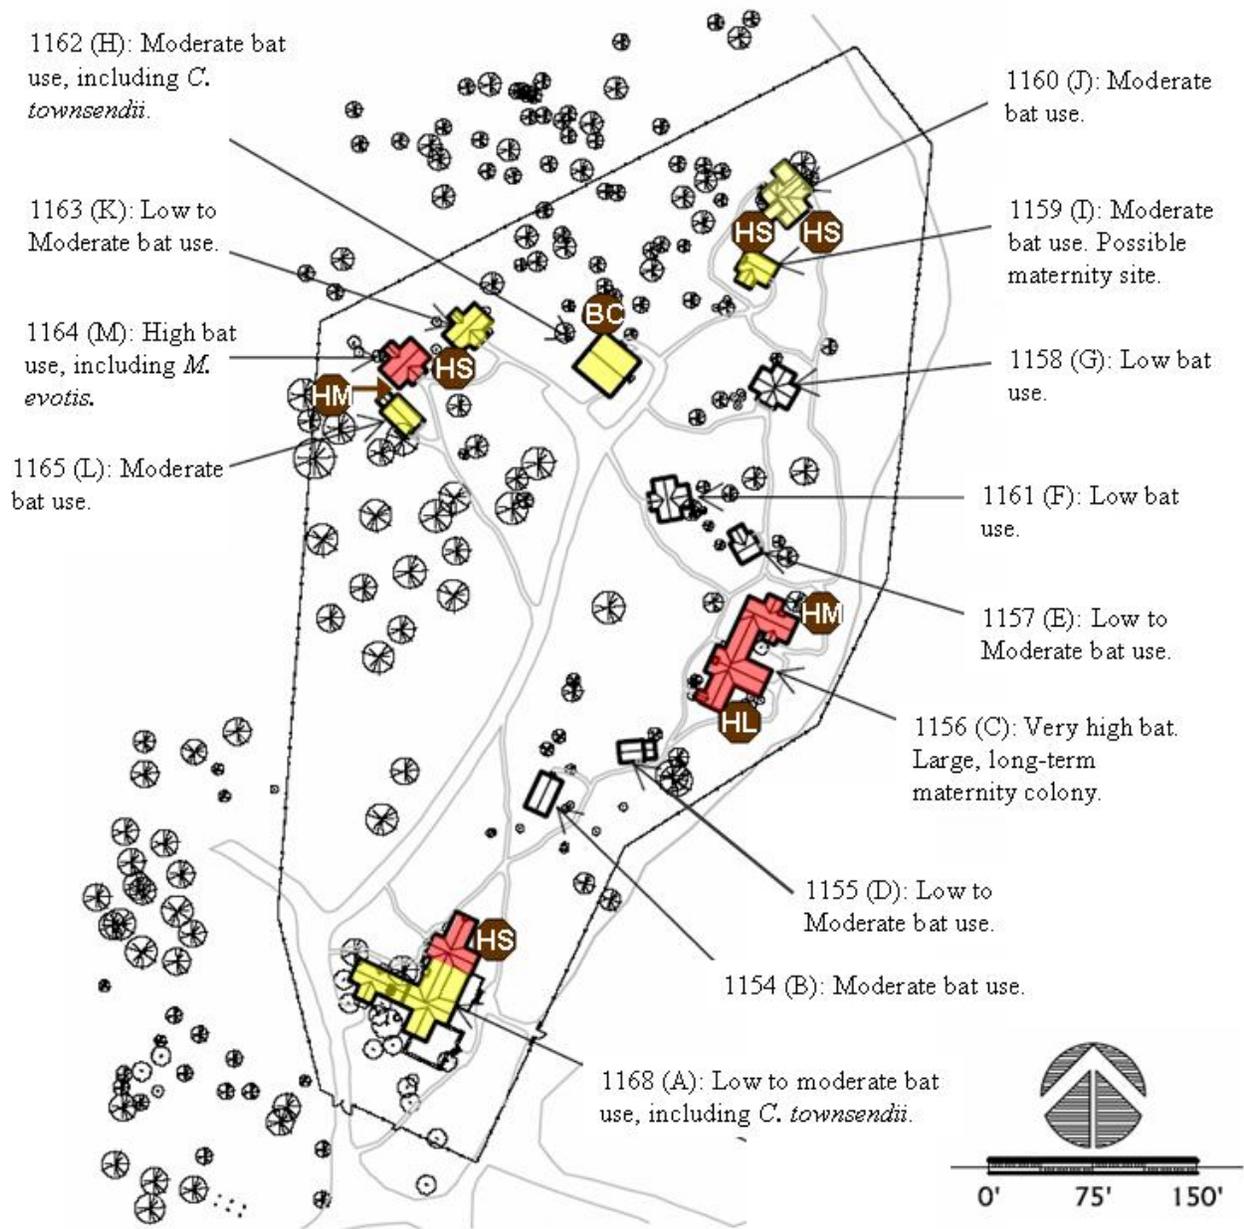
Figure 1: White Grass Ranch site diagram and summary bat findings, with suggested placement of bat mitigation structures.

- HL** Large bat house (15' linear roost space)
- HM** Medium bat house (10' linear roost space)
- HS** Smaller bat house (5' linear roost space)
- BC** "Bat Cave" designed to house Townsend's big-eared bats

NOTE: In particular, development of buildings 1156, 1162, and 1164 (see Figure 1) should be delayed as long as possible, and bat houses should be erected near them well before bats are excluded. Building 1162 will entail erecting a special Townsend’s big-eared bat roost at least one year before it is renovated.

Based on this study, it seems that adequate roosting area would be provided by erecting 7 bat houses (1 large, maternity house, 2 medium houses, and 4 smaller houses) and one structure for Townsend’s big eared bat. Suggested placement of these structures is noted coarsely in Figure 1 and more precisely in Appendix 1.

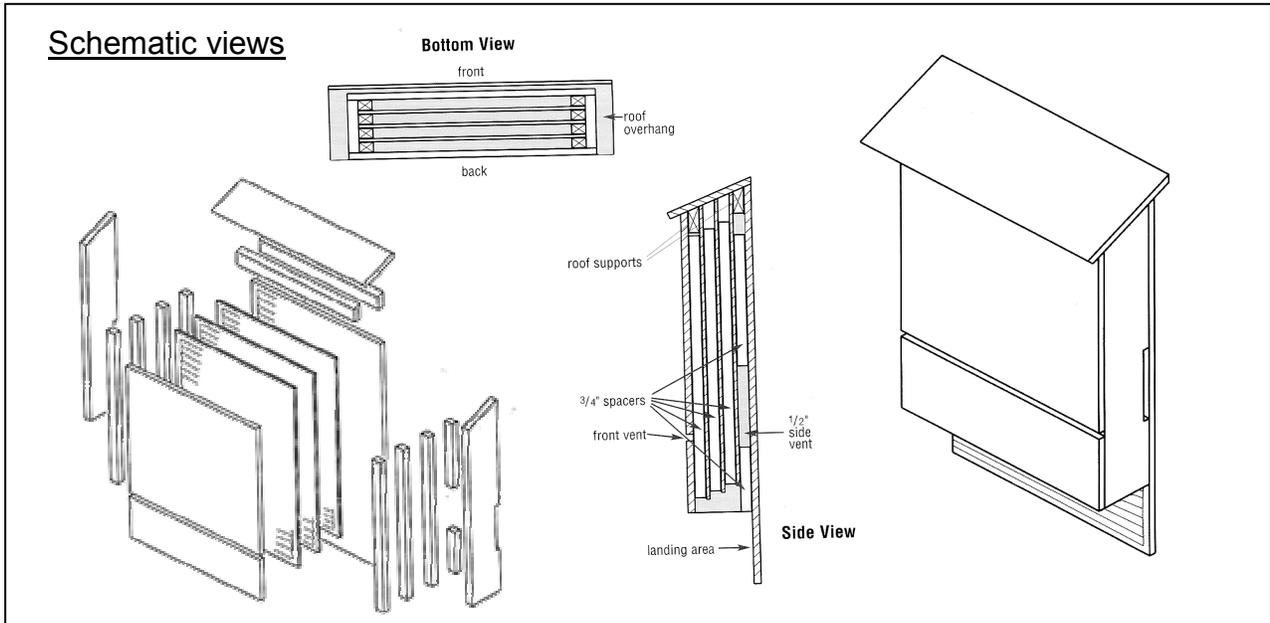
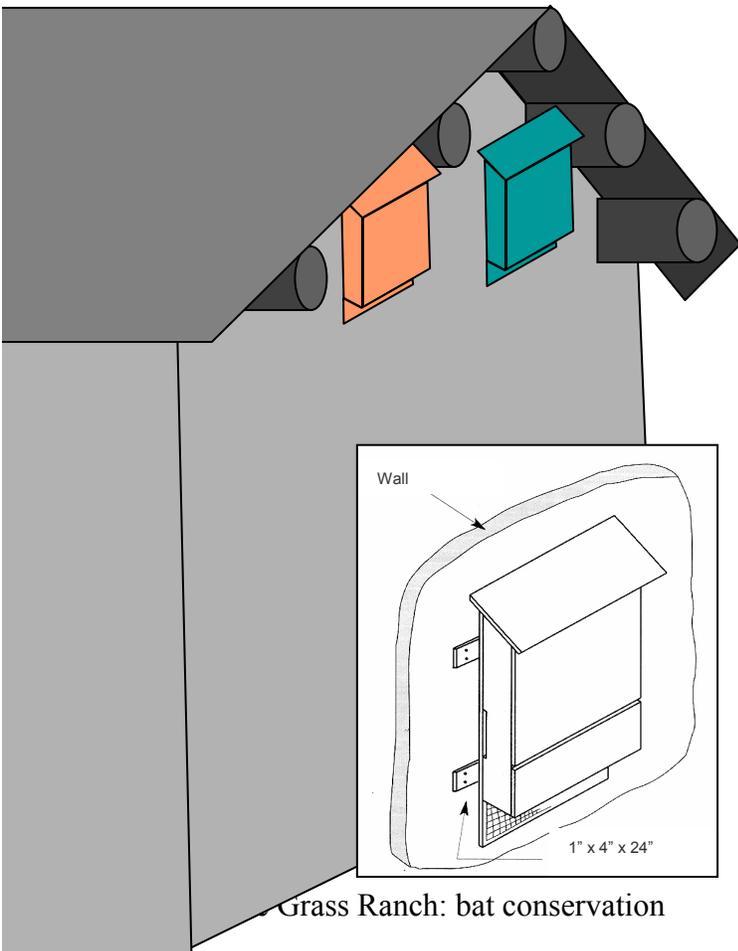
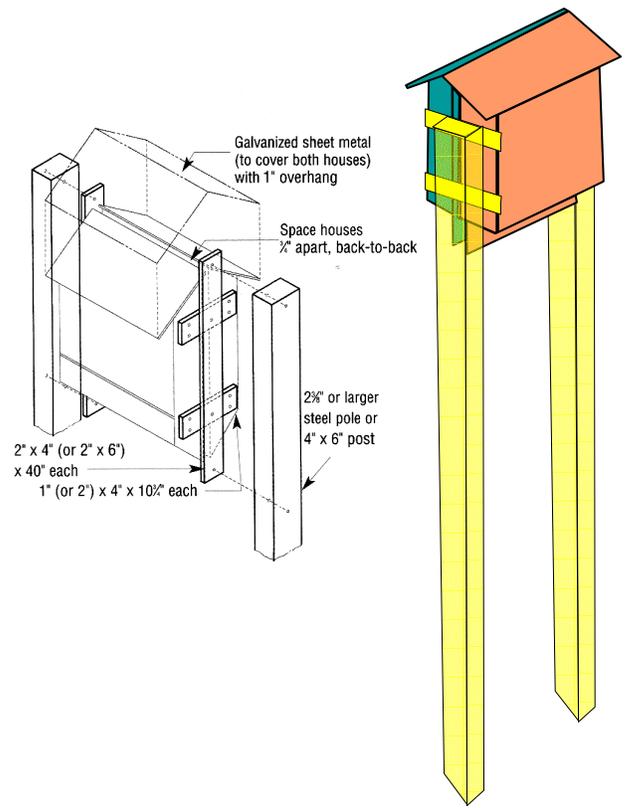
Figure 2: Schematic of four-chambered bat houses and suggestions for mounting. House drawings excerpted from Tuttle et al. (2004), which has complete instructions.

Mounting two units on a building

Mounting two units on poles

and priced house that contains roughly 5 feet of linear roost space. The large house at White Grass Ranch should consist of two units similar in design to the four-chambered nursery (e.g. Figure 2), each of which is about 50% wider than the house presented by Tuttle et al. (2004) to afford more roosting space. The two can either be mounted against the wall of building 1156, or back-to-back on poles immediately next to the building. Those mounted on poles can later be moved a short distance from their original position (see below). When mounted back-to-back, a slot should be cut in the back of each house allowing bats to move between the two. If this design is followed, this house will provide about 15 linear feet of roost space.

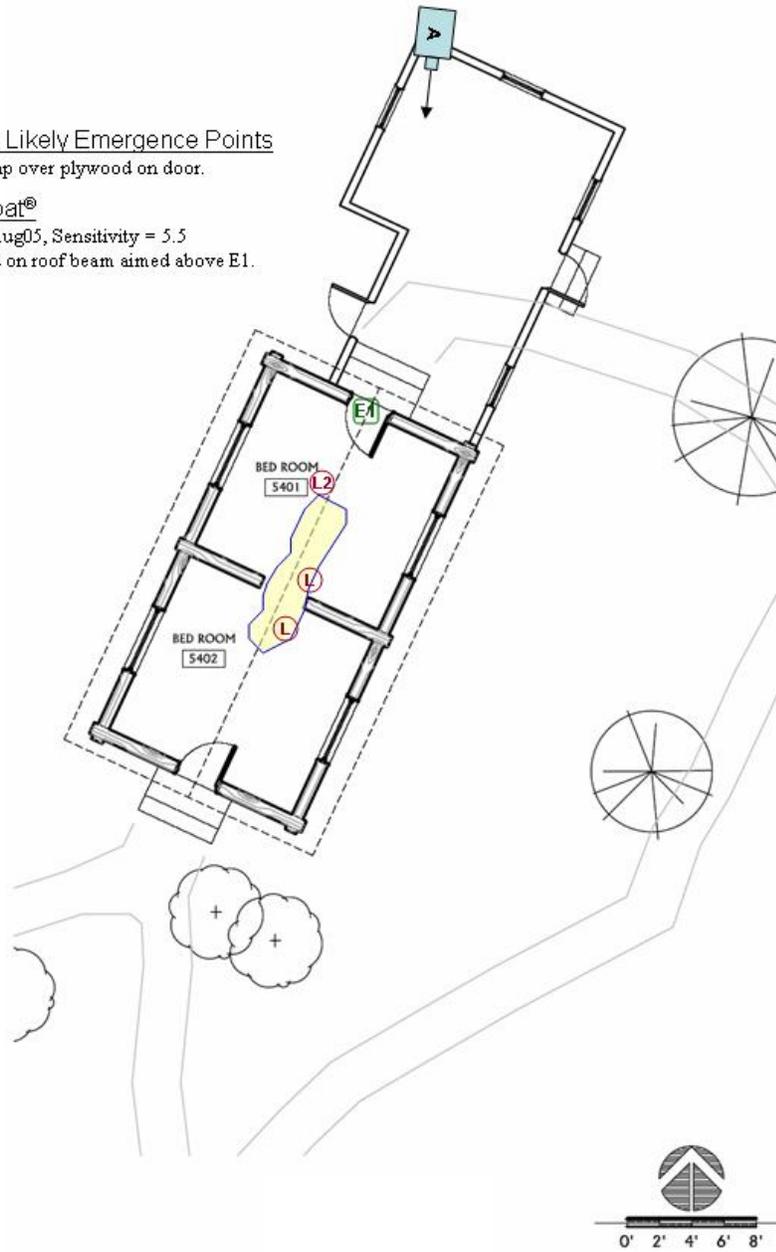
Building 1154 (WG-B in 2004 survey)

E1: Gap over plywood on door.

Set 8Aug05, Sensitivity = 5.5

Placed on roof beam aimed above E1.

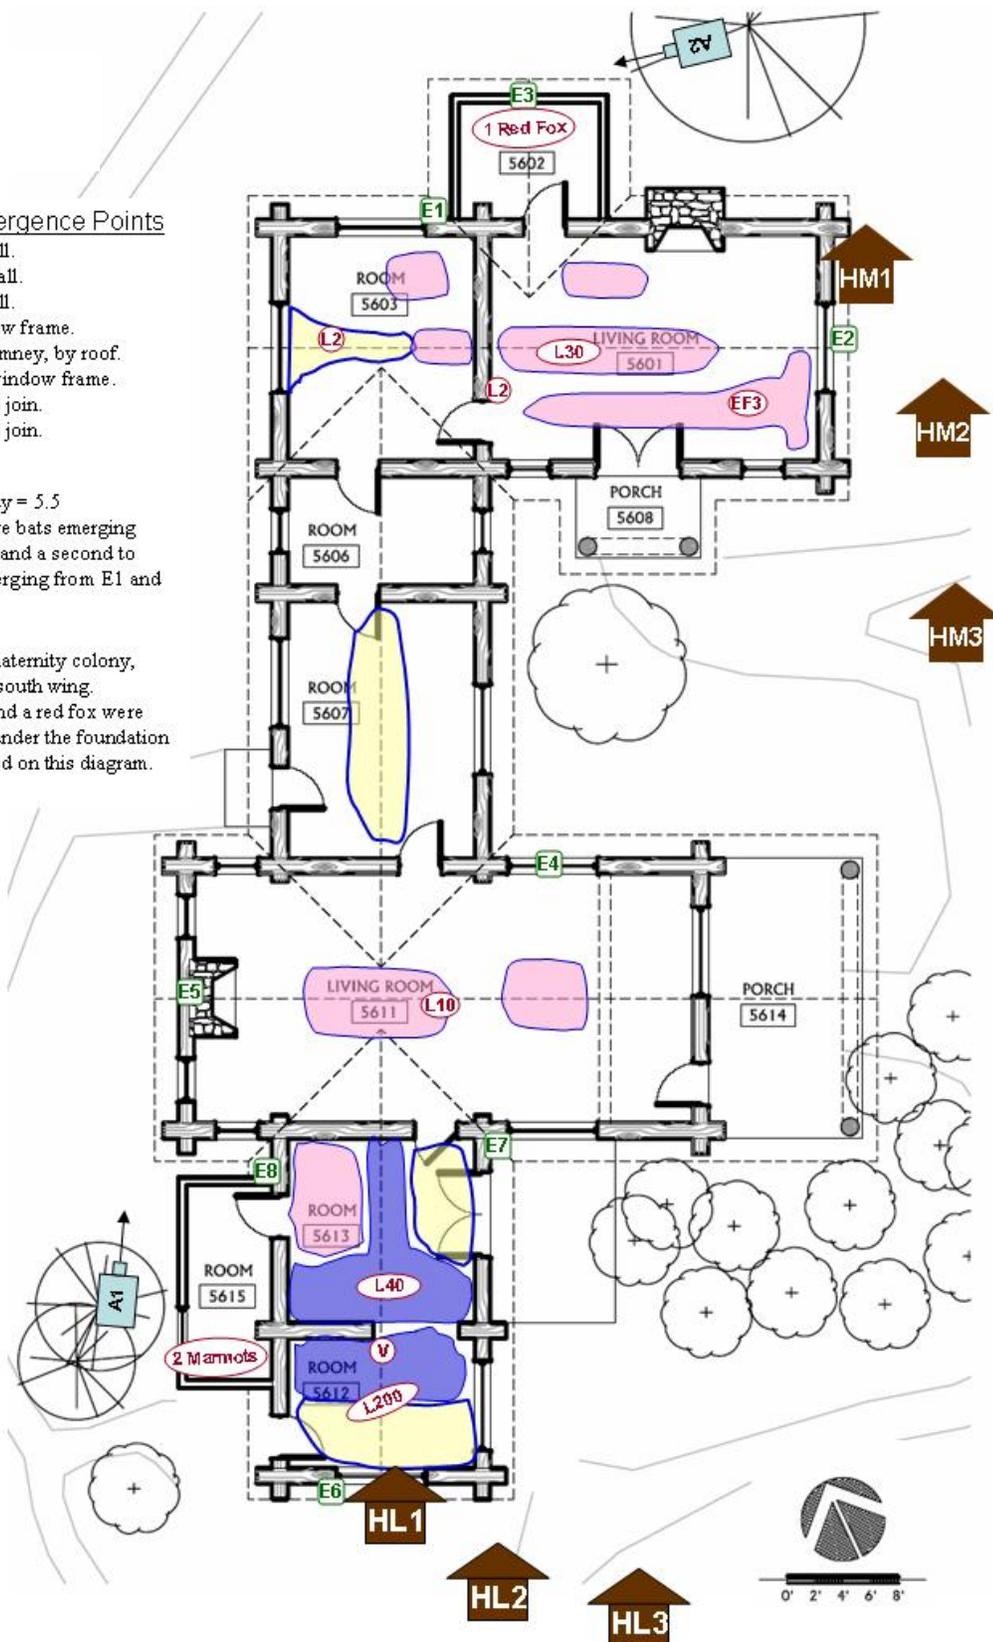
Building 1156 (WG-C in 2004 survey)

- E1: Gap at top of wall.
- E2: Gaps at top of wall.
- E3: Gap at top of wall.
- E4: Collapsed window frame.
- E5: Gaps around chimney, by roof.
- E6: Gap outside of window frame.
- E7: Gap where walls join.
- E8: Gap where walls join.

Set 7Jul05, Sensitivity = 5.5

Placed One to capture bats emerging from E5 and E8 and a second to capture bats emerging from E1 and E3.

- This is a large maternity colony, particularly the south wing.
- Two marmots and a red fox were found denning under the foundation in the areas noted on this diagram.

Building 1156 is a large, well established maternity colony, the southern wing of which seems to be an optimal nursery (see Appendix 1). If possible, the local bat community would benefit by leaving this building undisturbed except for minimal renovations conducted in the late fall and winter for the purpose of stabilizing the structure. Even leaving just the southern wing (Rooms 5612, 5613, and 5615) undisturbed would be beneficial, because they contain the largest concentration of bats. If it is not possible to leave this building or a portion thereof un-renovated, exclusion should at least be planned as noted in the preceding paragraphs.

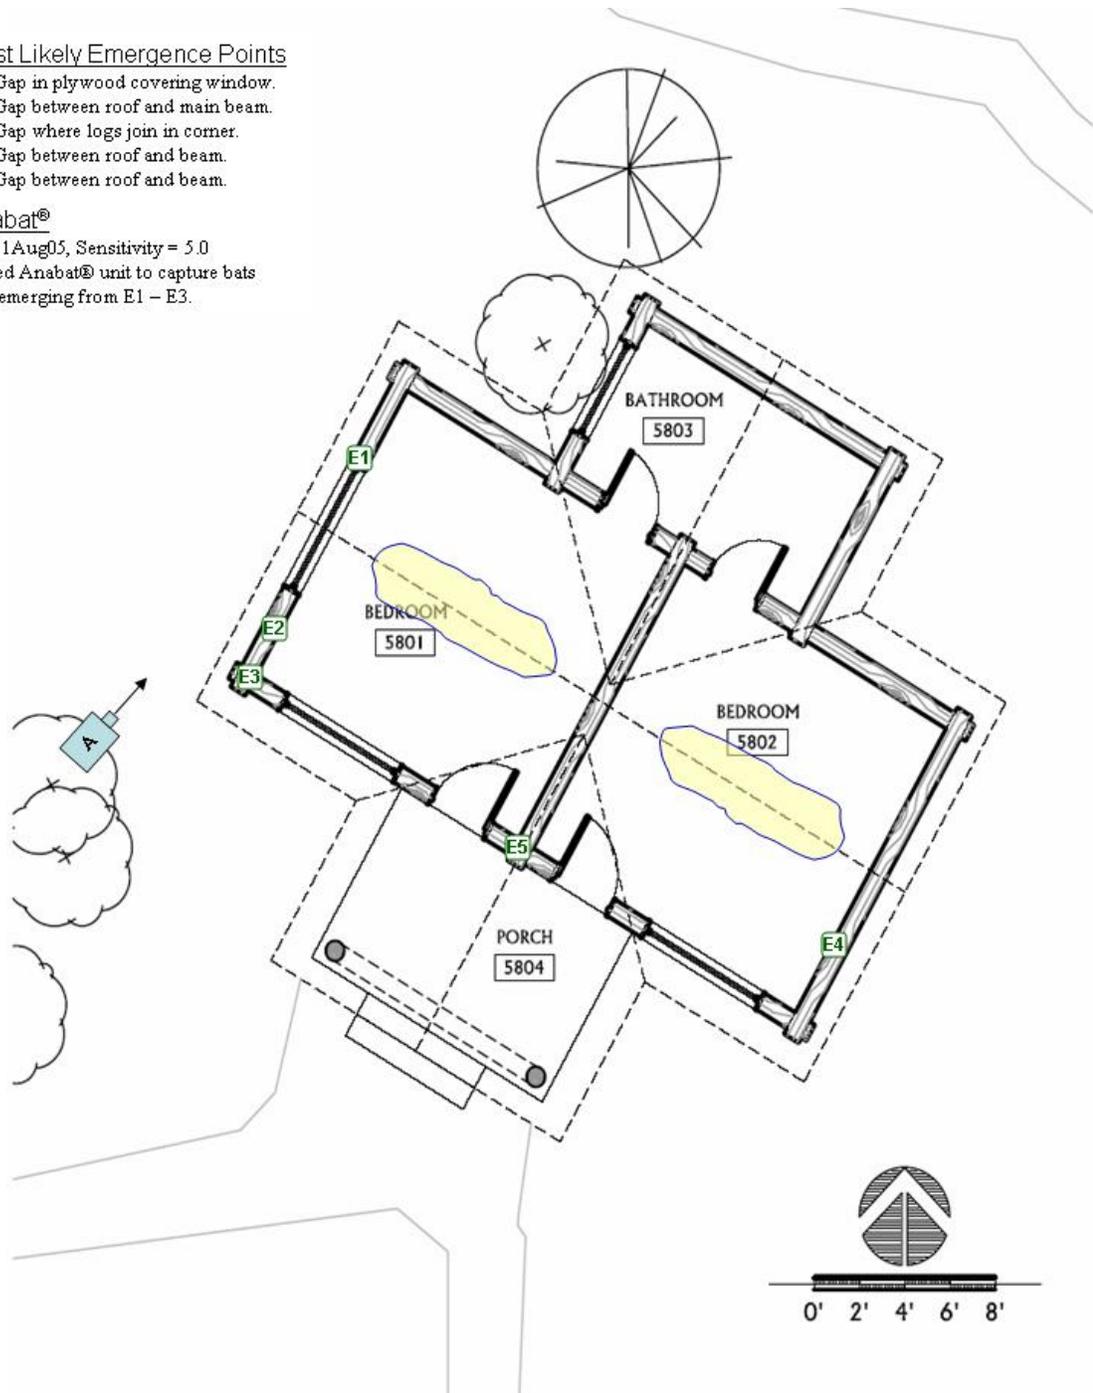
Building 1158 (WG-G in 2004 survey)

- E1: Gap in plywood covering window.
- E2: Gap between roof and main beam.
- E3: Gap where logs join in corner.
- E4: Gap between roof and beam.
- E5: Gap between roof and beam.

Set 11Aug05, Sensitivity = 5.0
Placed Anabat® unit to capture bats
emerging from E1 – E3.

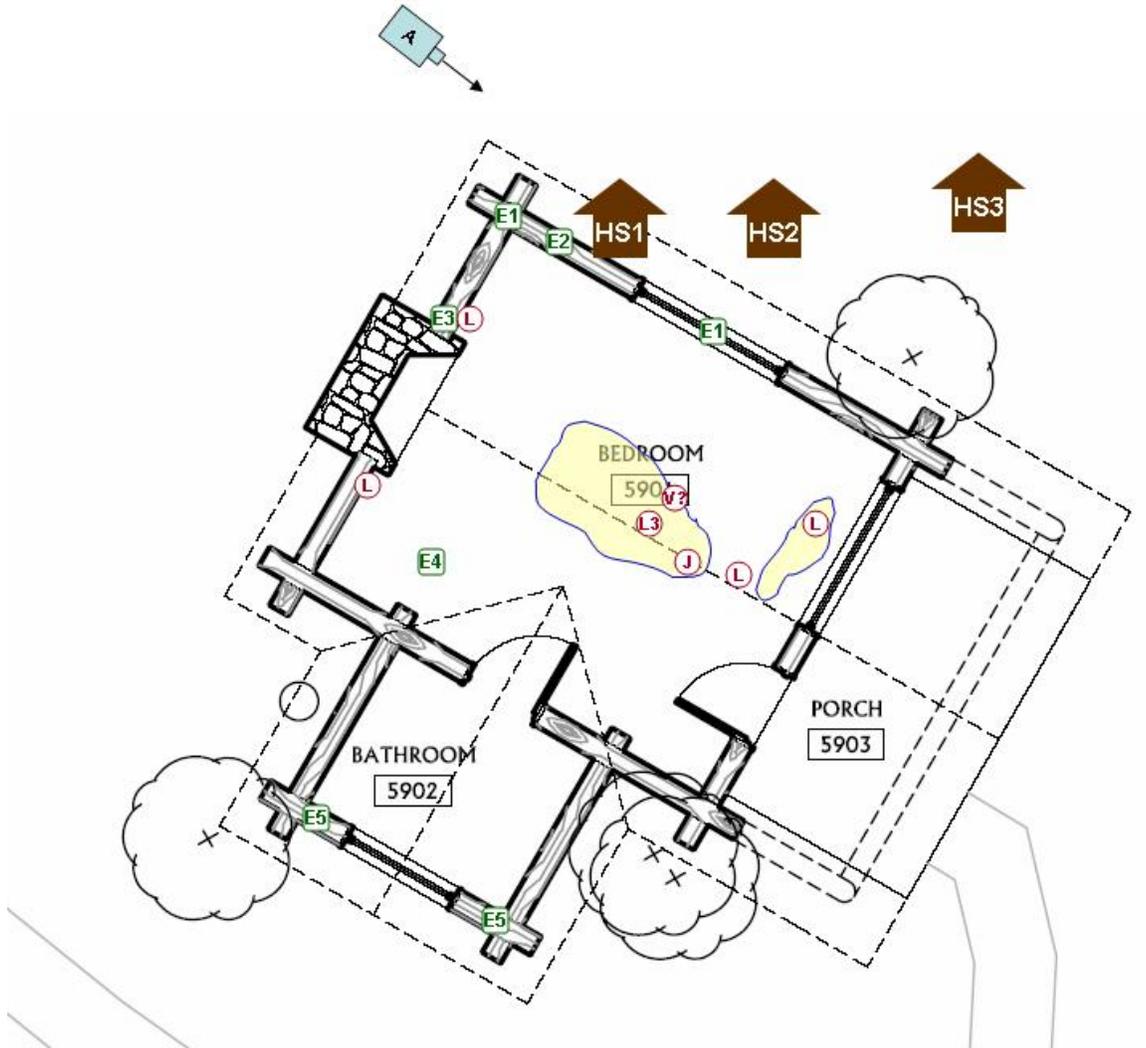
Building 1159 (WG-I in 2004 survey)

- E1: Large gaps where roof meets wall.
- E2: Gap between logs of wall.
- E3: Gaps along side of fireplace.
- E4: Stovepipe hole (covered in cobwebs).
- E5: Gaps where roof meets wall.

Set 9 Aug 05, Sensitivity = 5.0
 Placed Anabat® unit to capture bats
 emerging from E1 and E2.

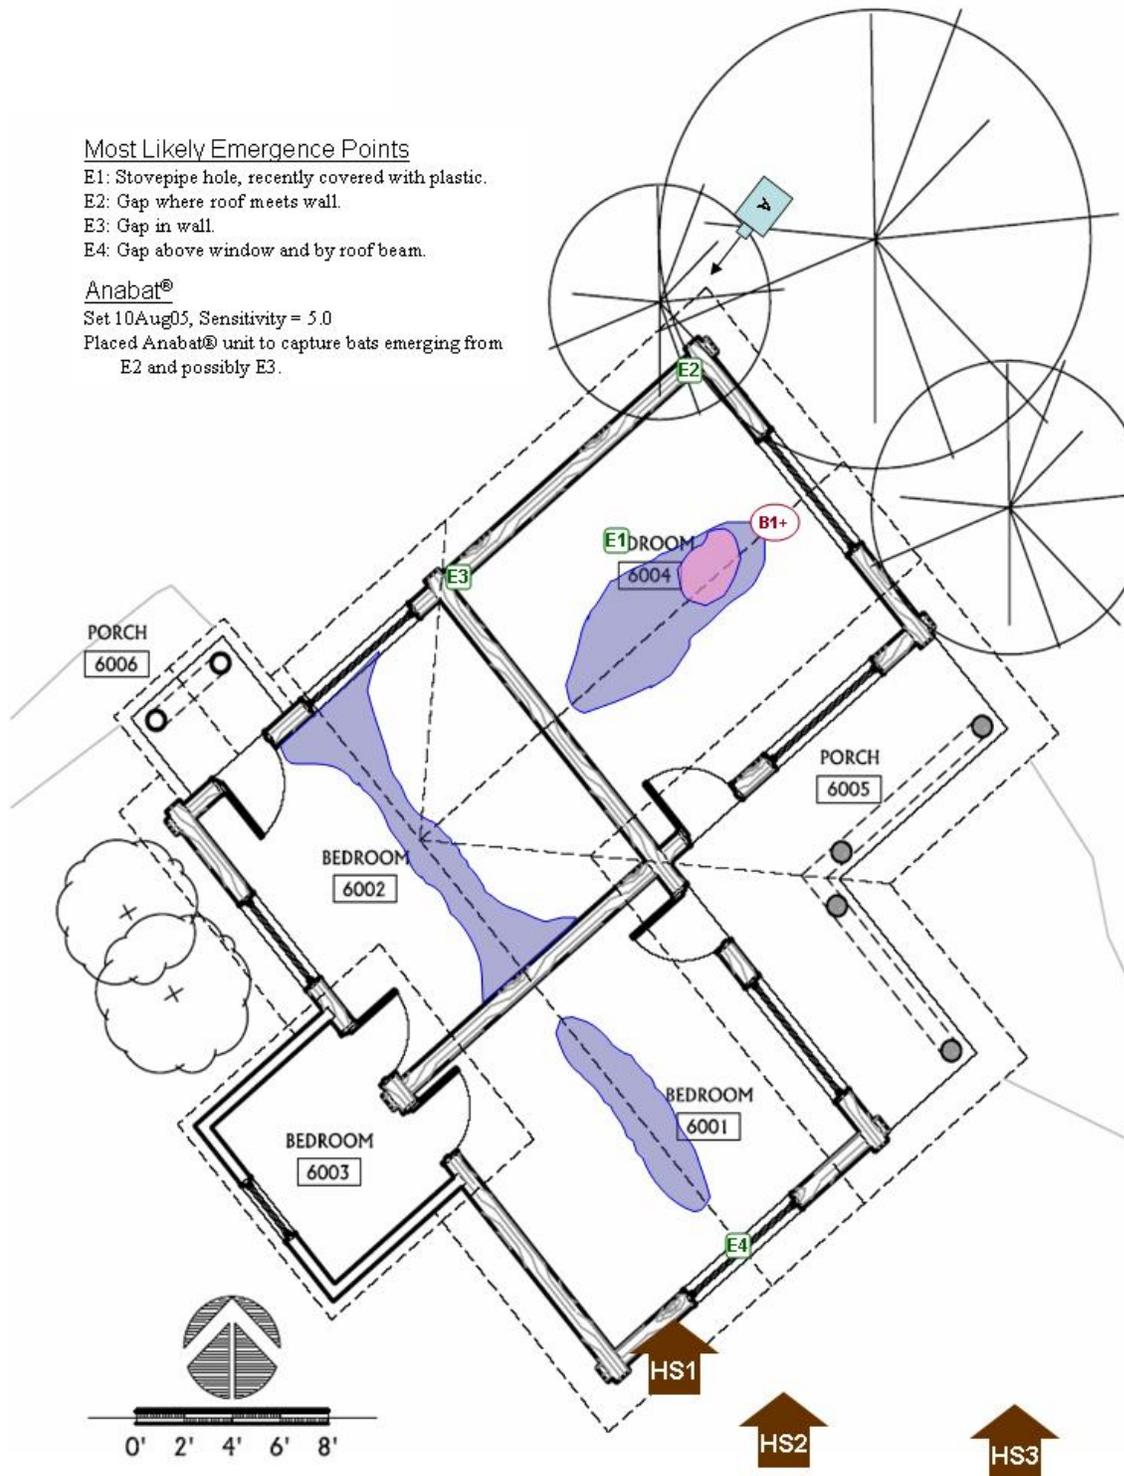
Building 1160 (WG-J in 2004 survey)

- E1: Stovepipe hole, recently covered with plastic.
- E2: Gap where roof meets wall.
- E3: Gap in wall.
- E4: Gap above window and by roof beam.

Set 10 Aug 05, Sensitivity = 5.0
Placed Anabat® unit to capture bats emerging from
E2 and possibly E3.

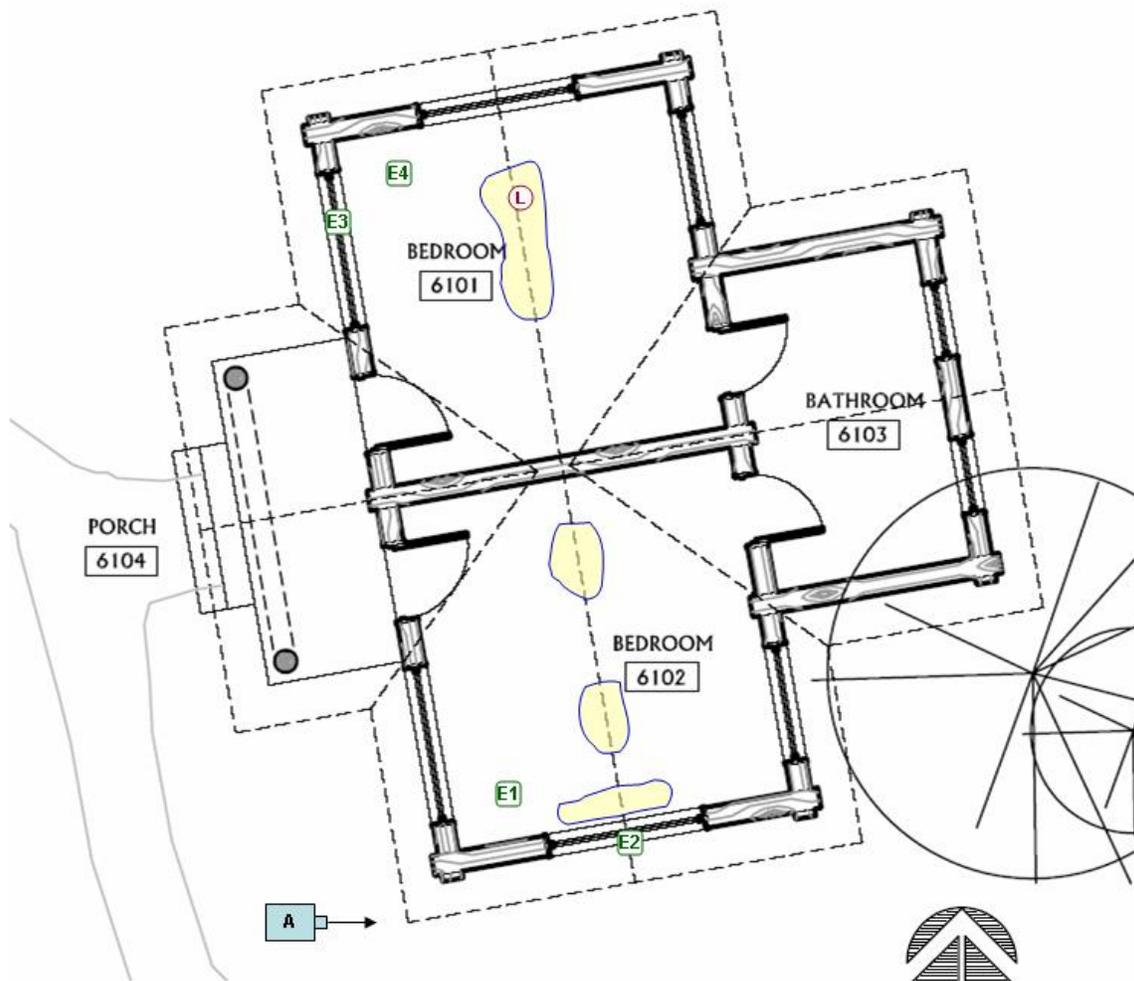
Building 1161 (WG-F in 2004 survey)

- E1: Stovepipe hole.
- E2: Gap by roof peak.
- E3: Gap in logs over window.
- E4: Small stovepipe.

Set 4Aug05, Sensitivity = 5.5
Placed Anabat® unit on log 2feet off the ground and angled to capture bats emerging from E2.

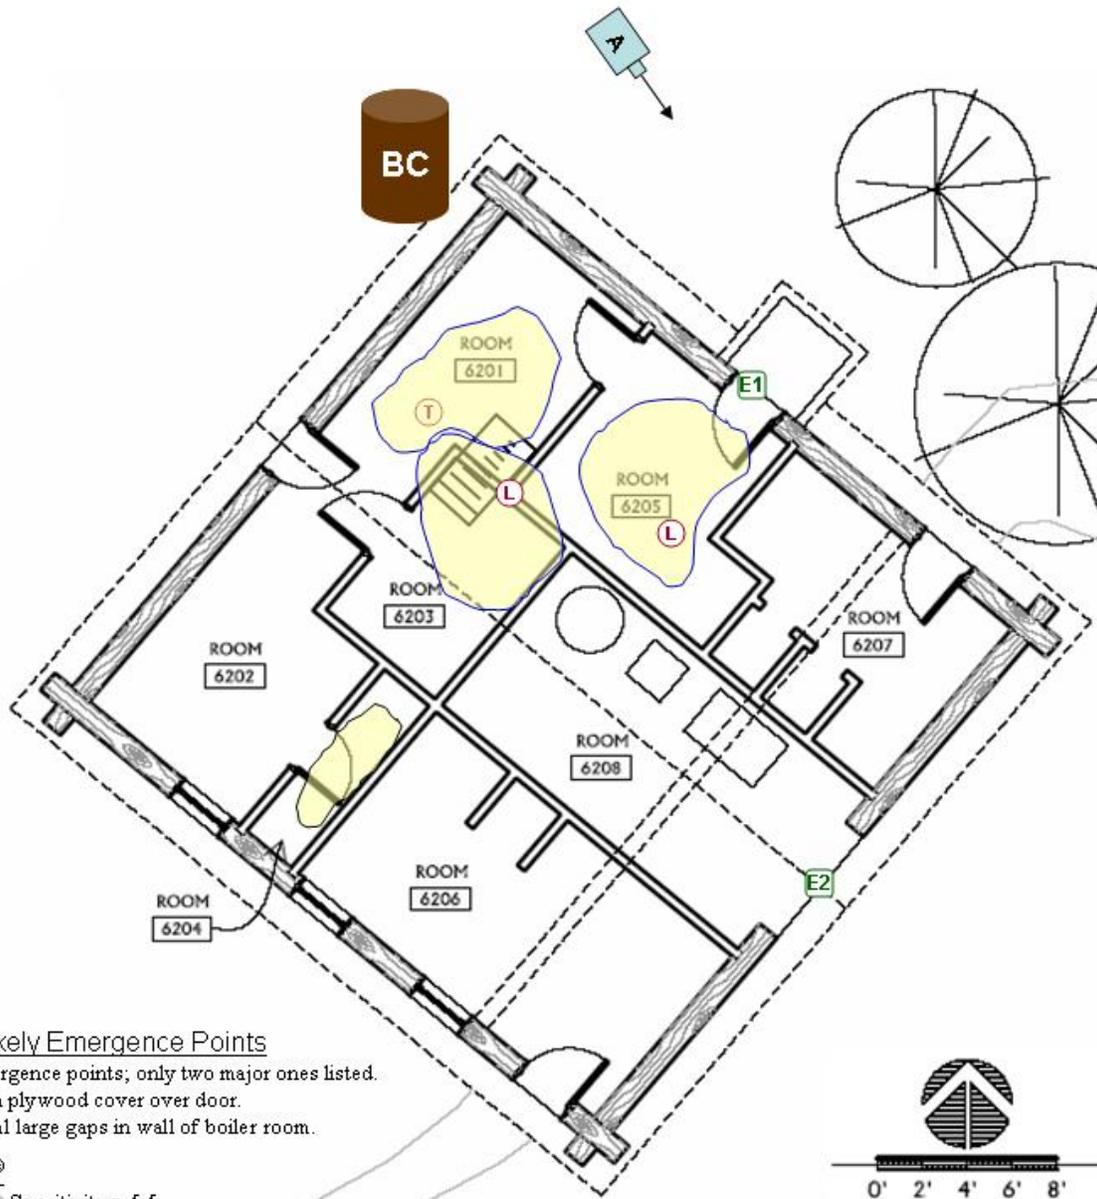
Building 1162 (WG-H in 2004 survey)

Many emergence points; only two major ones listed.

E1: Gap in plywood cover over door.

E2: Several large gaps in wall of boiler room.

Set 6Jul05, Sensitivity = 5.5

Placed Anabat® unit on log 1 foot off the ground and angled to capture bats emerging from E1.

C. townsendi and one *M. lucifugus* found in attic, not in main level.

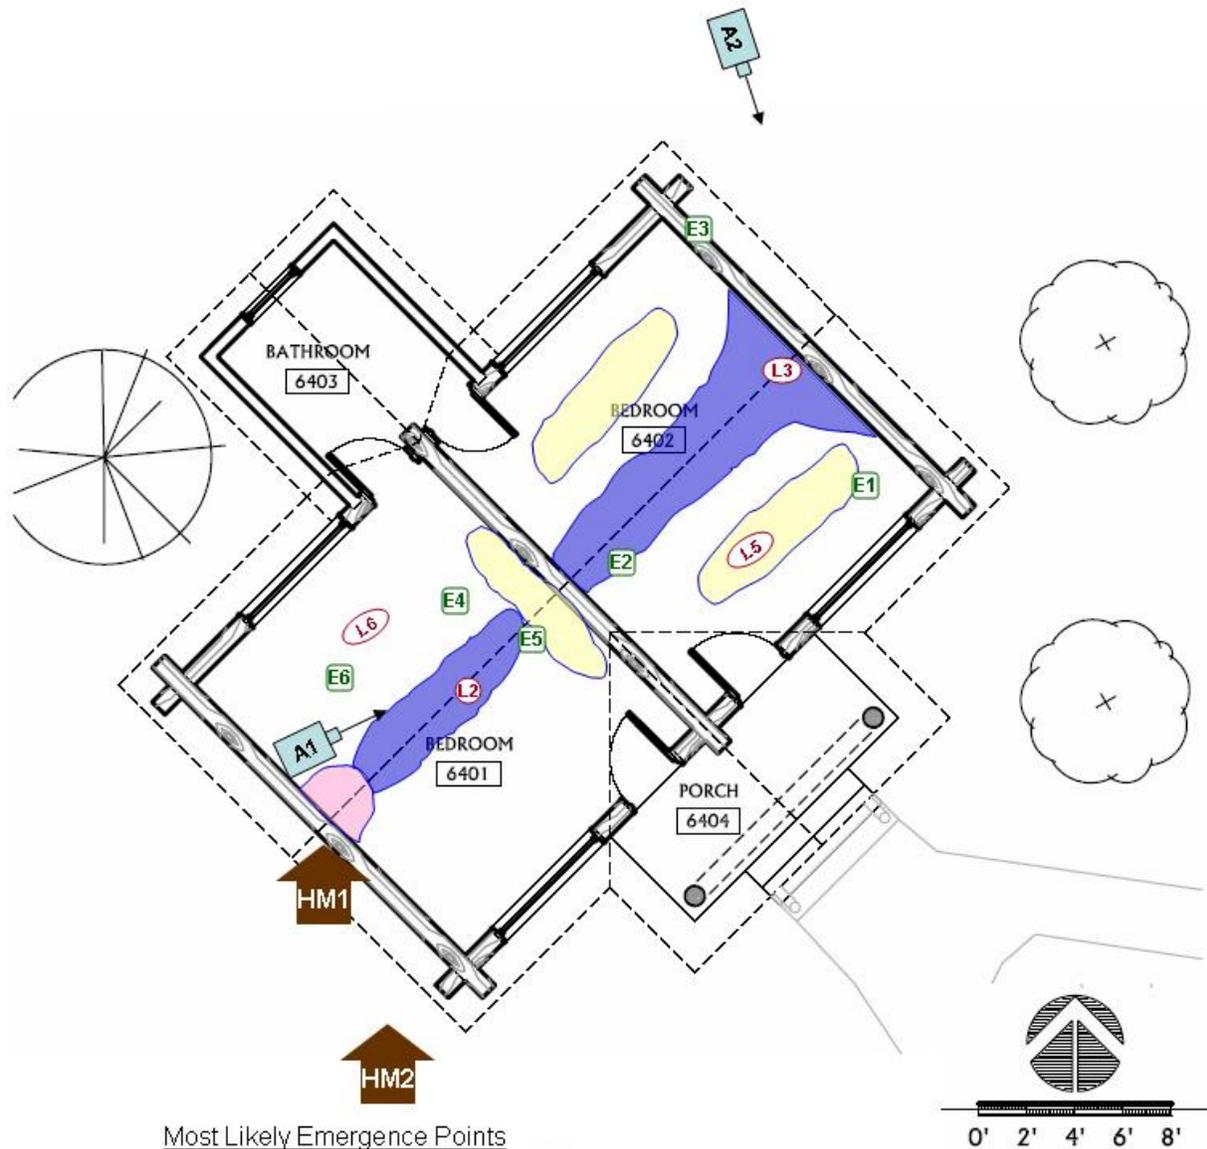
Building 1164 (WG-M in 2004 survey)

- E1: Stovepipe (w/ cobwebs).
- E2: Partially covered stovepipe.
- E3: Gap where roof meets wall.
- E4: Stovepipe hole.
- E5: Large stovepipe hole.
- E6: Gaps in roof boards.

Set: 8Jul05, Sensitivity = 5.5

Placed two units. One on roof to capture bats emerging from E4 and E5. Second on log and angled to capture bats emerging E3.

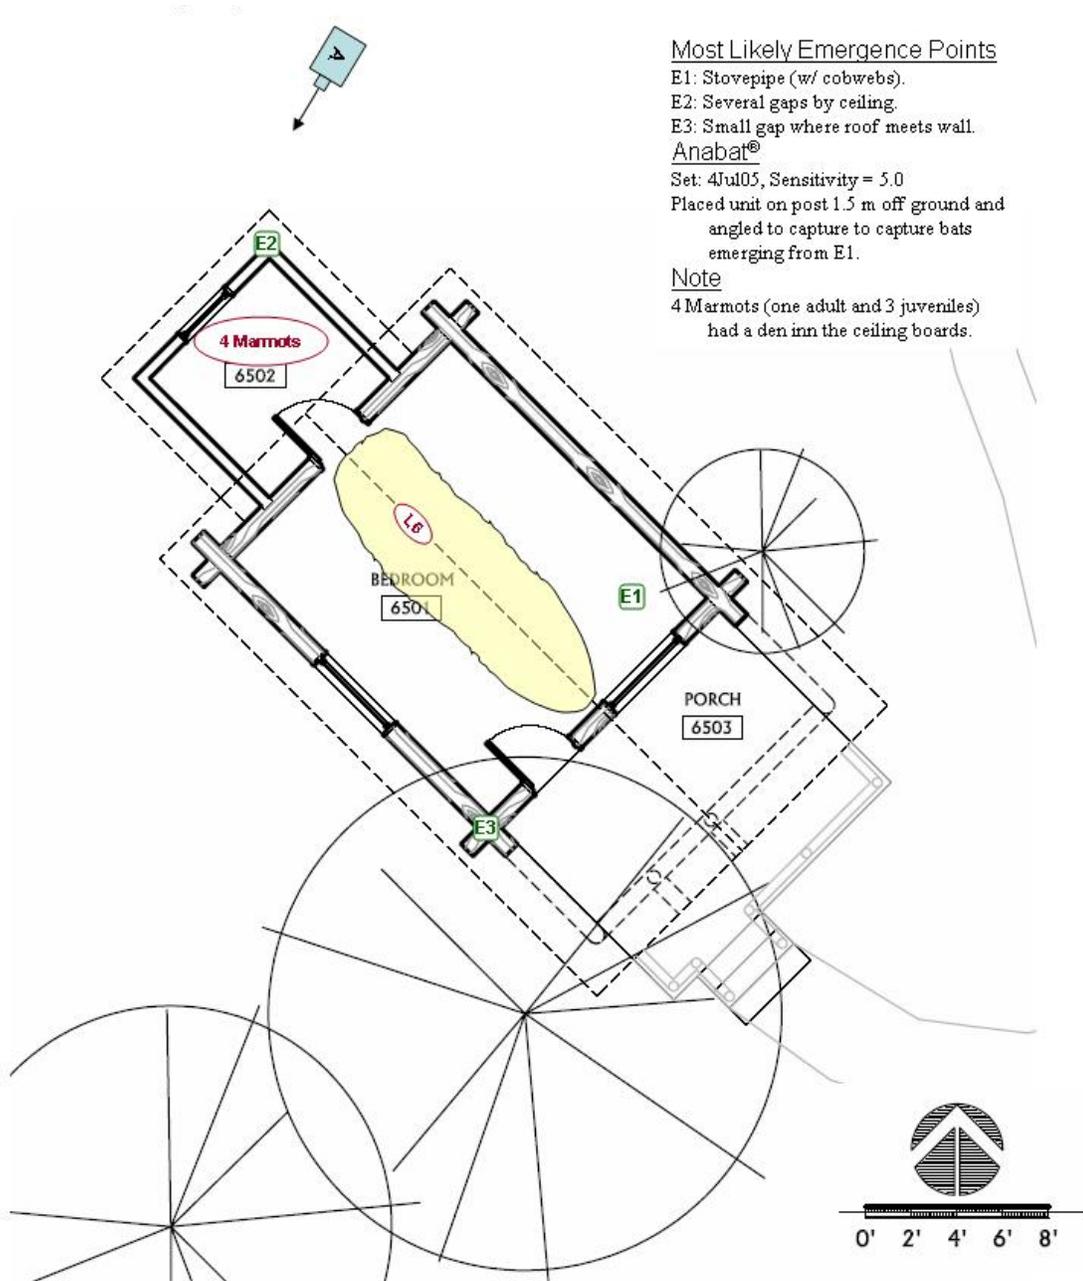
Building 1165 (WG-L in 2004 survey)

- E1: Stovepipe (w/ cobwebs).
- E2: Several gaps by ceiling.
- E3: Small gap where roof meets wall.

Set: 4Jul05, Sensitivity = 5.0

Placed unit on post 1.5 m off ground and angled to capture bats emerging from E1.

4 Marmots (one adult and 3 juveniles) had a den in the ceiling boards.

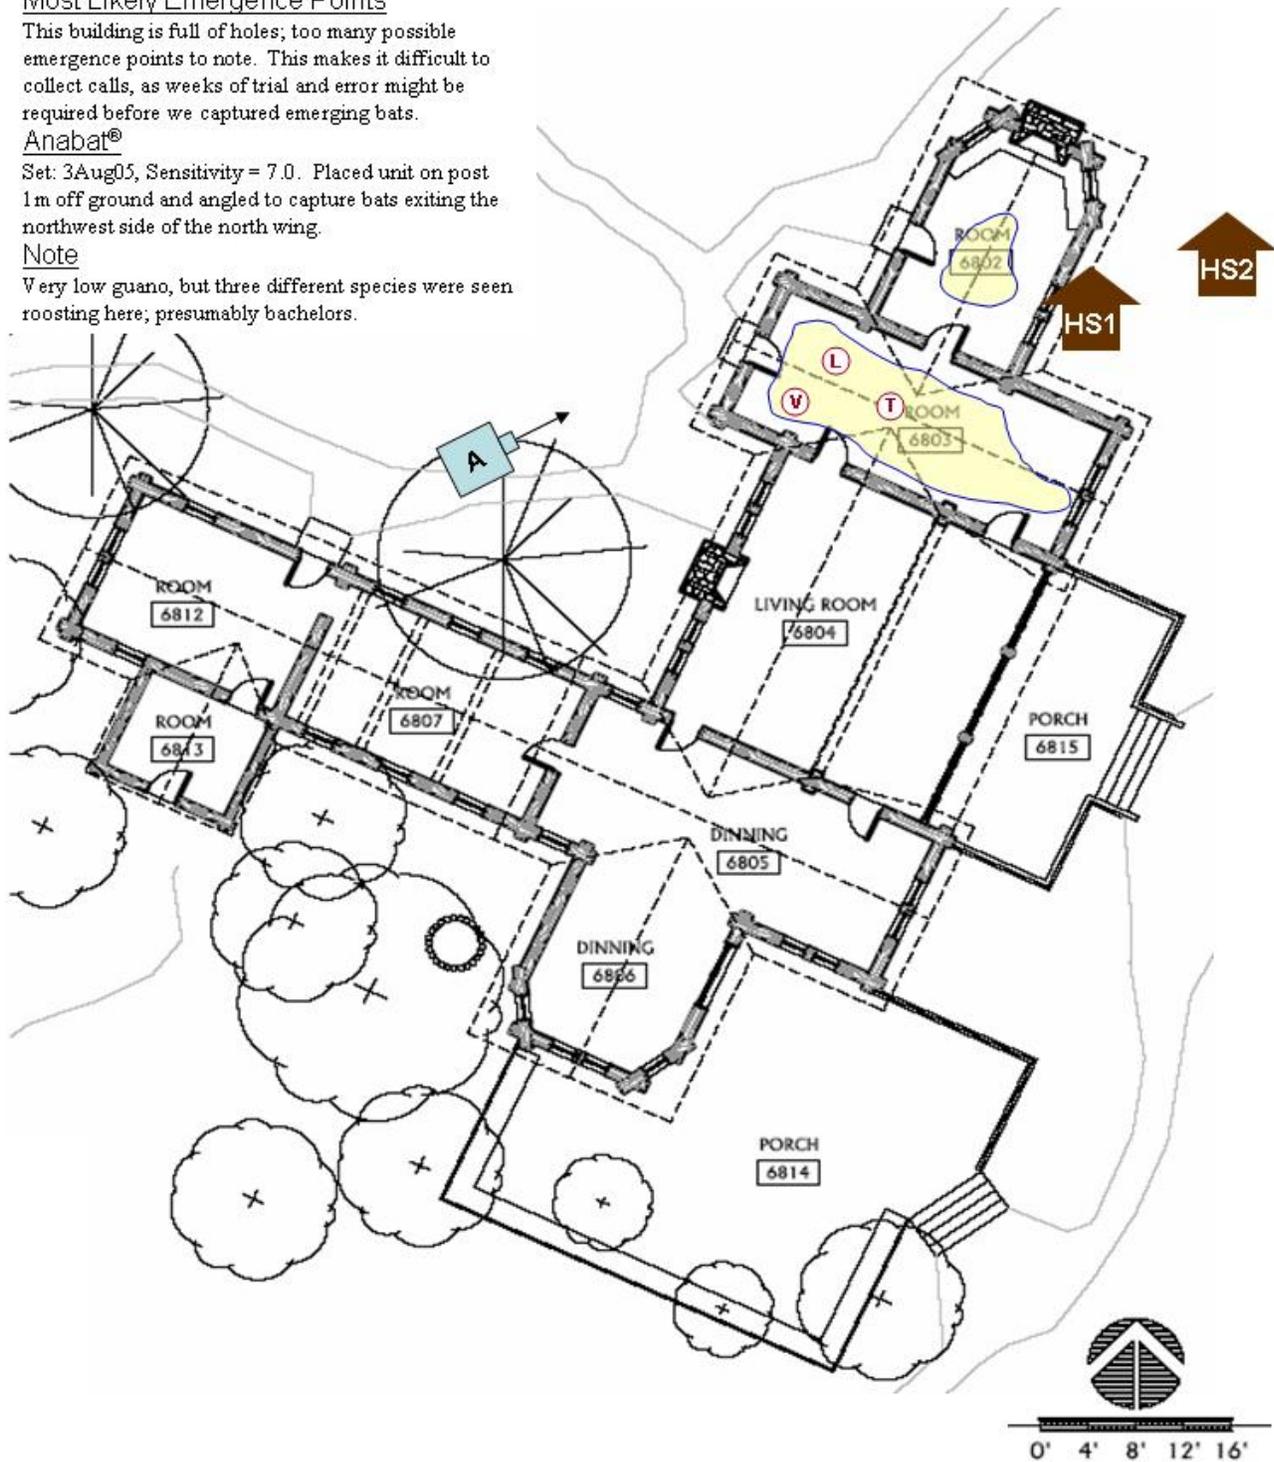
Building 1168 (WG-A in 2004 survey)

This building is full of holes; too many possible emergence points to note. This makes it difficult to collect calls, as weeks of trial and error might be required before we captured emerging bats.

Set: 3Aug05, Sensitivity = 7.0. Placed unit on post 1m off ground and angled to capture bats exiting the northwest side of the north wing.

Very low guano, but three different species were seen roosting here; presumably bachelors.

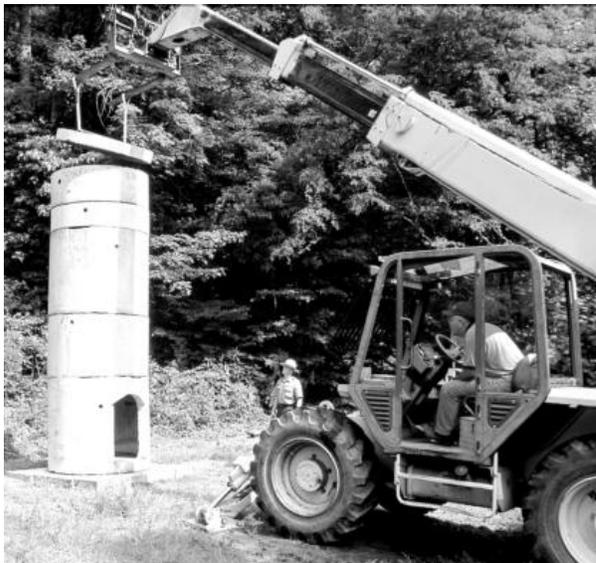
Ronnie Harrill sets the cap on an experimental roost for Rafinesque's big-eared bats at South Mountains State Park in North Carolina. These bats need artificial roosts to survive after losing traditional roosts in large tree hollows and cave entrance cavities. © Elaine Acker, BCI \ 9165402

For each roost, the top five feet of soil was excavated, replaced with clay, and leveled. A concrete pad, six feet (1.8 meters) on a side and eight inches (20.3 centimeters) thick, was installed. Roost sections were stacked on the pads and topped with a concrete cap. An entrance hole was precut in each base section. These varied in size and shape, although most were about 2 x 2 feet (61 x 61 centimeters). One or two 1 x 3-inch (2.5 x 7.6-centimeter) vertical slots were cut 4 to 5 feet (1.2 to 1.5 meters) from the top to provide additional access and escape routes. Floors and lower interior walls were painted dark to reduce interior light. Upper walls and ceilings were roughened by adding lumps of concrete mix, attaching plastic mesh, or cutting grooves to provide footholds for bats.

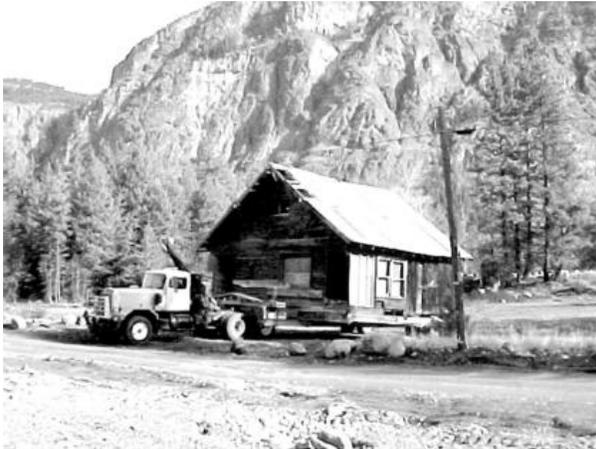
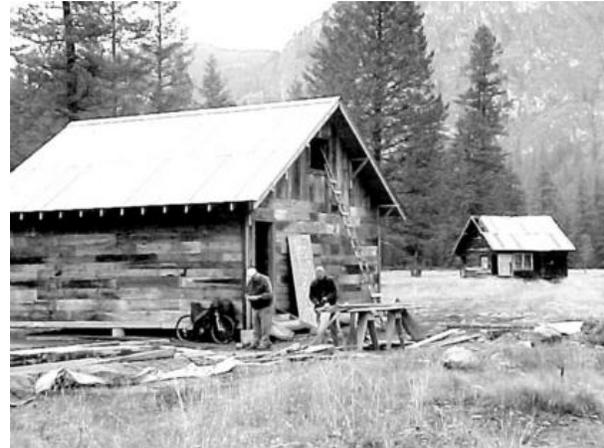
A dilapidated cabin (above left) in Washington was moved to a new location to protect it for Townsend's big-eared bats that had used it for years. To help the bats relocate, a second cabin (above right) was built at the new site. Some bats used both cabins in the first year. Photos © kent woodruff
