Appendix 3: Preliminary Bat Surveys of White Grass and Bar B C Ranches, Grand Teton National Park

by
Douglas A. Keinath
Senior Zoologist, Wyoming Natural Diversity Database

May 2005

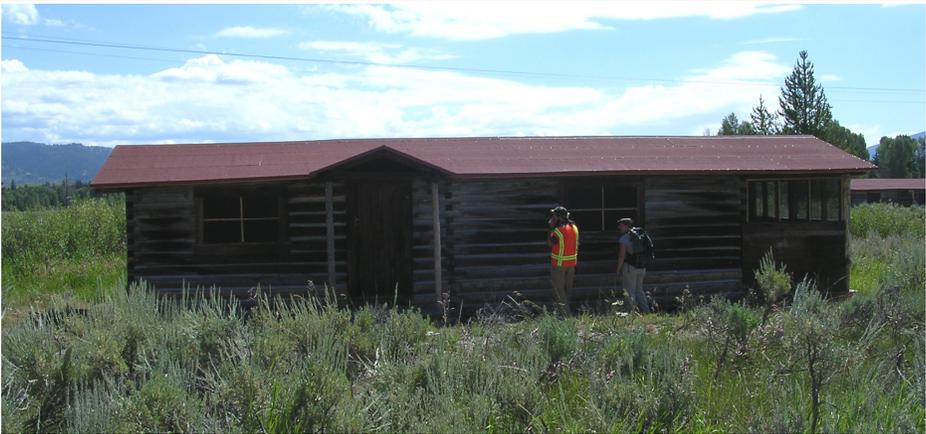
Building ID: BBC-a	GPS Location (E, N):	0524625	4838068	Location Error: 12 m
<p>Description:</p> <p>Sheet shingle roof log cabin with chinking. Small porch on west side. Screened porch n south.</p> <p>Beam and plank ceiling. Two rooms. Contains old shelves, table, lumber, and sheet insulation.</p> <p><u>Bat habitat Notes:</u> Many possible entrance holes for bats.</p>

Bat Use: None.					
Recommendations: No follow-up necessary.

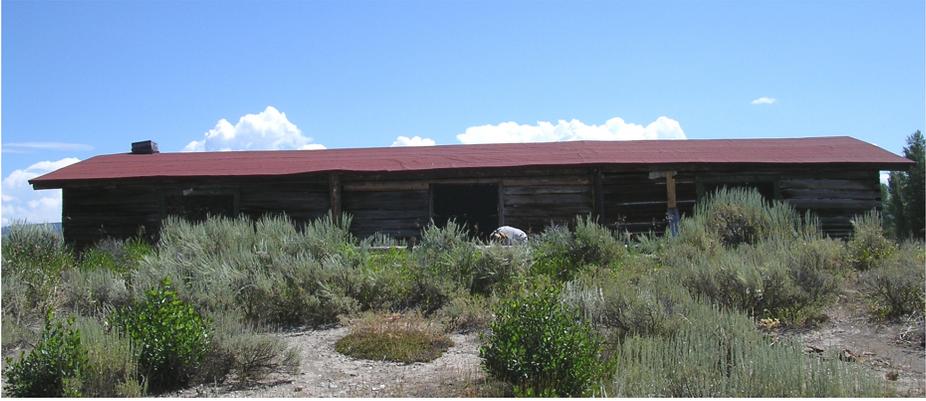
Building ID: BBC-e	GPS Location (E, N):	0524649	4838058	Location Error: 1 m
<p>Description:</p> <p>Mid-sized (7m X 16m) log cabin. Sheet-shingle roof with chimney on north side. Entrances on west and east sides.</p> <p>Beam and plank ceiling. One room. Contains lumber, tables, bench, dressers, and spare doors.</p> <p><u>Bat habitat Notes:</u> Bat entrances through many holes near floor level plus an open chimney.</p>

Bat Use: None.					
Recommendations: No follow-up necessary.

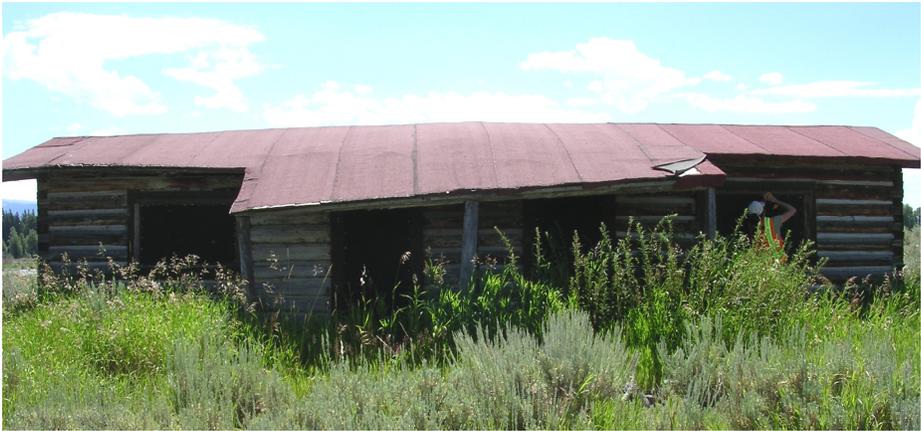
Building ID: BBC-f	GPS Location (E, N):	0524584	4837996	Location Error: 8 m
<p>Description:</p> <p>Mid-sized (4m X 12m) log cabin with chinking. Two entry doors, both on north side with porch. Four windows. Sheet-shingle roof.</p> <p>Beam and plank ceiling with stovepipe hole in the southeast. Two rooms.</p> <p><u>Bat habitat Notes:</u> Bat emergence point likely through stovepipe hole.</p>

Bat Use: None.					
Recommendations: None.

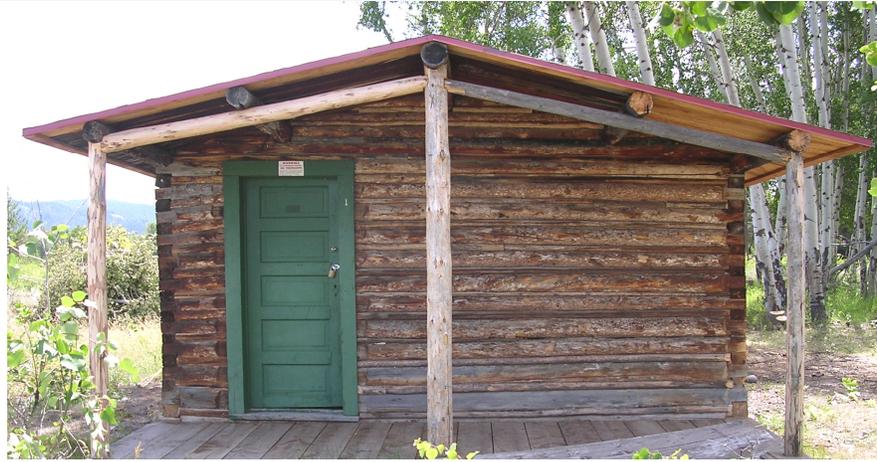
Building ID: BBC-h	GPS Location (E, N):	0524603	4838164	Location Error: 8 m
<p>Description:</p> <p>"Cabin 1." Small (4m X 4m) log cabin. One door on south, with porch. Two windows. Sheet-shingle roof.</p> <p>Beam and plank ceiling. One room.</p> <p><u>Bat habitat Notes:</u> None.</p>

<p>Bat Use: None.</p>					
<p>Recommendations: None.</p>

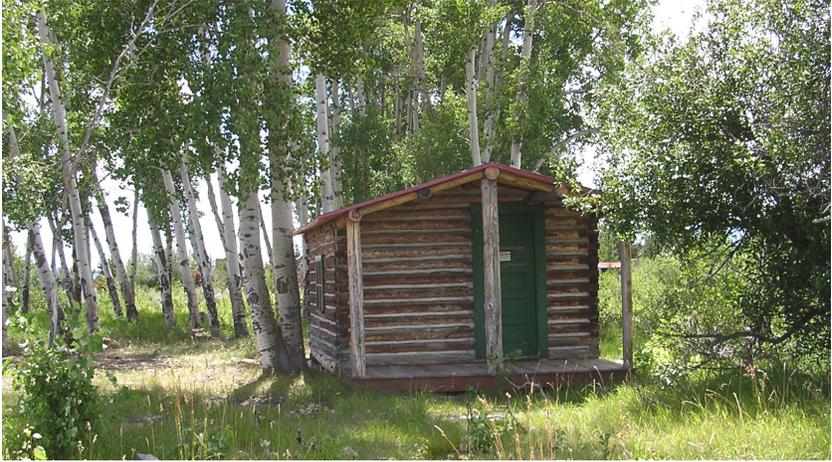
Building ID: BBC-i	GPS Location (E, N):	0524588	4838005	Location Error: 1 m
<p>Description:</p> <p>Small (4m X 5m) log cabin with most chinking in tact. Two entrance doors, with a porch on the north side. Two windows. Sheet-shingle roof.</p> <p>Beam and plank ceiling. One room. Contains an old stove and broken shelves.</p> <p><u>Bat habitat Notes:</u> Some possible entrance holes along the floor and around the south door.</p>

Bat Use: None.					
Recommendations: No follow-up necessary.

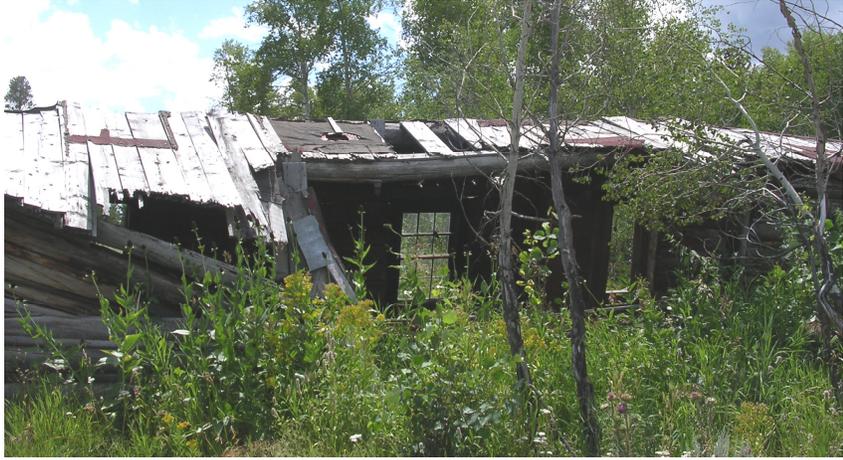
Building ID: BBC-j	GPS Location (E, N):	0524535	4838181	Location Error: 6 m
<p>Description:</p> <p>Small (4m X 9m), collapsed log cabin. One door, 5 windows, many holes. Wood plank roof.</p> <p>Beam and plank ceiling. Two rooms. Unstable!</p> <p><u>Bat habitat Notes:</u> None.</p>

Bat Use: None.					
Recommendations: None.

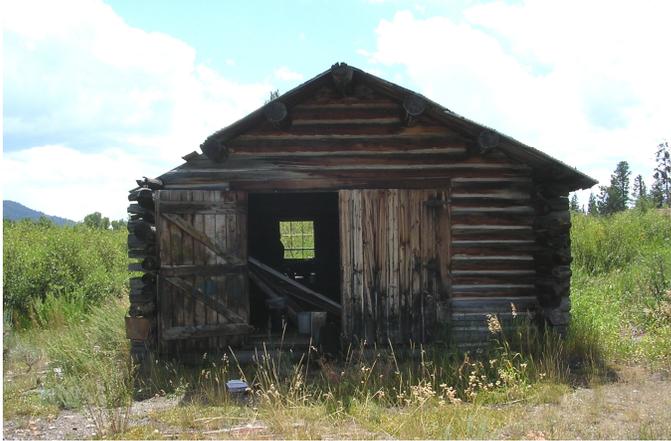
Building ID: BBC-k	GPS Location (E, N):	0524651	4838179	Location Error: 4 m
<p>Description:</p> <p>Small (5m X 9m) log cabin with most chinking in tact. Barn-style double doors on north and another door on south. 5 windows. Wood-slat roof with no shingles.</p> <p>Beam and plank ceiling. Much "junk"; looks like old tack shed. Windows and doors open.</p> <p><u>Bat habitat Notes:</u> Many large openings.</p>

Bat Use: None.					
Recommendations: No follow-up necessary.

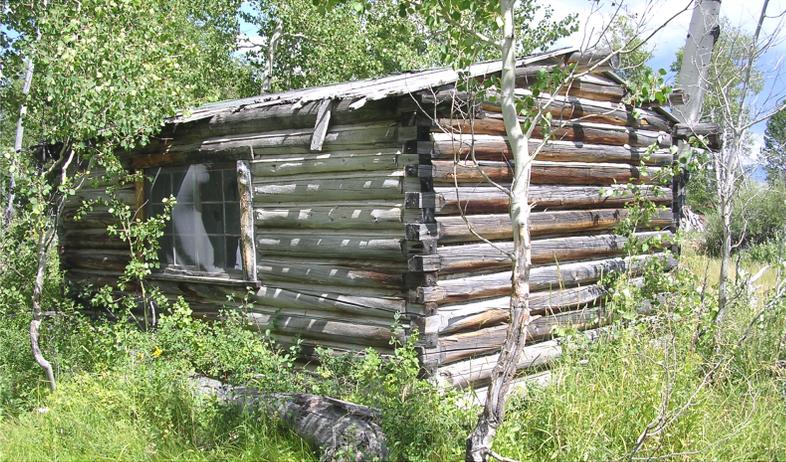
Building ID: BBC-l	GPS Location (E, N):	0524408	4838092	Location Error: 6 m
<p>Description:</p> <p>Small (4m X 5m) log cabin with chinking. One door and two windows. Unshingled roof.</p> <p>Beam and plank ceiling. One room.</p> <p><u>Bat habitat Notes:</u> Possible bat entry holes through deteriorating roof.</p>

Bat Use: None.					
Recommendations: None.

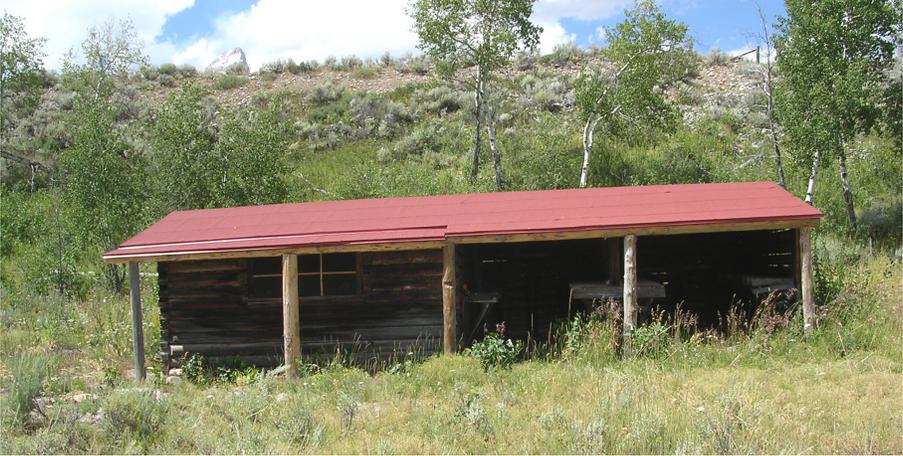
Building ID: BBC-m	GPS Location (E, N):	0000000	0000000	Location Error: 00 m
<p>Description: Mid-sized log cabin. Sheet-shingle roof. Door on north and window on east. Half of building is open and contains saddle rests. Beam and plank ceiling. One inside room, one open room with saddle bars. Contains some shelves. <u>Bat habitat Notes:</u> Entrance points above door on north wall and on top of south wall.</p>

Bat Use: None.					
Recommendations: No follow-up necessary.

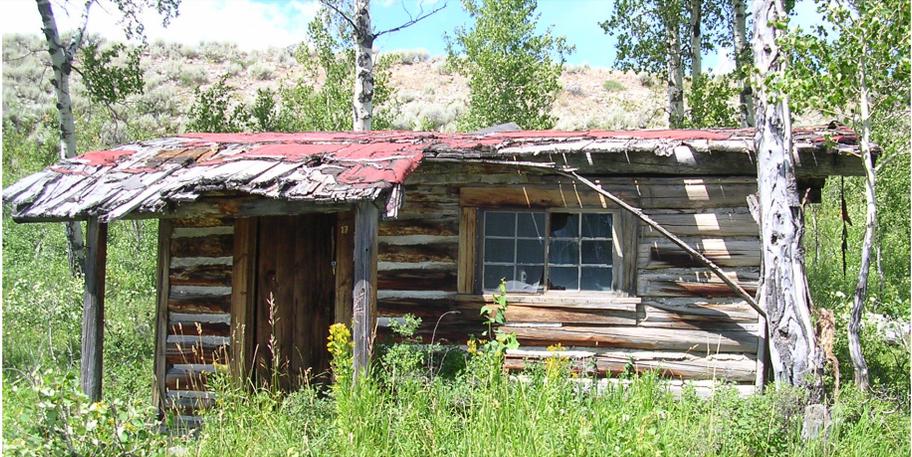
Building ID: BBC-o	GPS Location (E, N):	0524468	4838124	Location Error: 4 m
<p>Description:</p> <p>"Cabin 17" Small log cabin with worn chinking. Crumbling plank roof with shingles. Door on southeast (kicked in) and window on southeast.</p> <p>Beam and plank ceiling. One room. Contains a table and shelves.</p> <p><u>Bat habitat Notes:</u> Small holes in ceiling and on upper southeast wall could provide entrance points.</p>

<p>Bat Use: None.</p>					
<p>Recommendations: No follow-up necessary.</p>

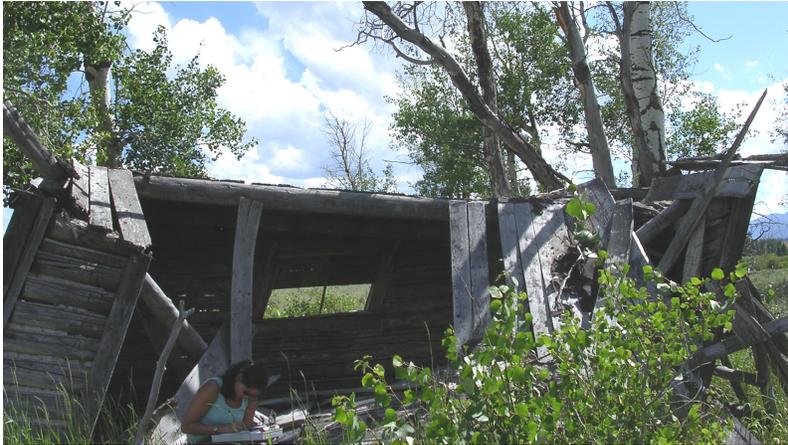
Building ID: BBC-t	GPS Location (E, N):	0524408	4837869	Location Error: 7 m
<p>Description:</p> <p>Old wood and log building with north side collapsed. Wooden roof that's half missing.</p> <p>One partially remaining room with piles of wood.</p> <p><u>Bat habitat Notes:</u> Entrances everywhere, but no decent roosting space.</p>

<p>Bat Use: None.</p>					
<p>Recommendations: None.</p>

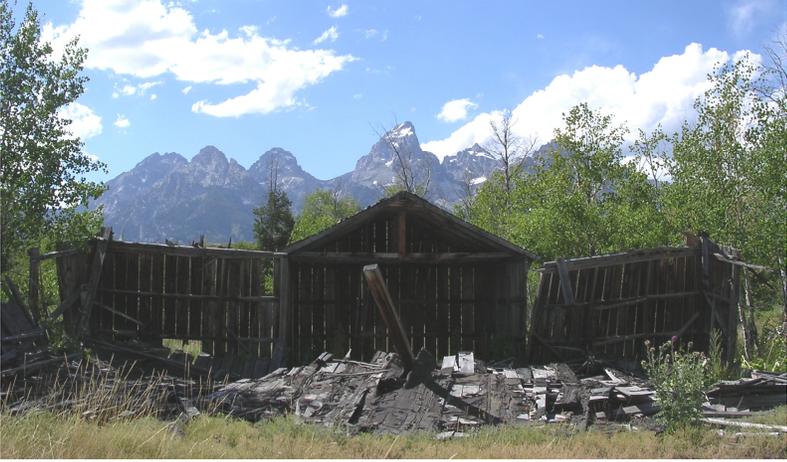
Building ID: BBC-v	GPS Location (E, N):	0524405	4837886	Location Error: 5 m
<p>Description:</p> <p>Wooden barn with east side collapsed.</p> <p>One partially remaining room.</p> <p><u>Bat habitat Notes:</u> Entrances everywhere, but no decent roosting space.</p>

<p>Bat Use: None.</p>					
<p>Recommendations: None.</p>

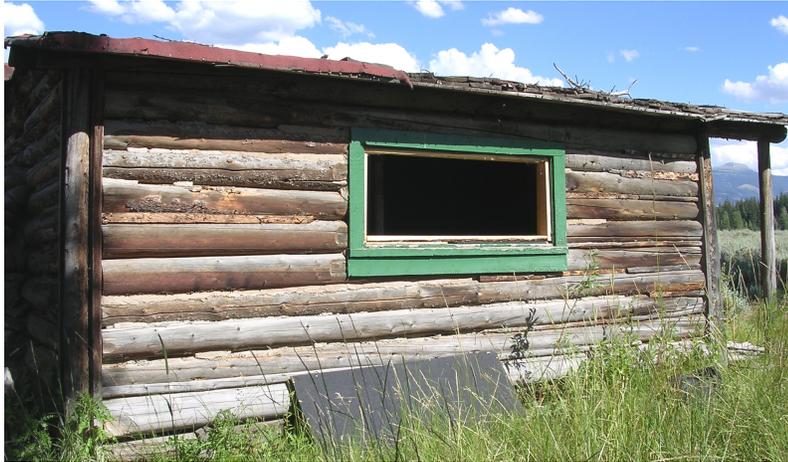
Building ID: BBC-x	GPS Location (E, N):	0524514	4838045	Location Error: 6 m
<p>Description:</p> <p>Small (4m X 5m) log cabin. One door and one window. Sheet-shingled roof with chimney.</p> <p>Beam and plank ceiling. One room.</p> <p><u>Bat habitat Notes:</u> Possible bat entrance through chimney.</p>

Bat Use: None.					
Recommendations: None.

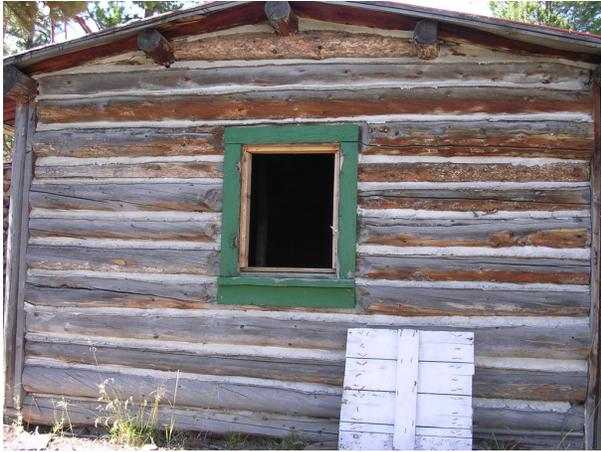
Building ID: BBC-z	GPS Location (E, N):	0524510	4838056	Location Error: 13 m
<p>Description:</p> <p>Small (4m X 5m) log cabin with chinking. Tin roof with chimney. One door and two windows.</p> <p>Beam and plank ceiling. One room.</p> <p><u>Bat habitat Notes:</u> Possible bat entrance through chimney.</p>

Bat Use: None.					
Recommendations: None.

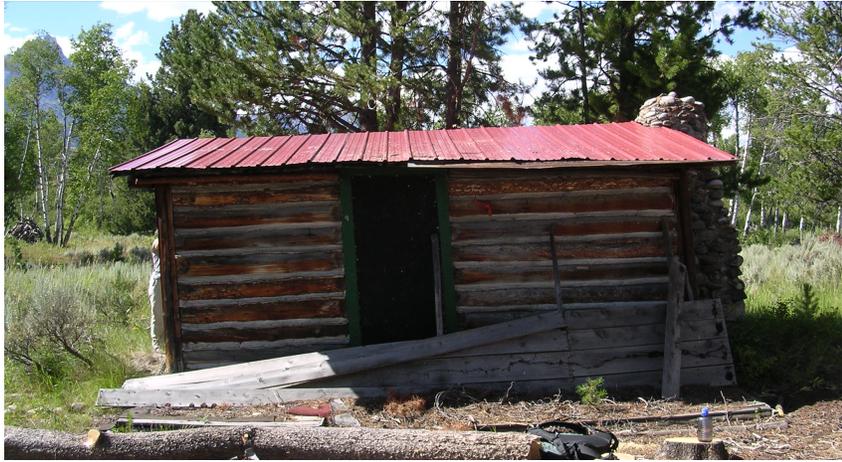
Building ID: BBC-aa	GPS Location (E, N):	0524503	4838046	Location Error: 3 m
<p>Description:</p> <p>"Cabin 9." Small log cabin with chinking. One door with porch on south side. Two windows. Sheet-shingle roof with stone chimney on east side.</p> <p>Beam and plank ceiling. One room with closed chimney. Contains: old shelves. Large bird nest.</p> <p><u>Bat habitat Notes:</u> Some open entry points.</p>

Bat Use: None.					
Recommendations: None.

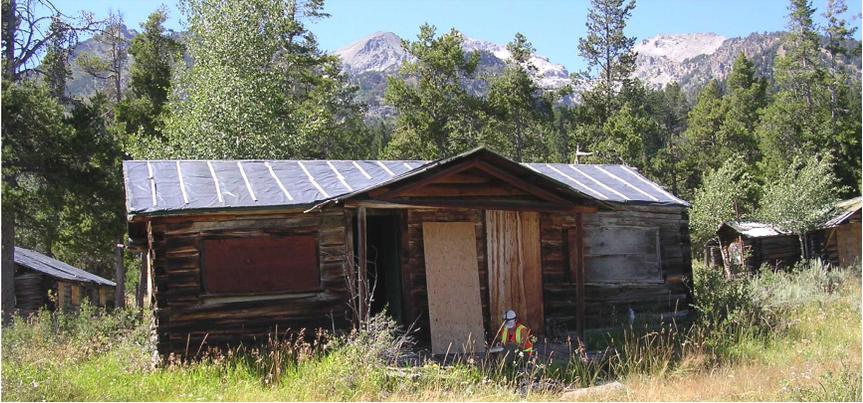
Building ID: WGg	GPS Location (E, N):	0518298	4833904	Location Error: 10 m
<p>Description:</p> <p>Small (4m X 8m) duplex cabin. Log construction. Plastic sheet over plywood roof.</p> <p>Beam and plank A-frame ceiling. Two rooms and a bathroom.</p> <p><u>Bat habitat Notes:</u> The main emergence point is a hole hear the ceiling beam in the north room.</p>

Bat Use: No evidence of bat use.					
Recommendations: None.

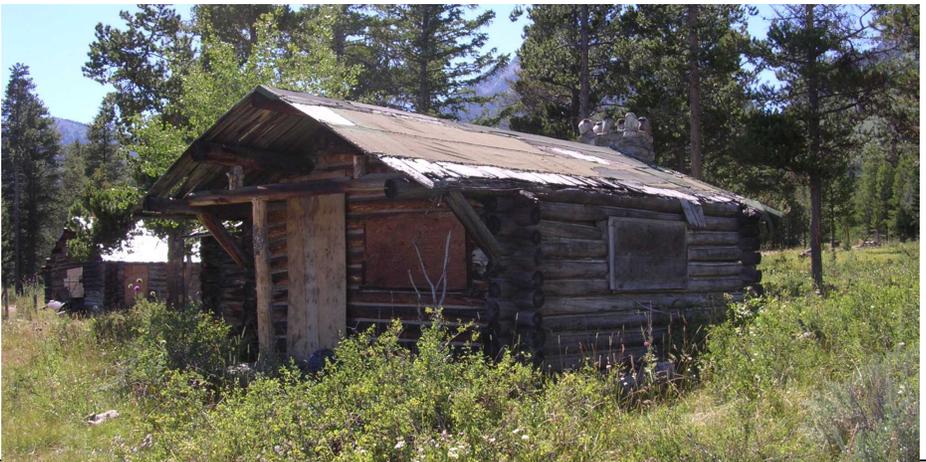
Building ID: WGi	GPS Location (E, N):	0518277 4833923	Location Error: 8 m
<p>Description:</p> <p>Small (3m X 6m) cabin. Log construction. Plank roof with chimney.</p> <p>Beam and plank A-frame ceiling. One room and a bathroom.</p> <p><u>Bat habitat Notes:</u> Many possible emergence holes.</p>

Bat Use: None.			
Recommendations: None.
