ROAD BARRIER CONDITION ASSESSMENT IN WIND RIVER INDIAN RESERVATION, WYOMING

Final Report For the

Department of Transportation of Wind River Indian Reservation

December, 2017

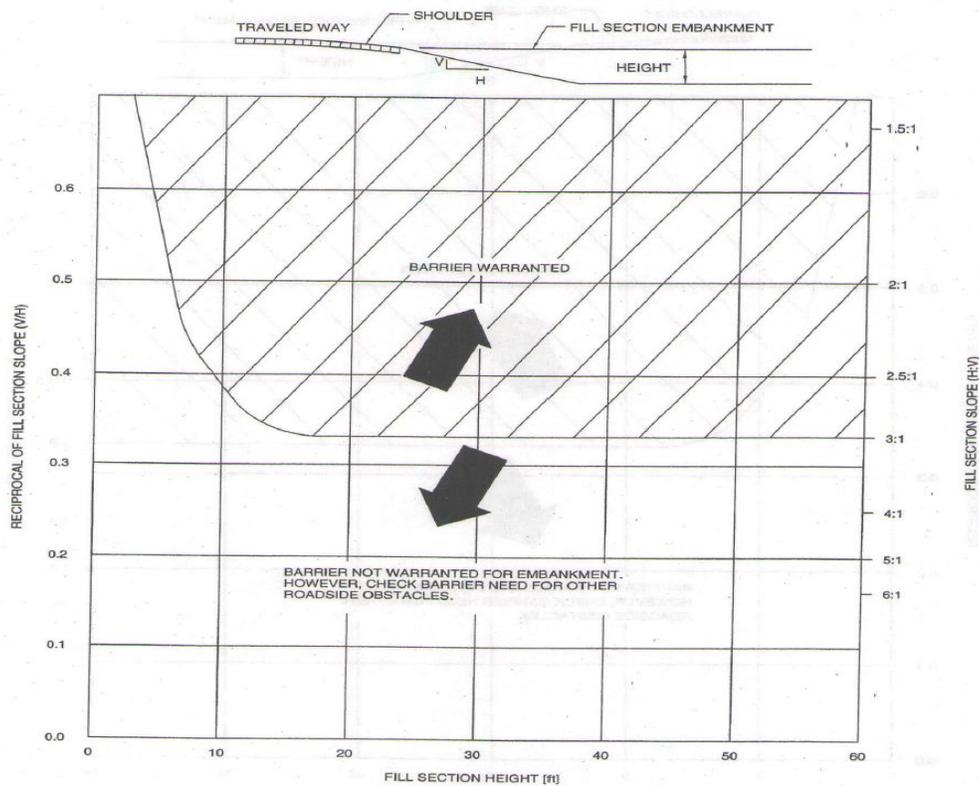
Figure 15. Barrier warrant analysis based on AASHTO 2011.

Based on the recommendations of RDG (AASHTO 2011), fill section height, and the sideslope rate are two main parameters to determine whether a barrier system is needed. The method is also shown in Figure 15. Site No. 4 is by a river with a fill section height of 10 ft and the sideslopes about 2H:1V on each side. Therefore, according to Figure 15, a barrier system is warranted for both directions. Therefore, the assigned site score is 1.0 which means the highest priority for installing a barrier system.

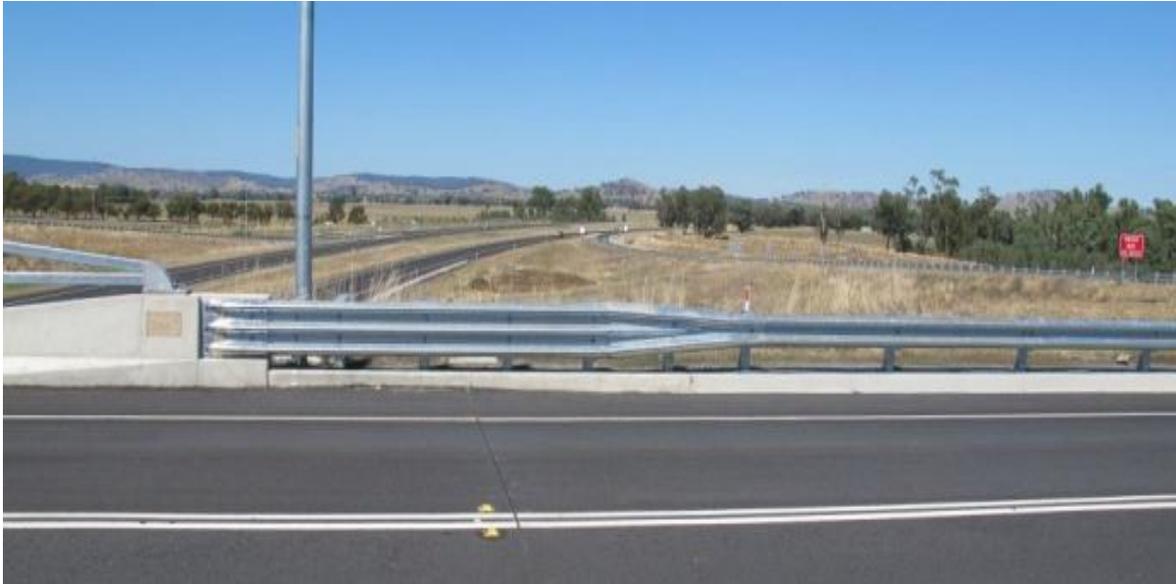
Figure 26. An appropriate design of the bridge transition section.

At this point, no improvement is required for the bridge barrier and it is anticipated that the barrier would not face any serious issues at least in the next five years. However, it is required to improve the condition of the end-treatments. The post spacing near the bridge should be only 3' instead of the typical 6' spacing to provide a good transition between the rail and the bridge barrier. A Thrie-Beam is recommended to provide a smoother transition (from the semi-rigid

guardrail to the rigid barrier on the bridge). Figure 26 shows an example of a proper bridge transition installation.

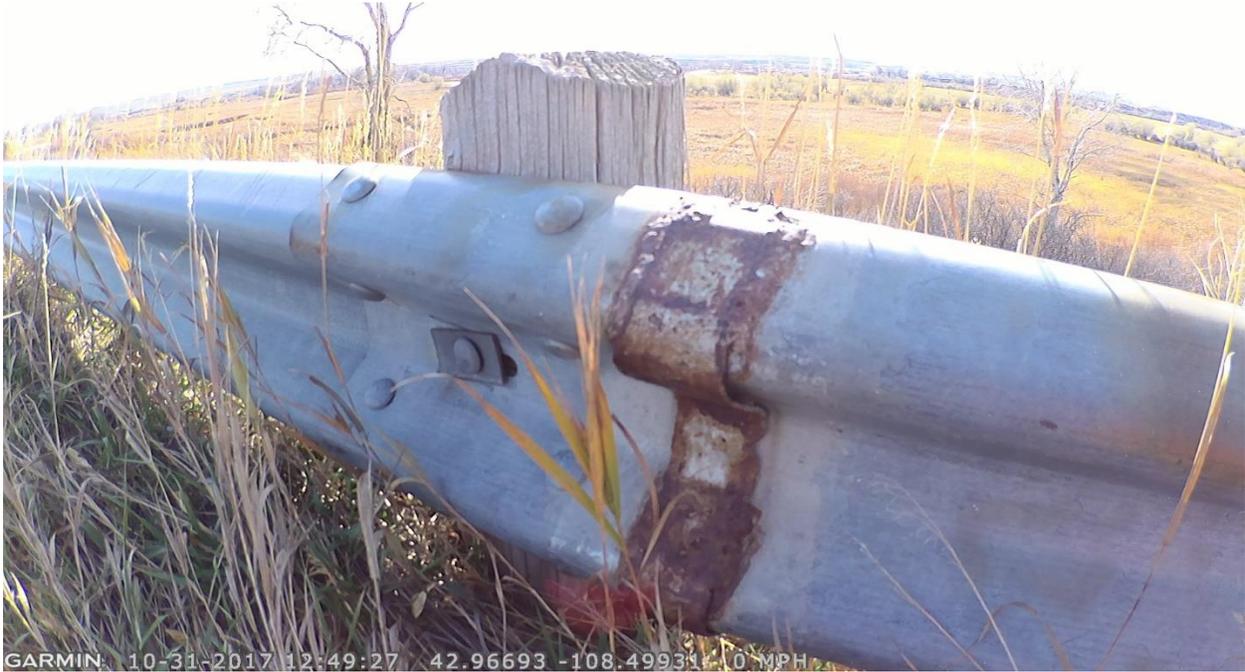
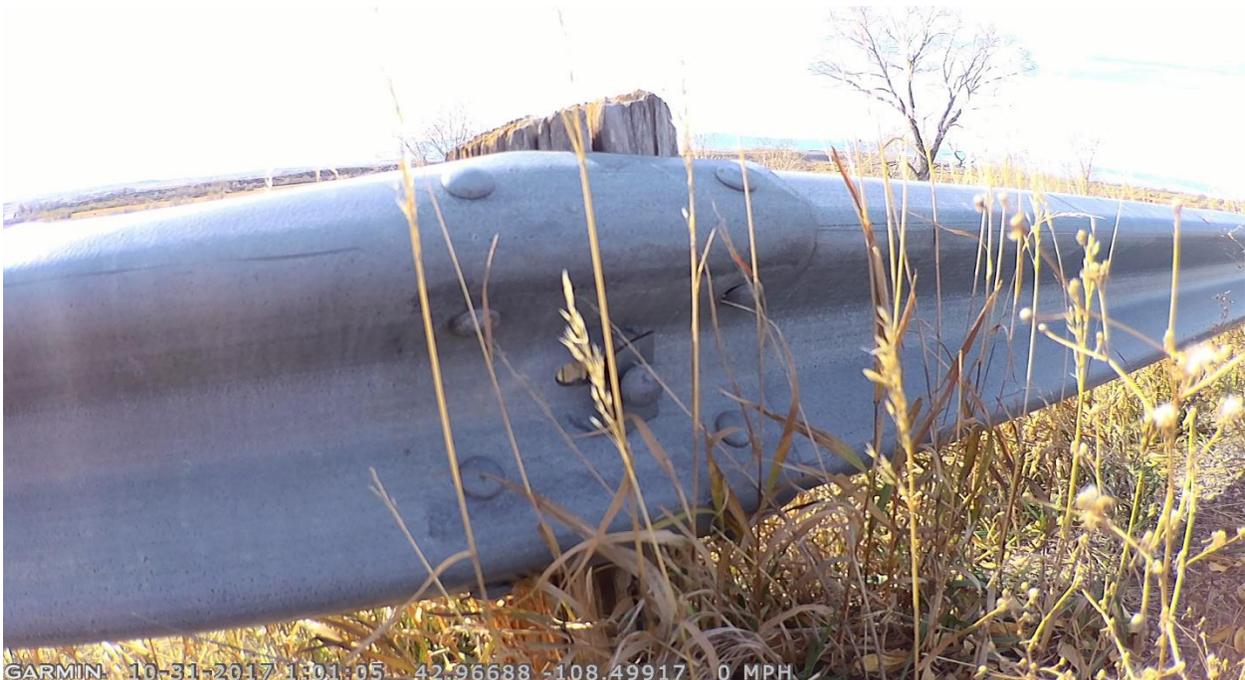
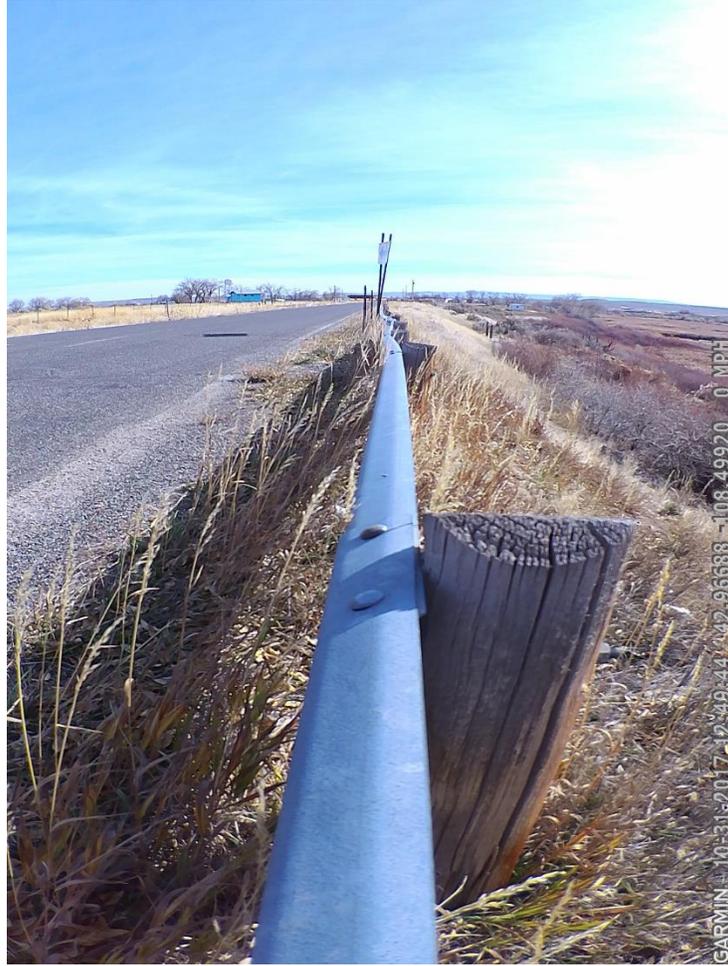
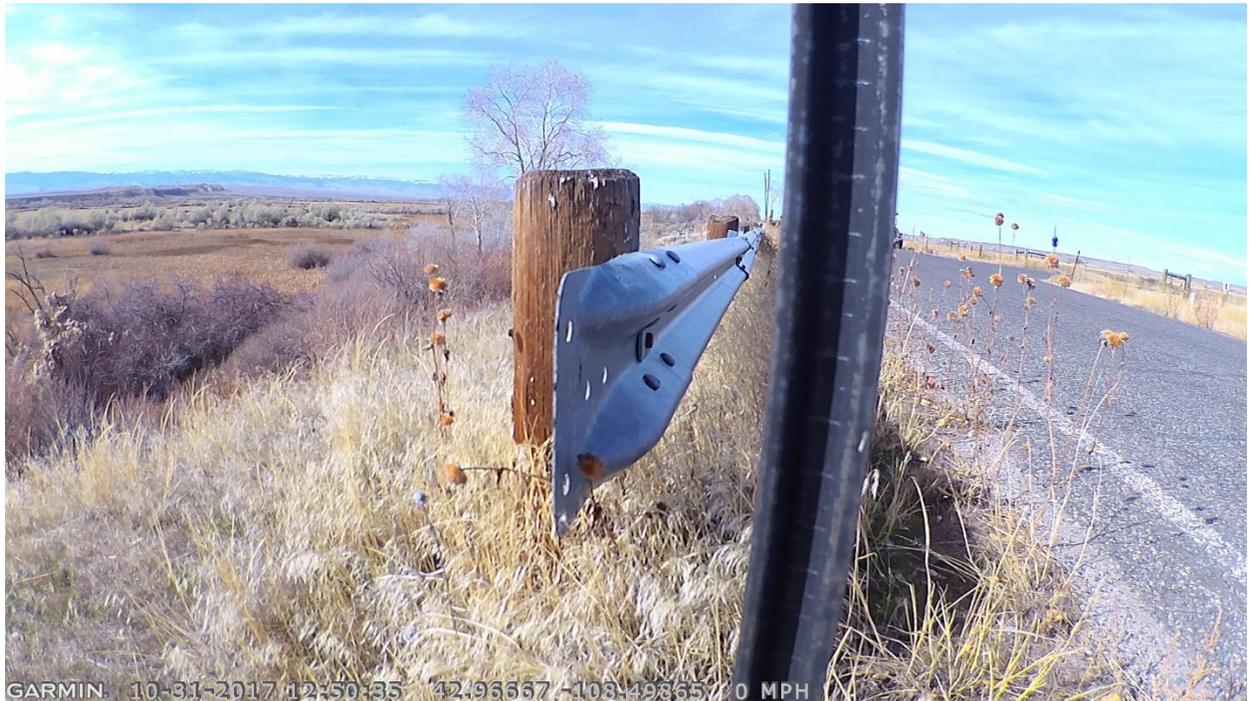
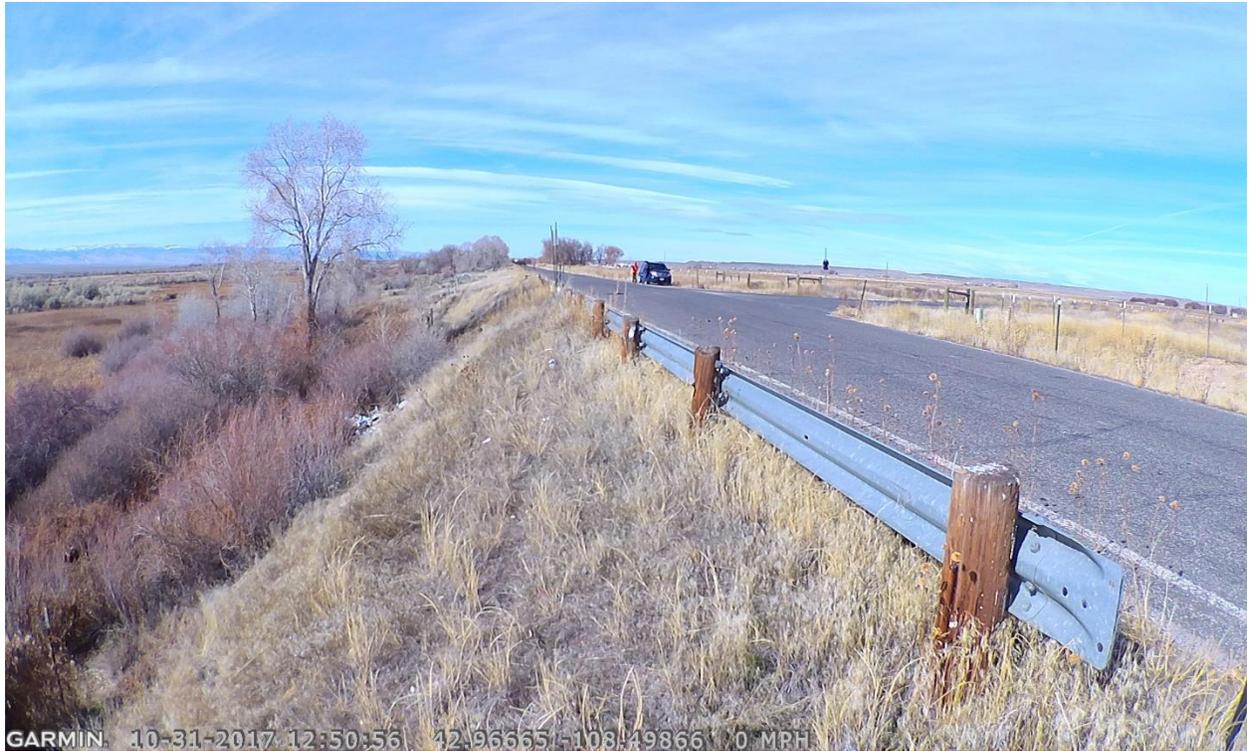
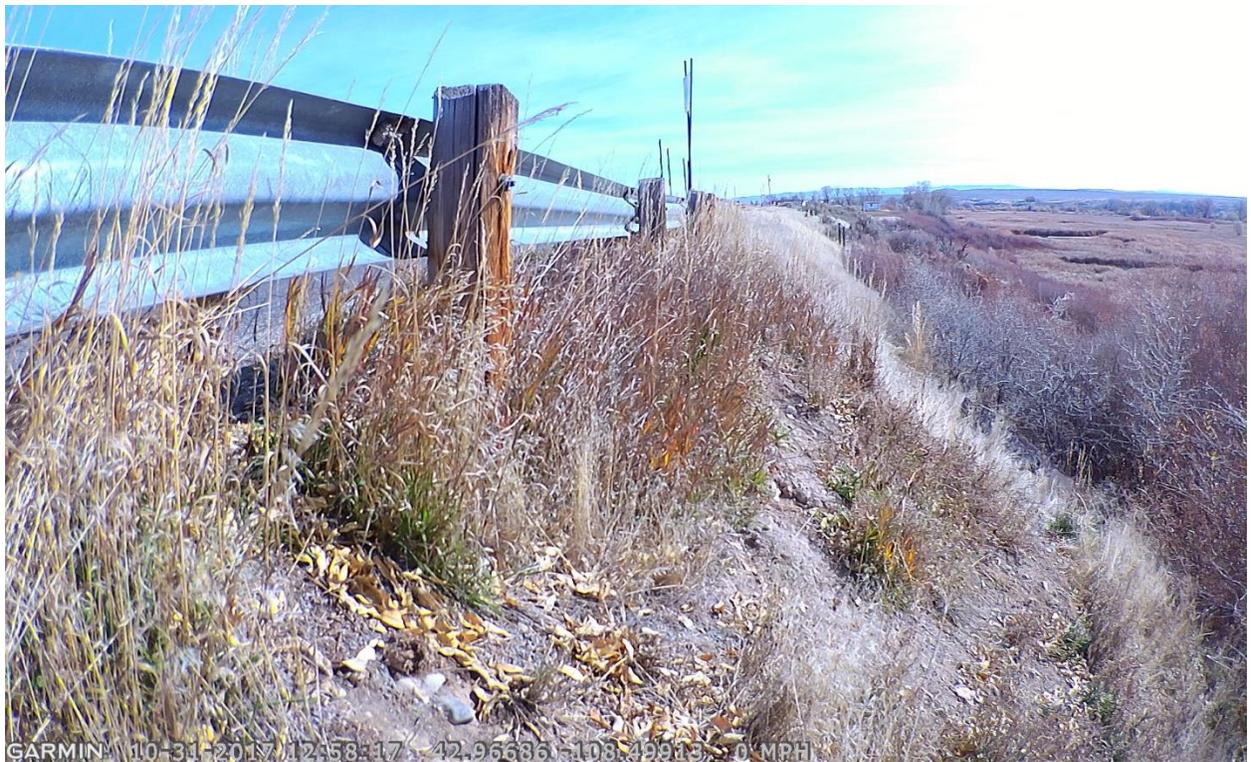
Site No. 1 has a semi-rigid W-Beam guardrail with wood posts (without blockout). The poor condition of end-treatments was investigated as the main problem in this segment. As it is shown in Figure 4, one of the end-treatment seems to be a “trailing end W-Beam guardrail anchorage” type while a part of the end-post is missed. The existing end-post can apply a serious damage to

vehicles involved in a crash. In other words, it would perform the same as a sharp blade in the collisions. The first end-treatment was also missing the end terminal portion. Moreover, the offset from the edge of pavement was measured as 1 ft which is not acceptable based on the recommended offset of 4 ft in the roadside design guide (RDG) (AASHTO 2011).

25 ft of the guardrail segment had severe lateral deflection, high-severity deterioration was observed on the panels, and there was a missing bolt in the connection of two panels. As shown in Figure 6, the traffic signs were not placed behind the guardrail, and this can impact the performance of the barrier in crashes. Worksheets and pictures in Appendices A and B also refer the GPS coordinates and the condition of these damages more precisely.

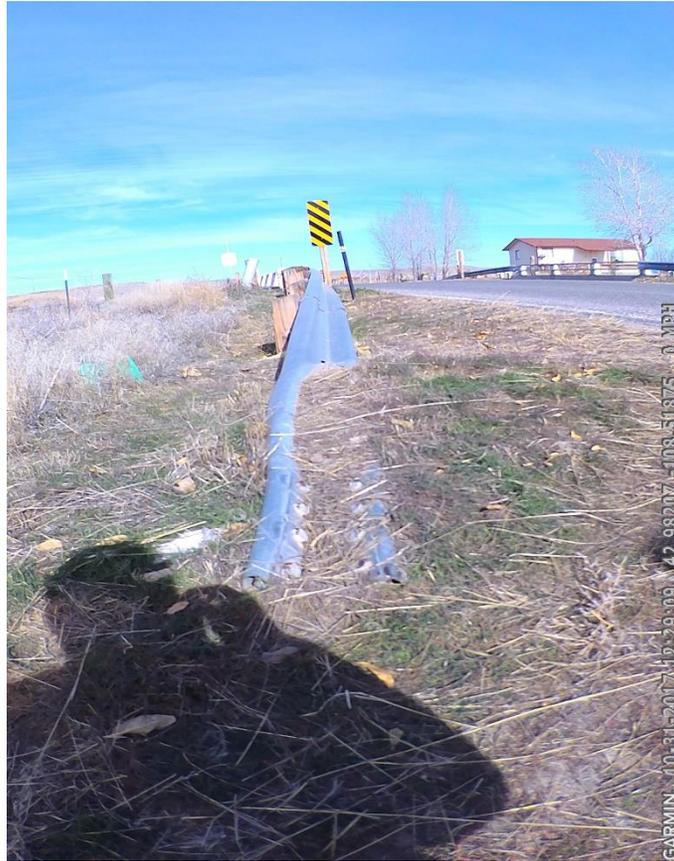
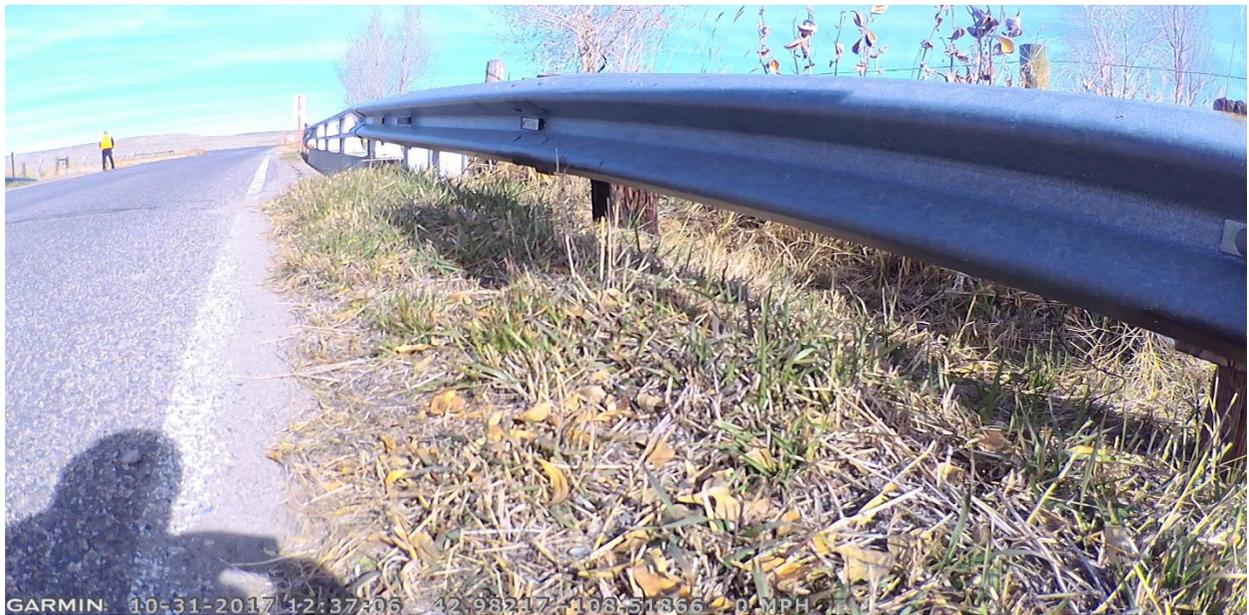
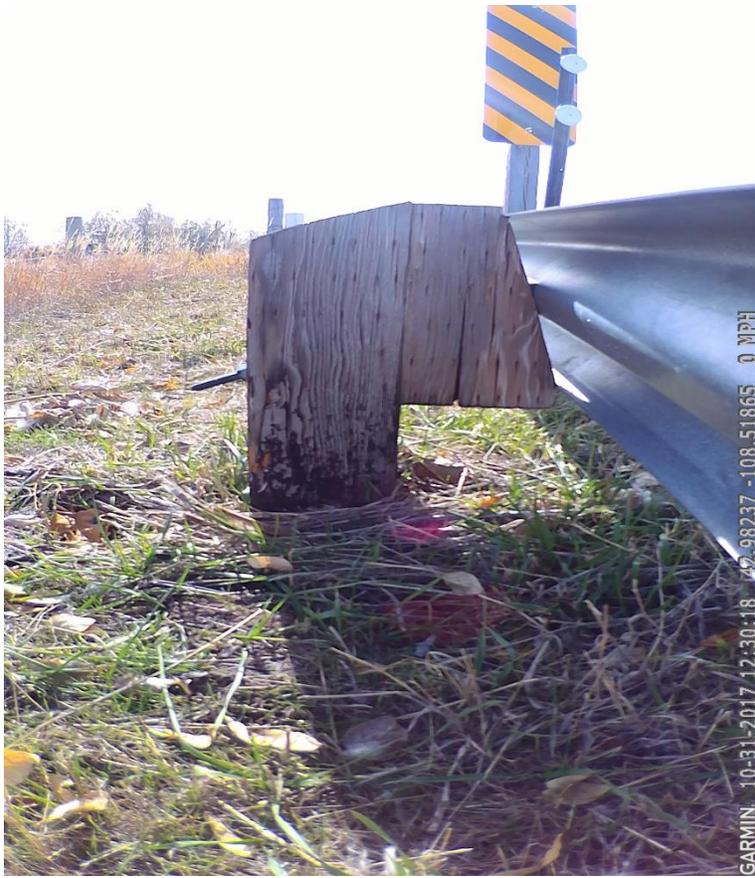
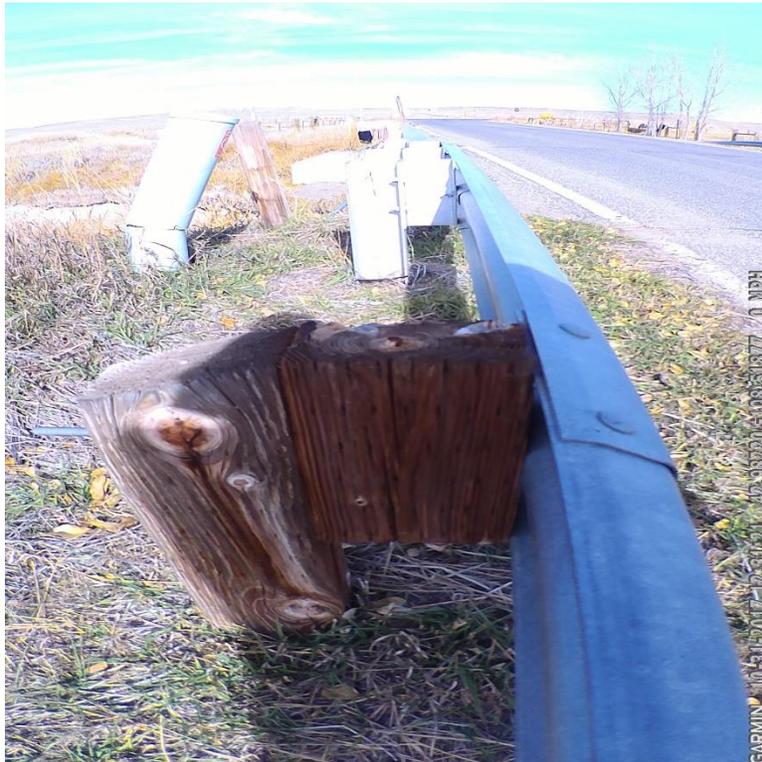
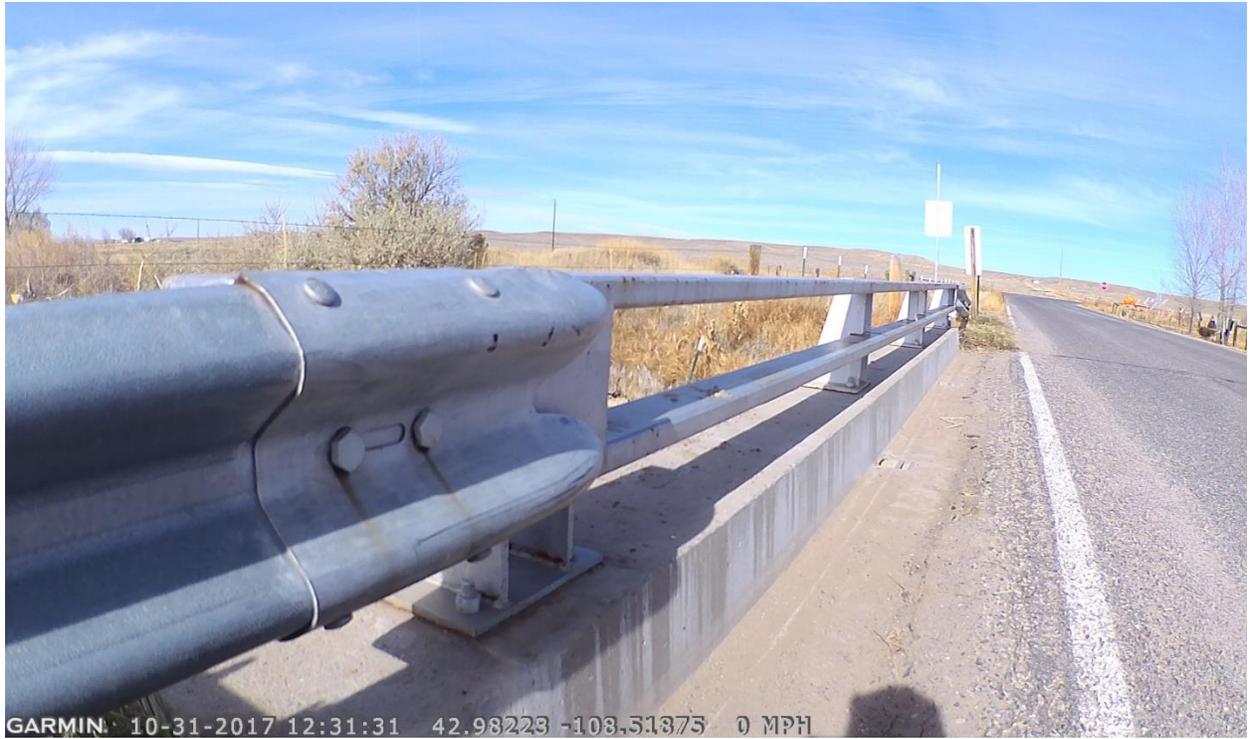
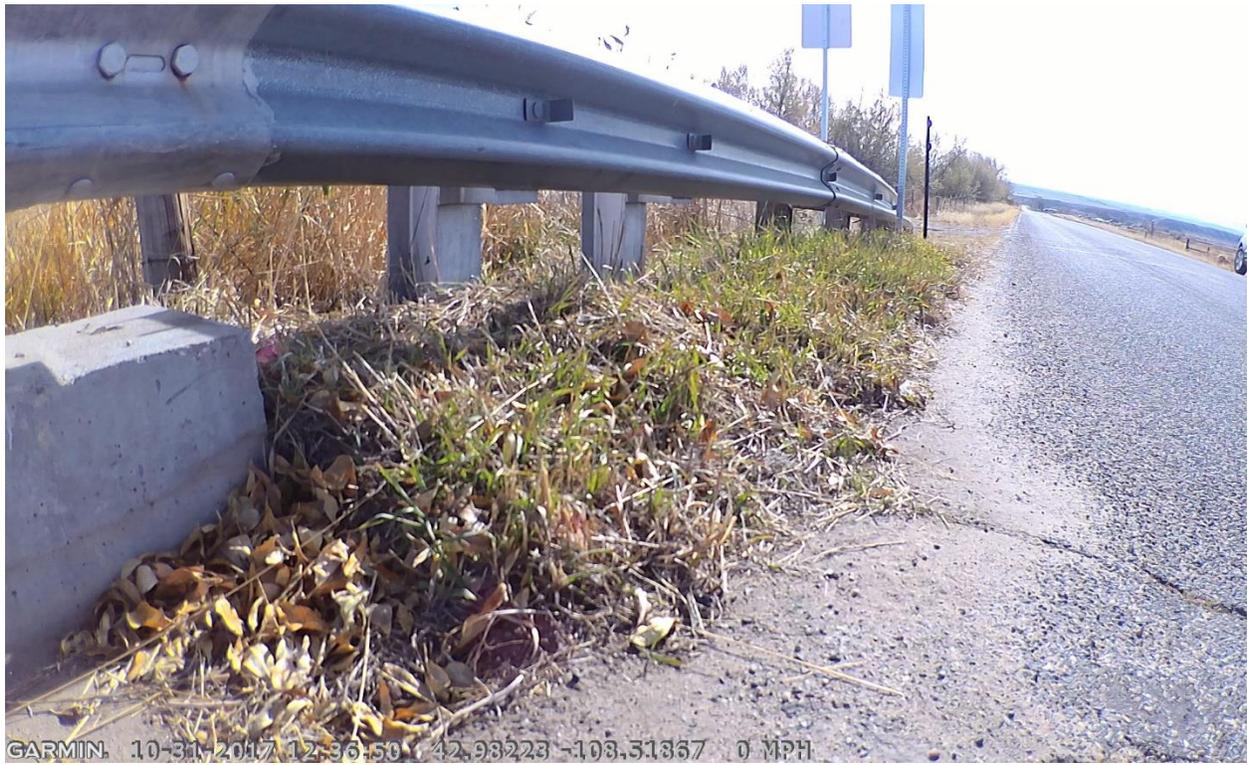
Site No. 2

The barrier system at site No. 2 has a Wyoming Two-Tube Bridge Railing” on the bridge and W-Beam guardrails as the end-treatments. No serious problems were observed for the barrier segment on the bridge but a low-severity deterioration due to the weather is shown in Figure 8.

End-treatments seemed to be in good condition. Despite the good shape of the guardrails, there was a serious problem regarding the height of the end-treatments due to improper installation. In fact, the existing end-treatments has a turned-down terminal which was popular in the early 1960; however, this type of the terminal failed based on tests done by Federal Highway Administration (FHWA) and it is not acceptable to use turned-down terminals since 1994 (Wiebelhaus et al. 2013). The existing end-treatment can be called as a “W-Beam Guardrail Anchored (Buried) in Backslope” with wrong installation. An ideal backslope of 1V:2H is suggested (AASHTO 2011) for this type of end-treatment, while the topography of the location has no backslope. In this situation, a different type of end-treatment is more appropriate. Figure 9 shows a comparison between the existing end-treatments and the acceptable type based on RDG (AASHTO 2011).

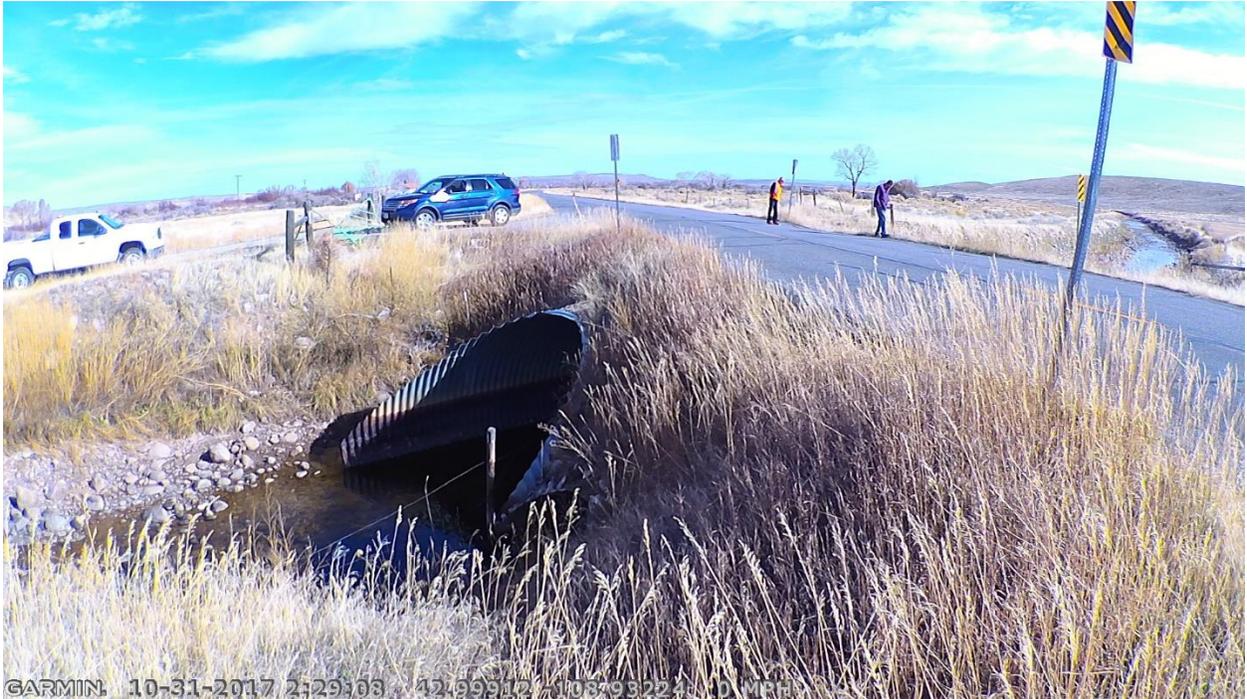
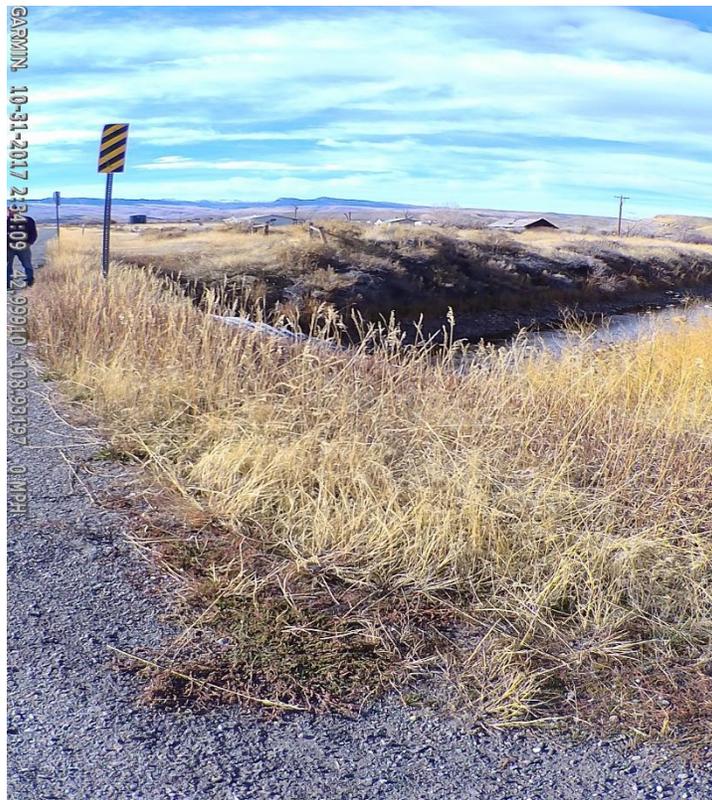
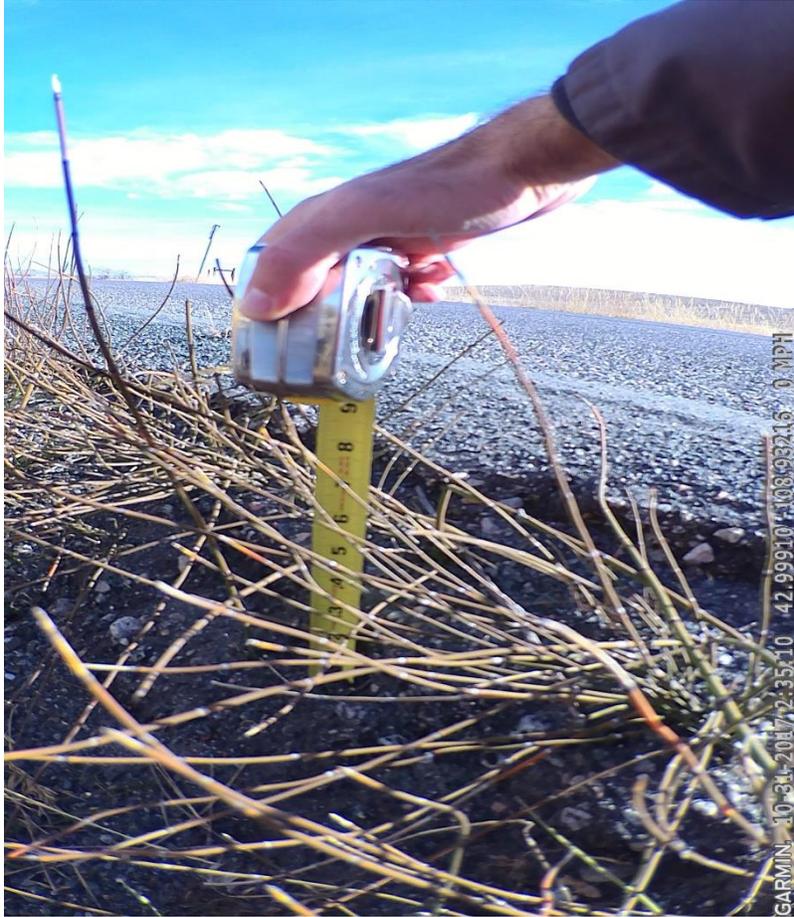
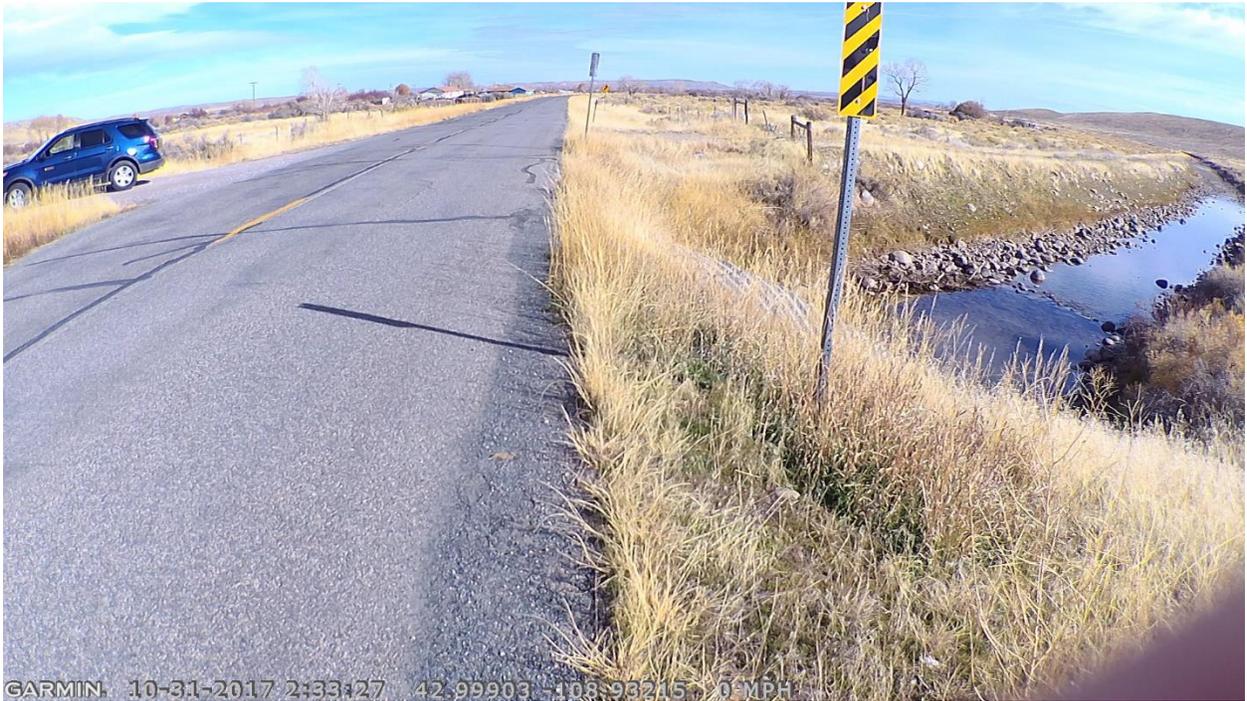
Site No. 4

- The existing road had a pavement width of 24 ft. This width is adequate for having two proper traffic lanes; however, a minimum width of 2 ft on each side is required for establishing the new barrier system.
- Soil erosion (or shoulder drop-off) with a height of 5 inches was observed all along the bridge on each side. This point should be considered regarding providing proper height for the barrier.
- As a restriction in the design phase, there were four adjacent entrances (to private properties) which could limit the length of the barrier system.
